Keeyask Generation Project Terrestrial Effects Monitoring Plan

Habitat Loss and Disturbance Monitoring Report

TEMP-2019-01

By
ECOSTEM Ltd.

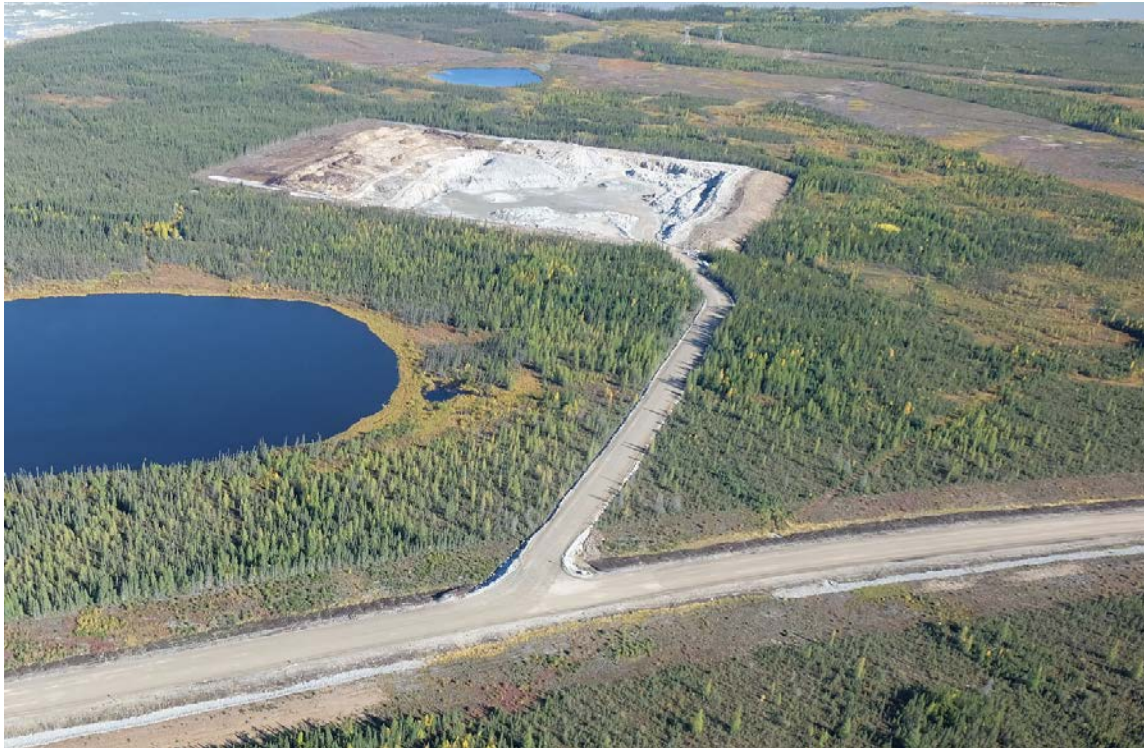
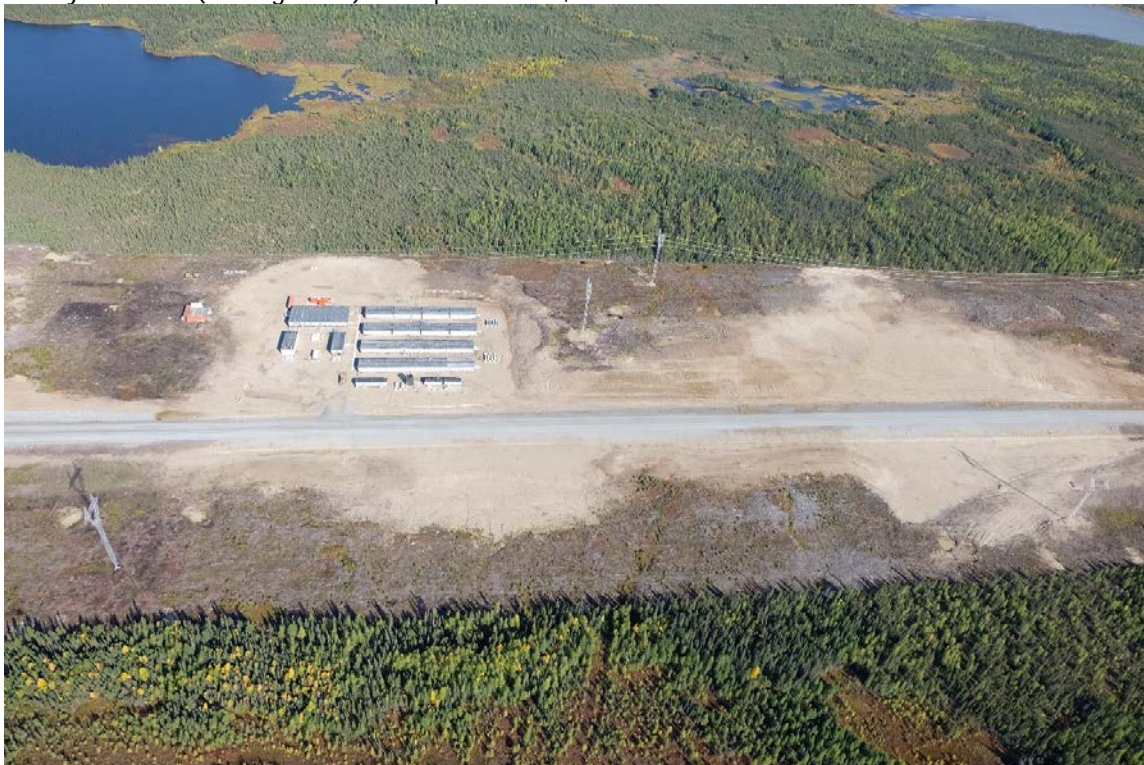
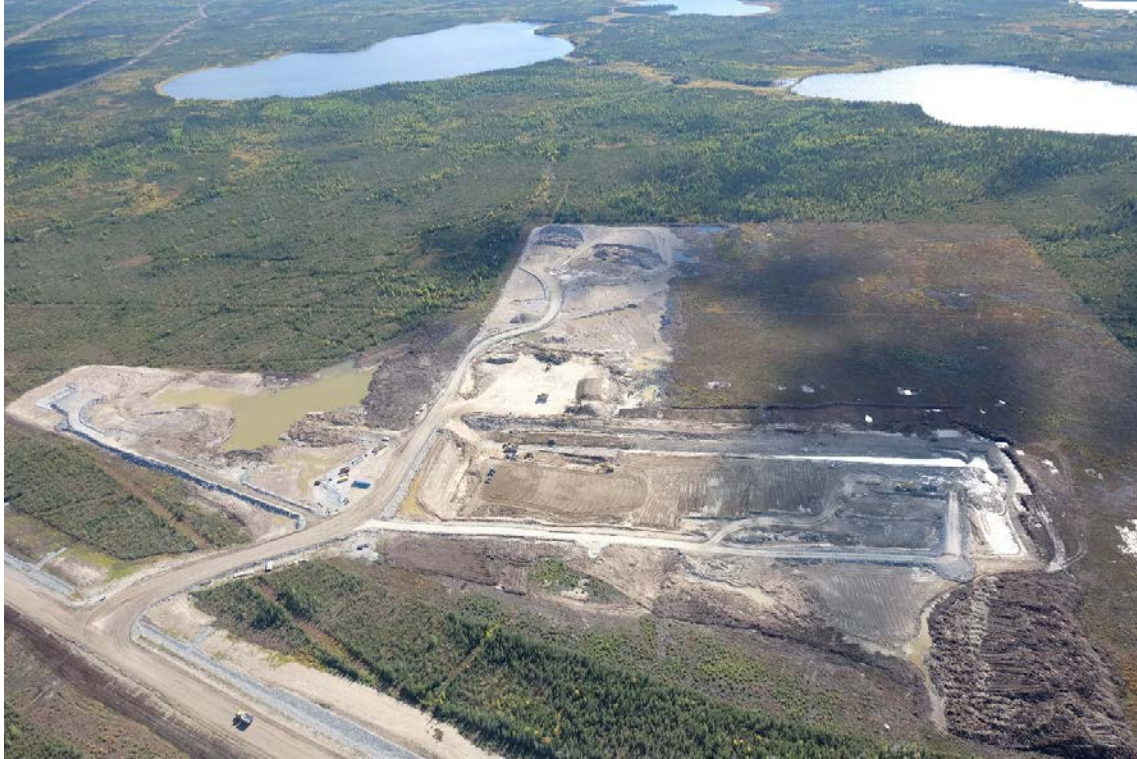
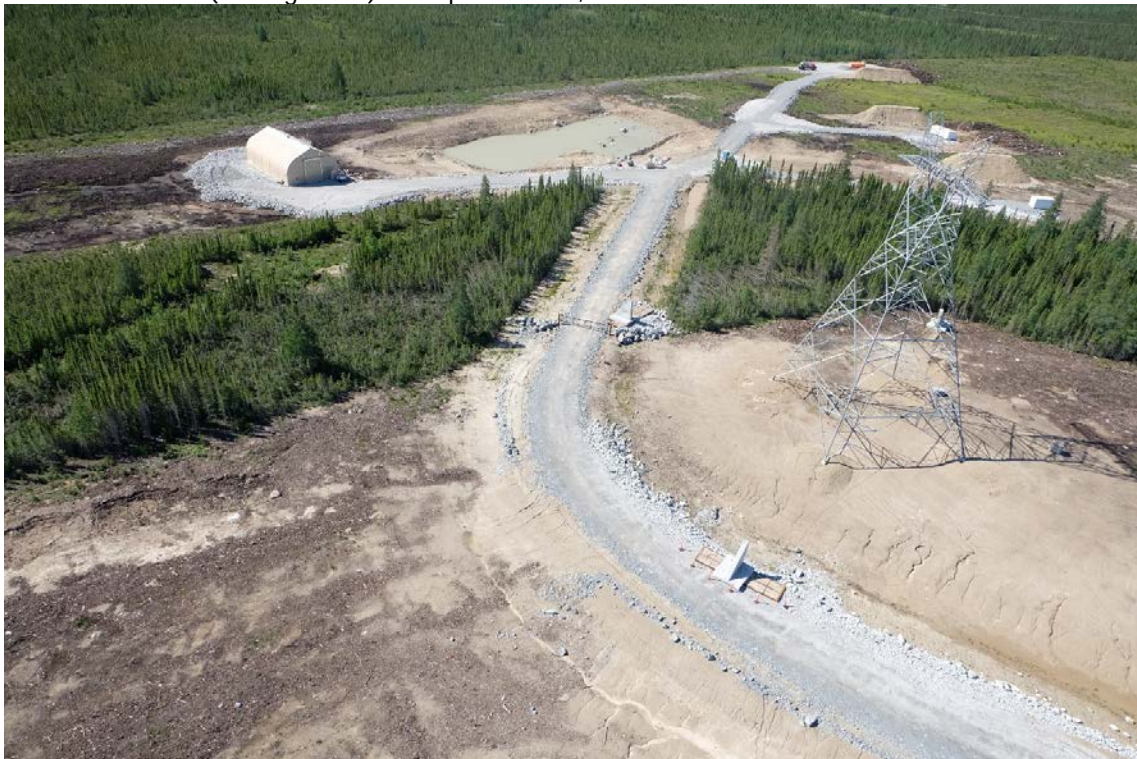
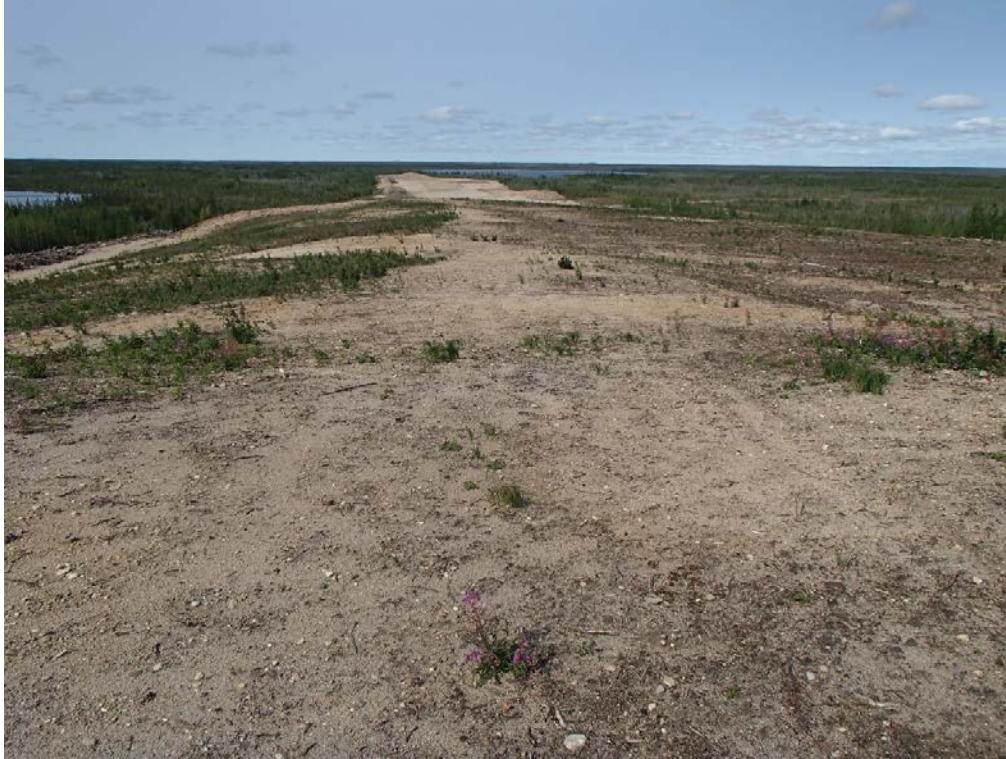
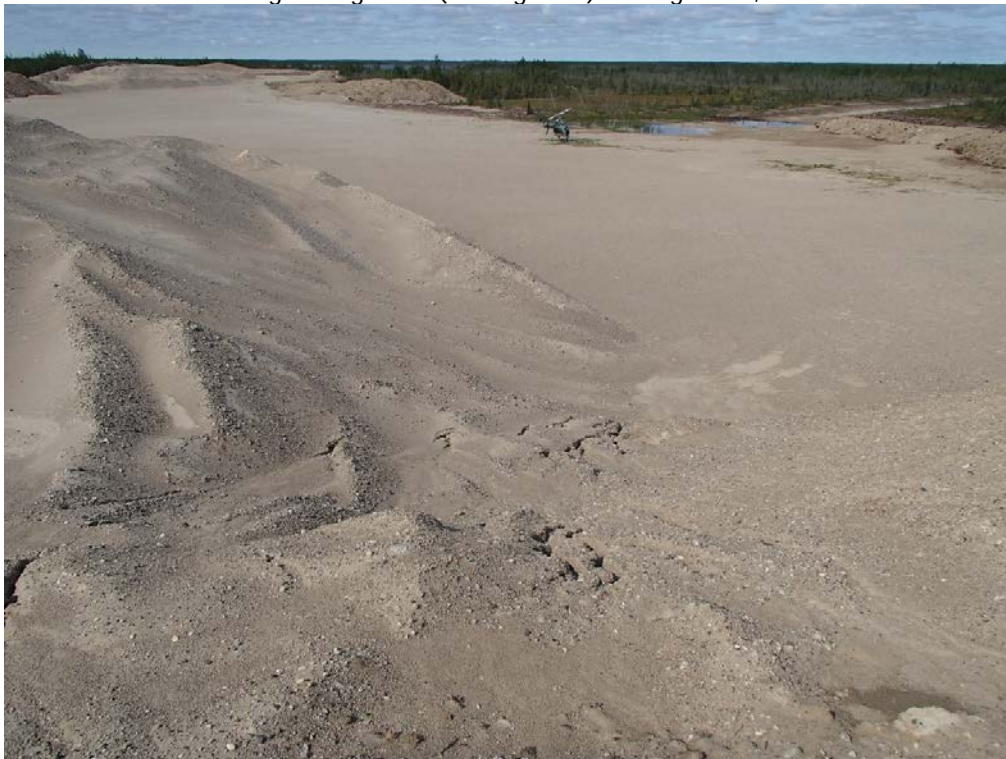
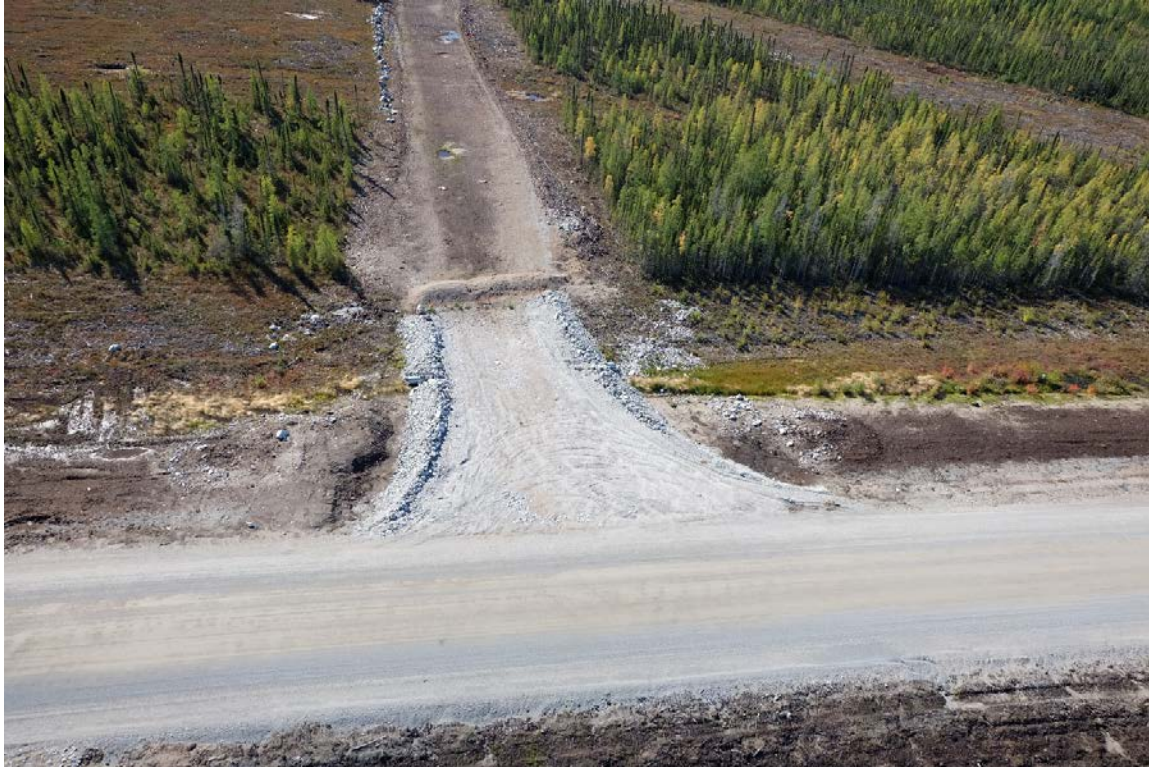
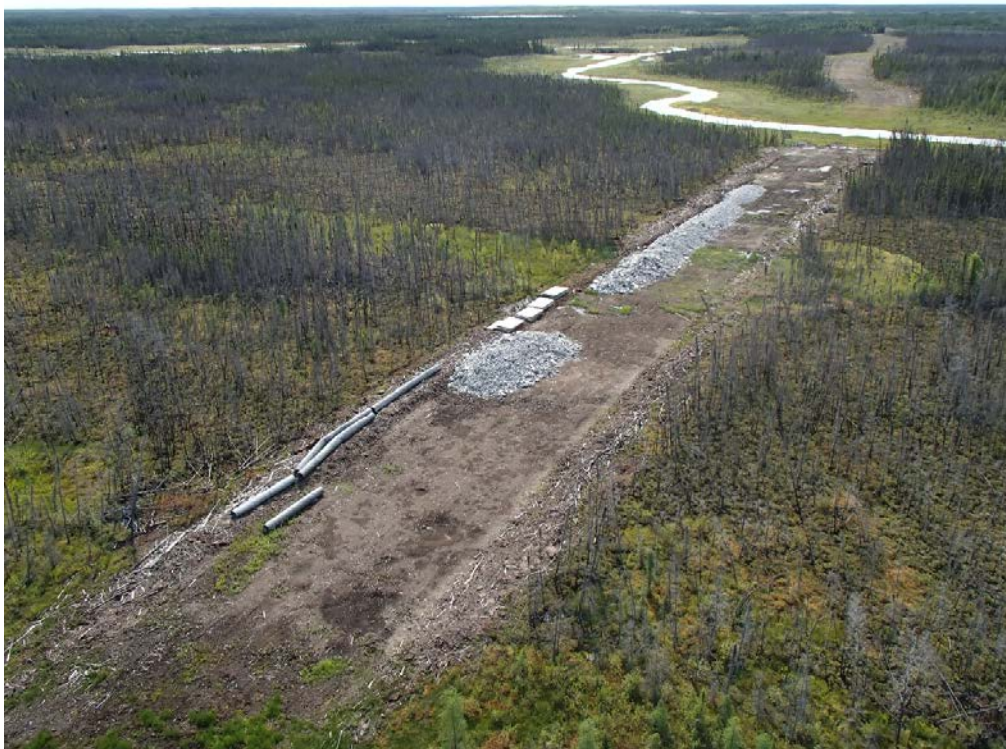
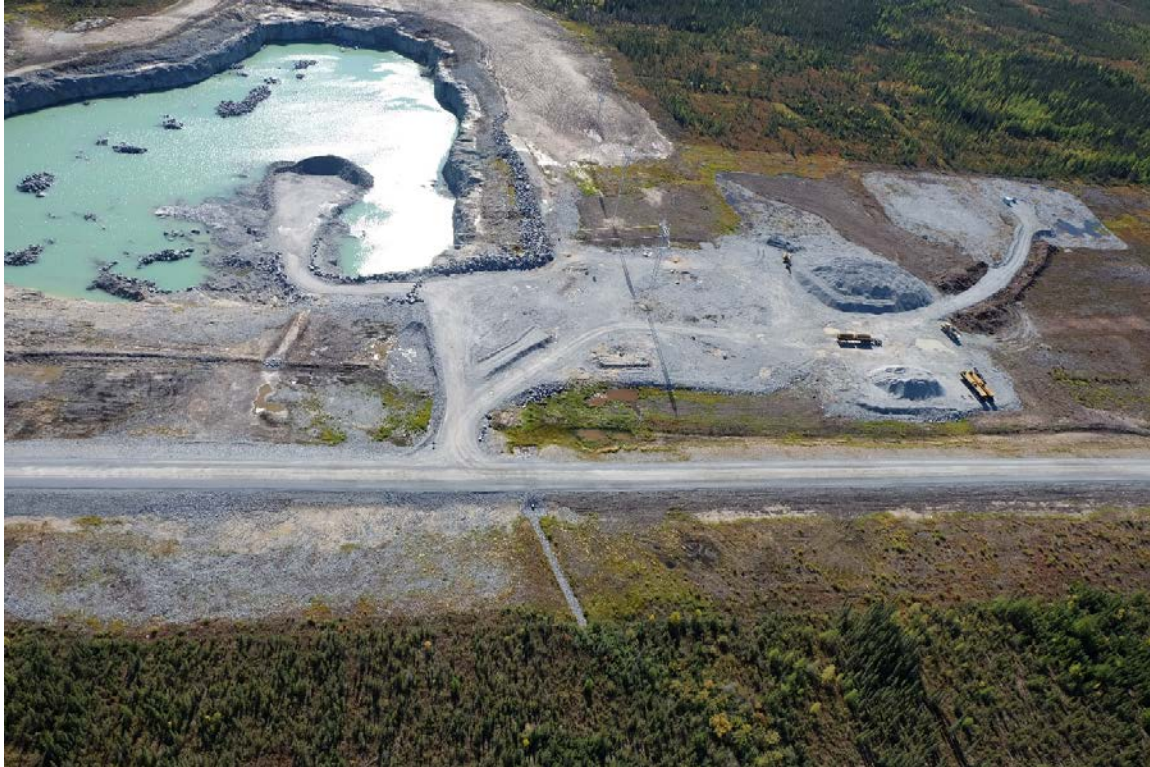
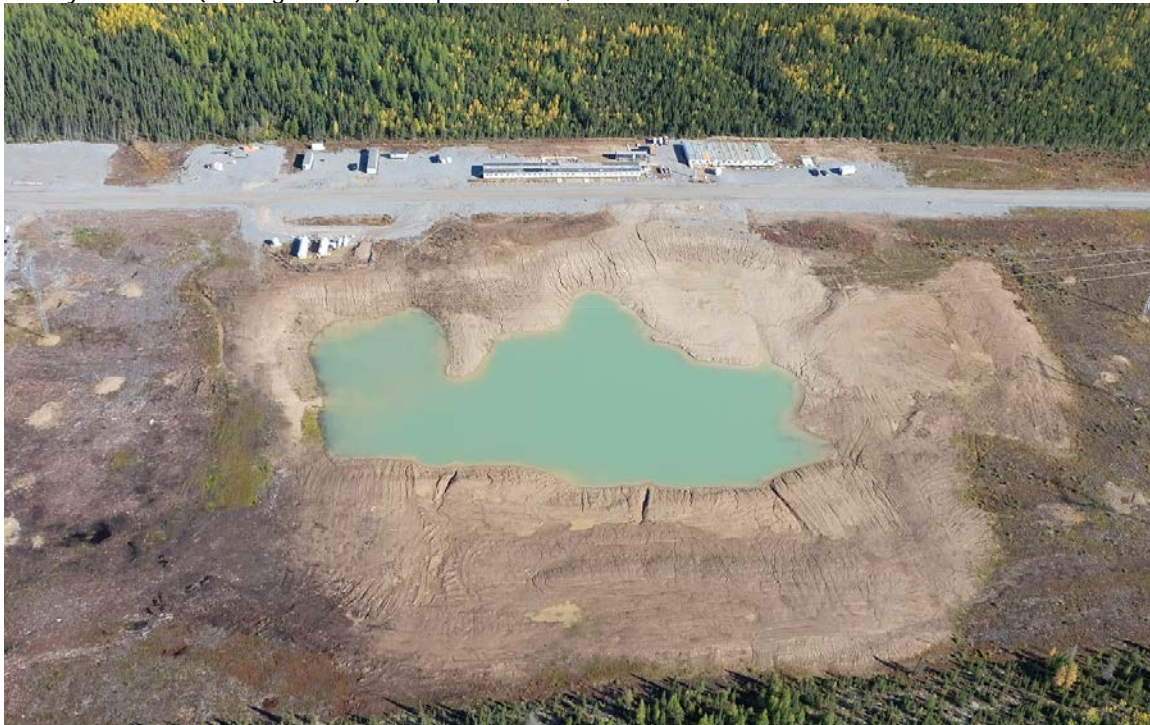
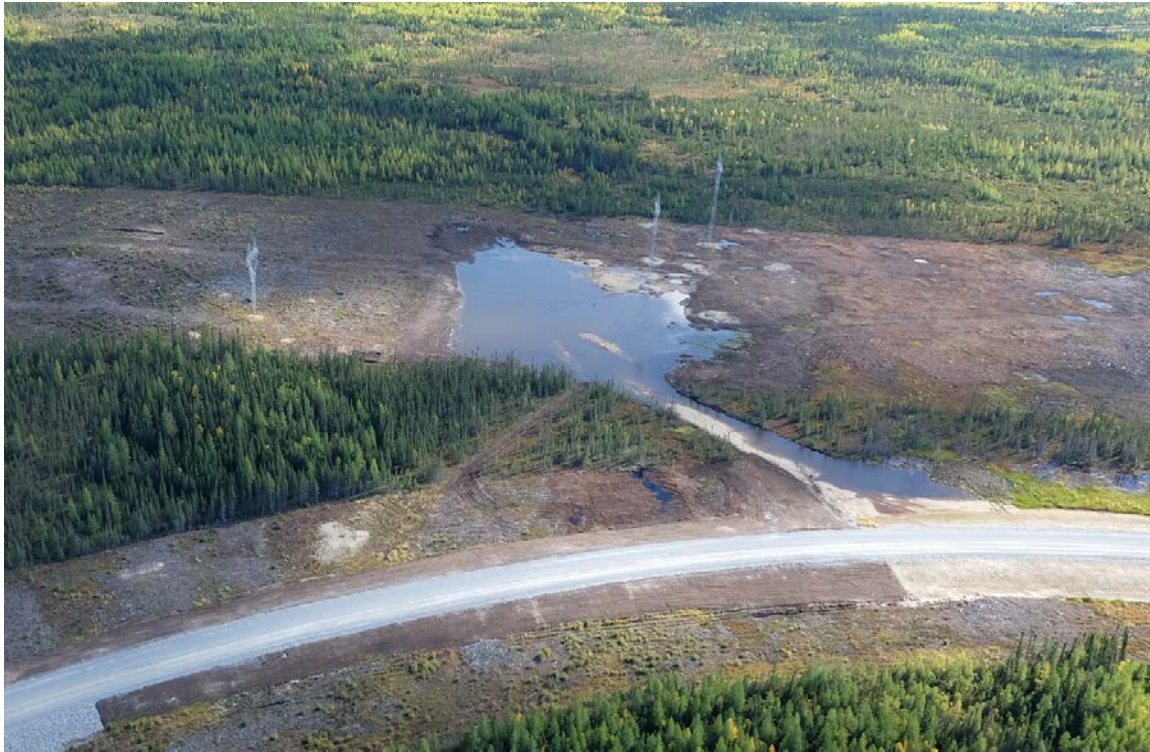
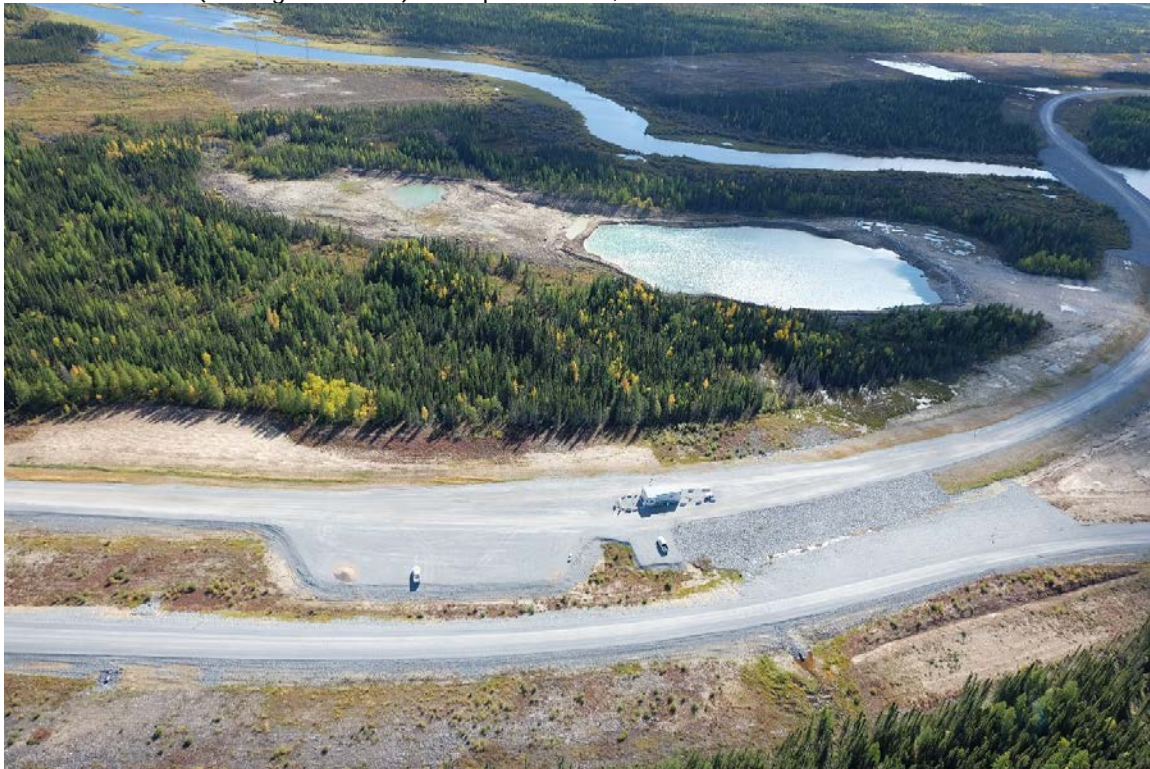
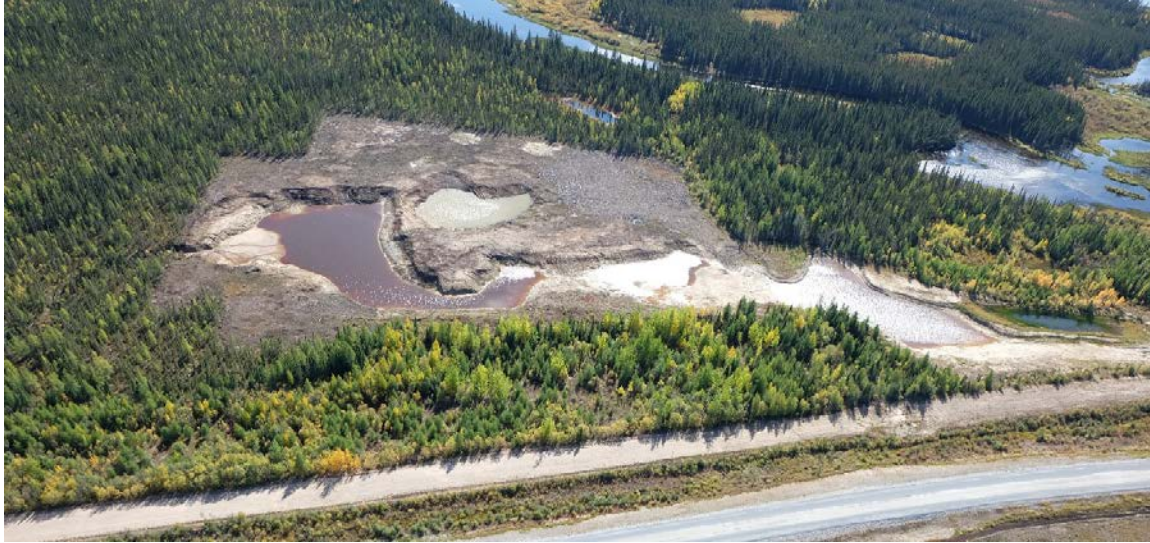
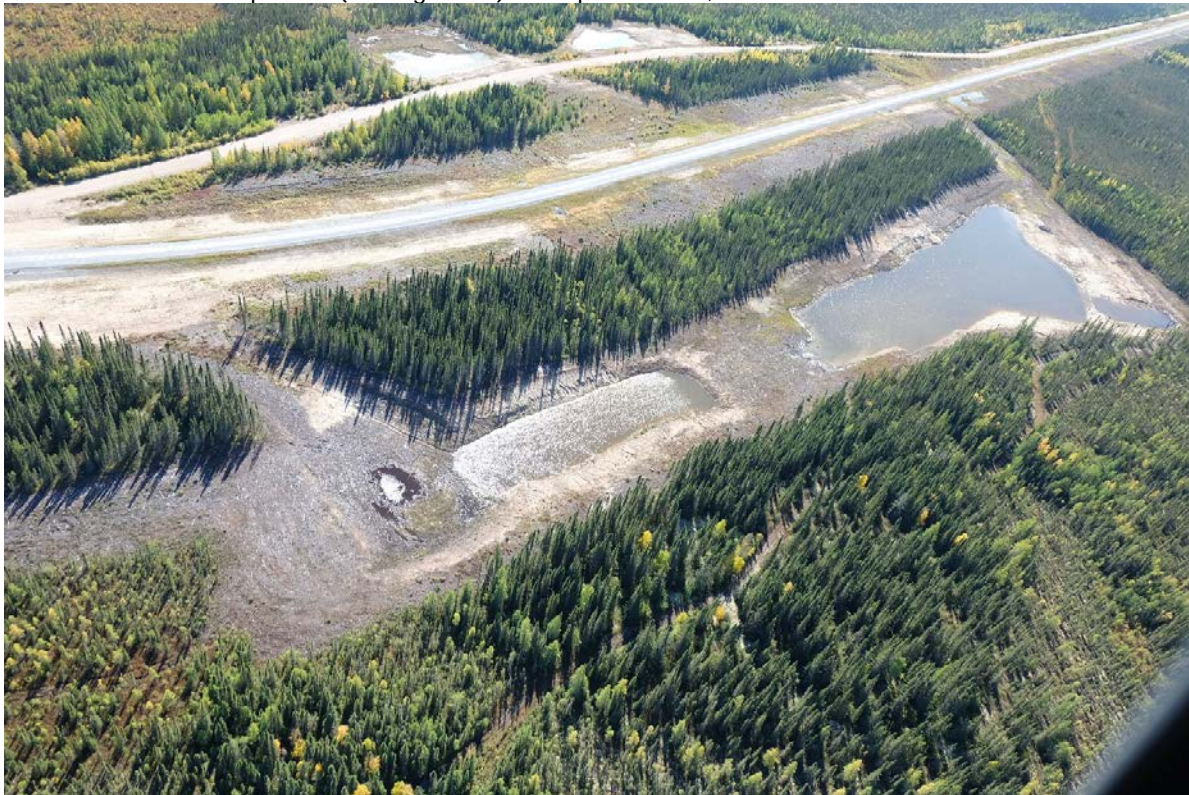
Figure 3-8: Clearing and excavation in borrow areas south of the Nelson River

Quarry Area Q-1 (looking north) on September 15, 2018

Borrow Area B-2 (looking north) on September 15, 2018

Borrow Area S-2a (looking south) on September 15, 2018

Borrow Area S-2b (looking southwest) on September 15, 2018

Borrow Area E-1 clearing from ground (looking west) on August 24, 2018

Borrow Area E-1 excavation from ground (looking northwest) on August 24, 2018

Borrow Area E-1 access entrance (looking south) on September 15, 2018

Borrow Area E-1 access at stream crossing (looking south) on August 24, 2018

Quarry Area Q-9 (looking south) on September 15, 2018

Borrow Area B-3 (looking north) on September 15, 2018

Borrow Area B-5 (looking southeast) on September 15, 2018

Borrow Area B-6 west portion and SAR Gate (looking south) on September 15, 2018

Borrow Area B-6 east portion (looking south) on September 15, 2018

Borrow Area B-8 (looking southwest) on September 15, 2018

Between September 2017 and 2018, most (55 ha) of the new vegetation clearing associated with borrow areas was for the newly developed Borrow Area E-1 and its 8.6 km winter access road (Figure 3-8). The remaining borrow area clearing was an approximately 2.5 ha expansion of Borrow Area Q-1.

On the south side of the Nelson River, a portion of Borrow Area B-2 had been developed into a temporary camp area (Figure 3-8). The camp was not in use at the time of the 2018 surveys.

In total, there was 58 ha of borrow area clearing within the possibly disturbed Project footprint as of September 2018 (Table 3-3). This was a nearly 52 ha increase from September 2017. The large increase was due to the clearing of Borrow Area E-1, none of which was in the planned Project footprint. Clearing or disturbance outside of the approved Project footprint associated with borrow area clearing increased to 5.39 ha in 2018, all of which was associated with Borrow Area E-1 (Figure 3-8; Map 3-2; Appendix 1: Table 6-1).

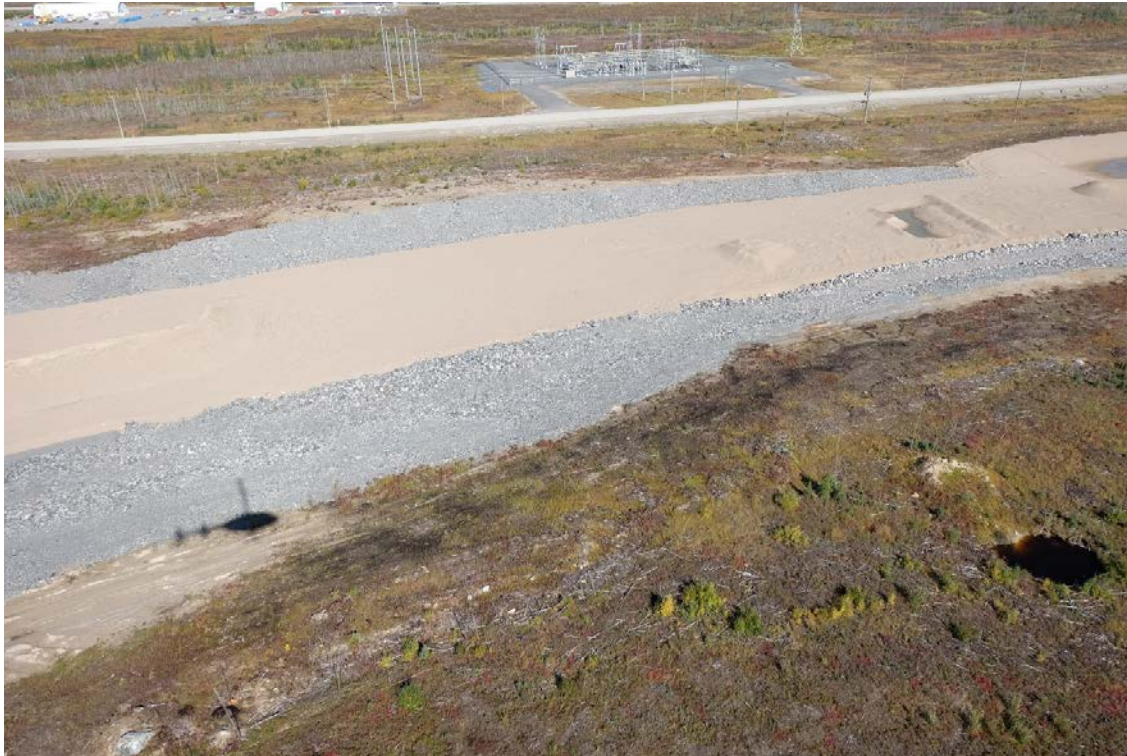
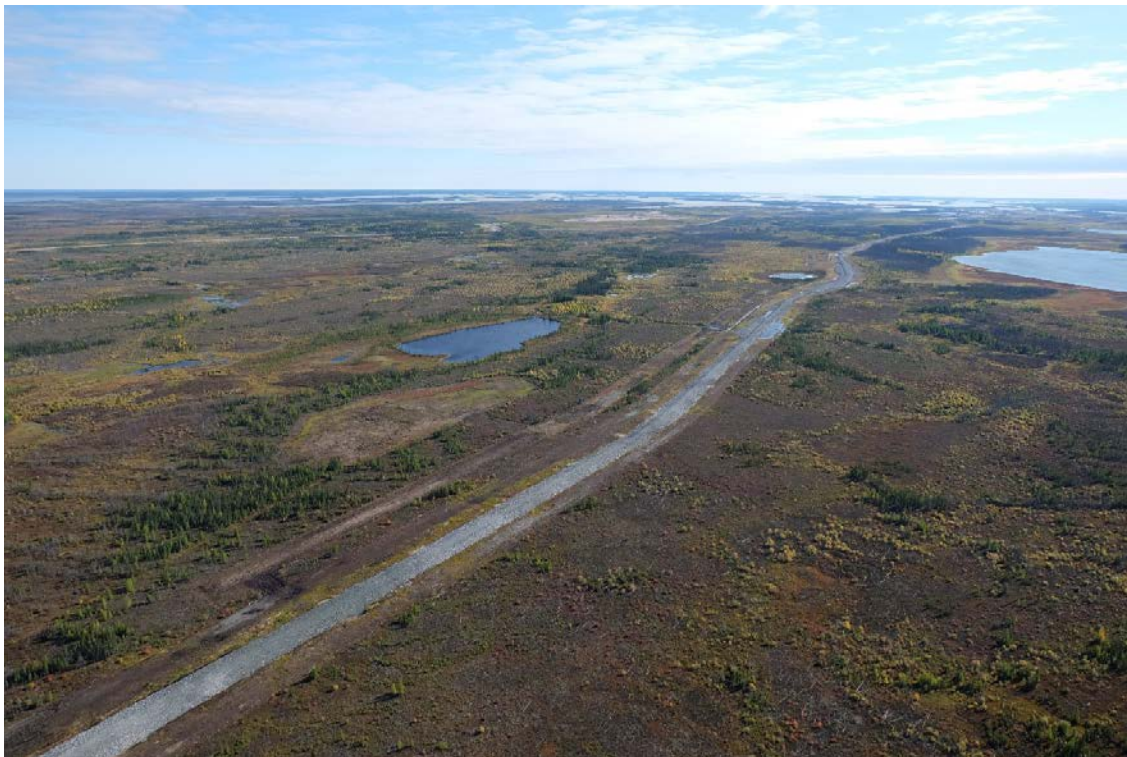
Figure 3-11: North dyke

North dyke, near east end (looking north) on September 15, 2018.

North dyke, near west end (looking east) on September 15, 2018

Between September 2017 and 2018, an additional 1 ha of new clearing had occurred along the North Dyke as its construction continued (Figure 3-11). Additionally, 8 ha of new clearing was present along the South Dyke (Map 3-2; Figure 3-12). Since September 2017, several sections of the South Dyke were gravelled, and the east end of the dyke was under active construction at the time of the 2018 surveys.

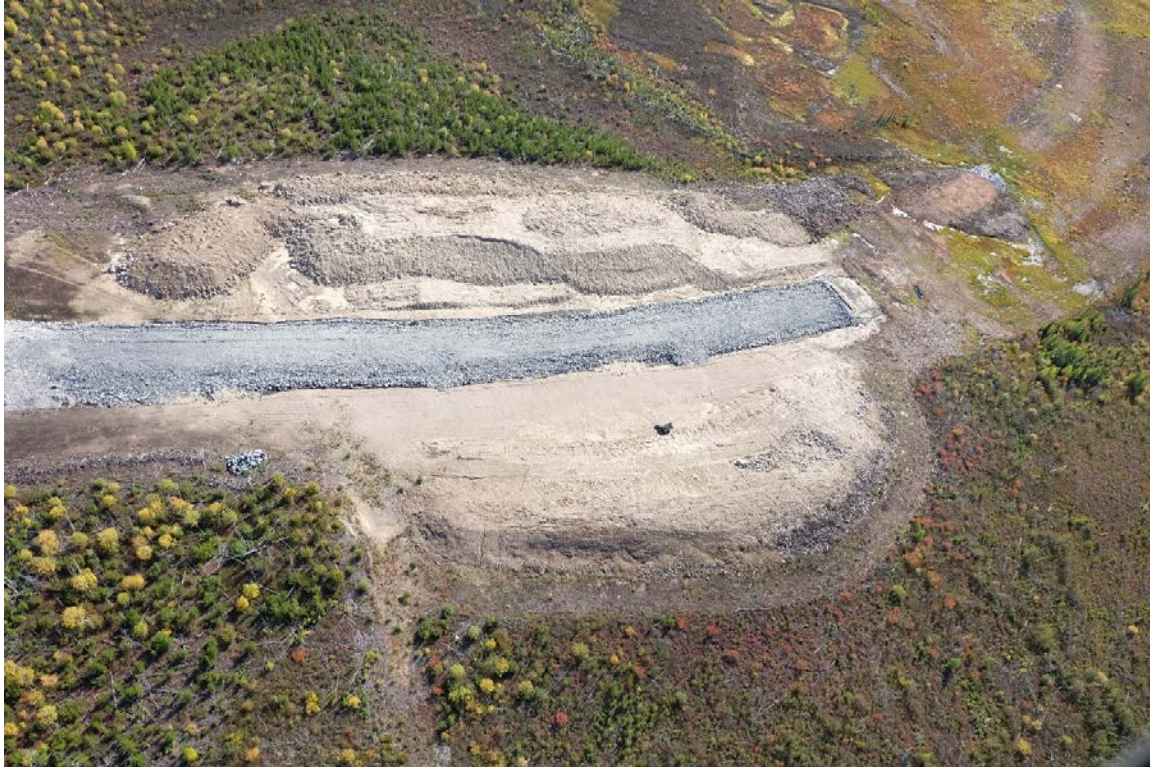
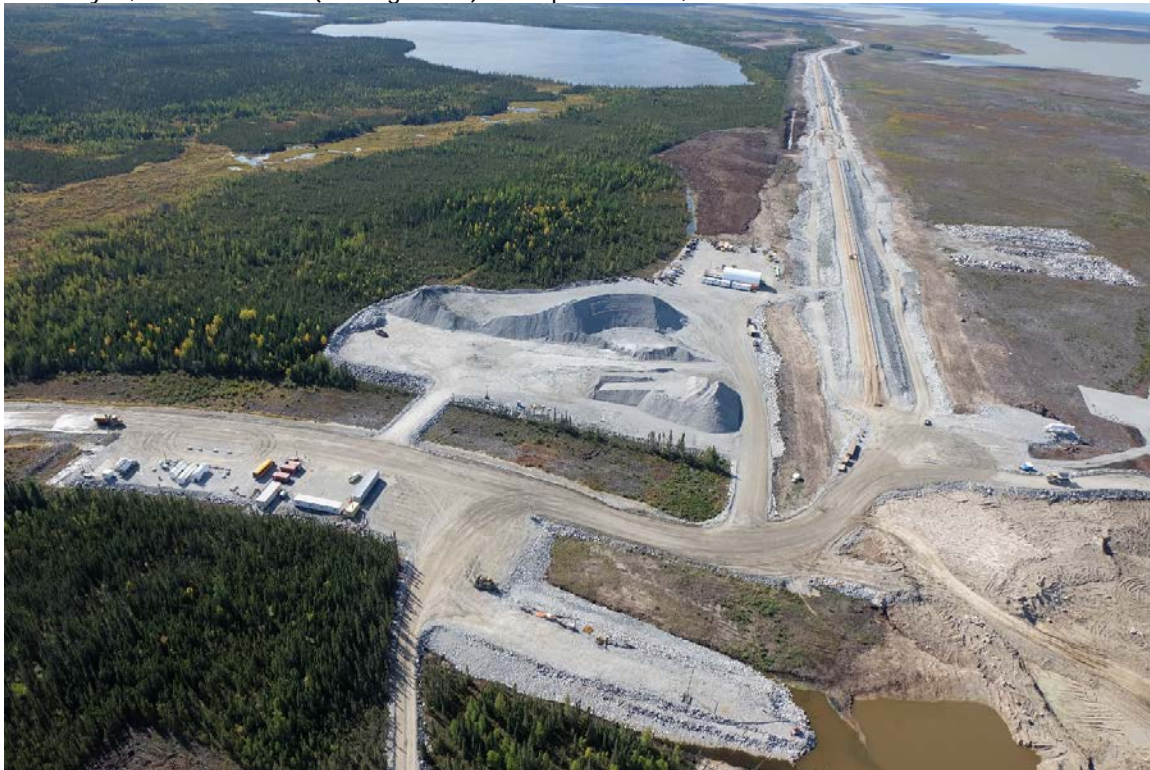
Figure 3-12: South dyke

South dyke, near west end (looking south) on September 15, 2018

South dyke, east end (looking west) on September 15, 2018

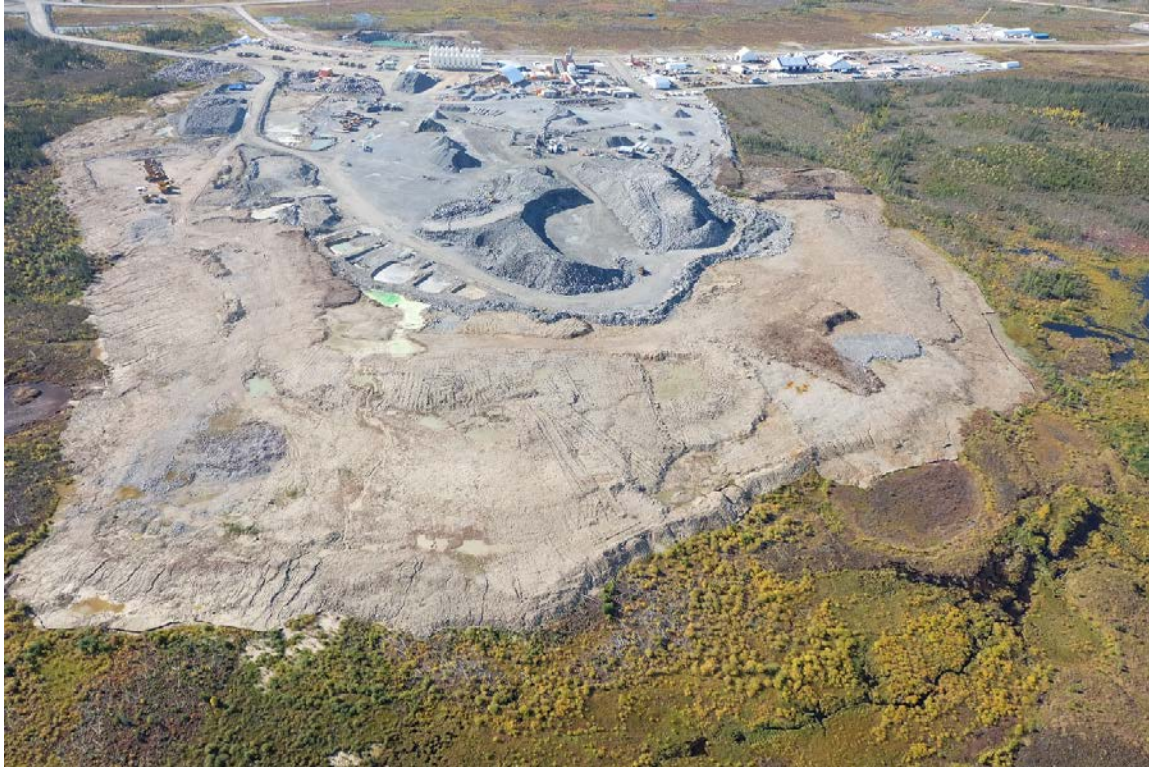
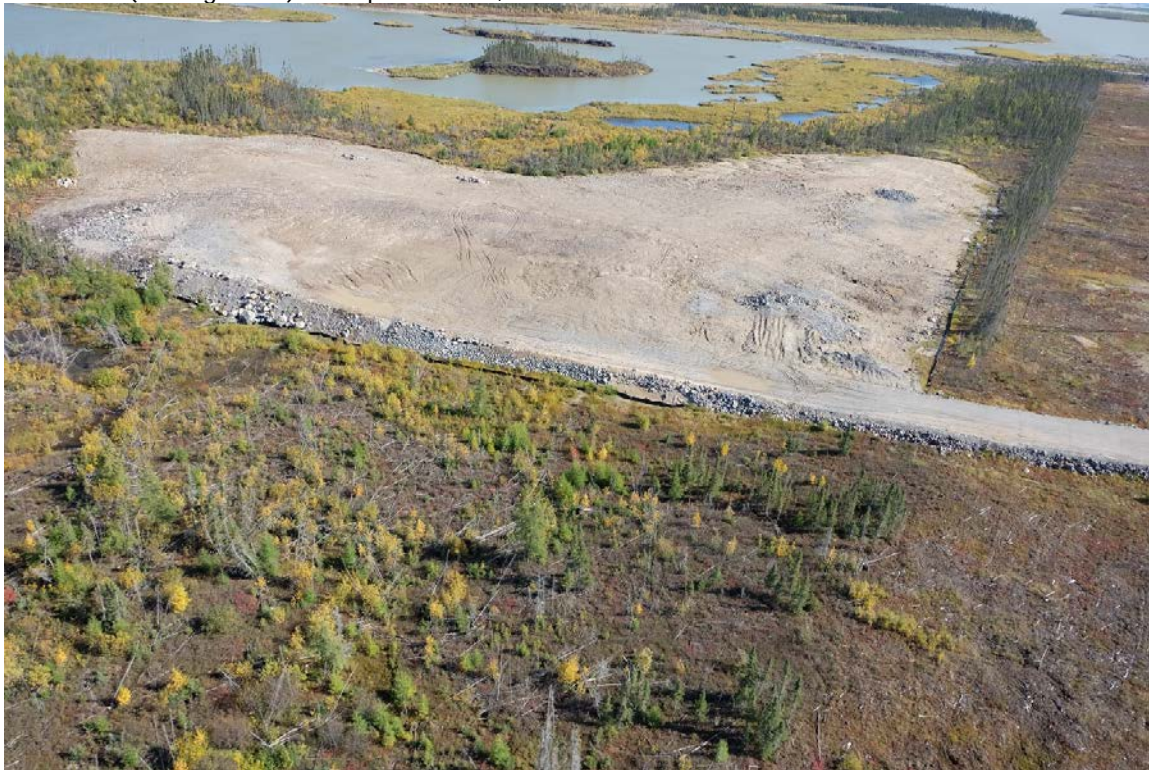
Figure 3-13: Excavated material placement areas in use

EMPA D16 (looking south) on September 15, 2018

EMPA D17 (looking east) on September 15, 2018

The situations at EMPAs D16 and D17 in September 2018 were similar to each other. Between September 2017 and 2018, bank slopes had been graded (Figure 3-13) and erosion was carrying sediment from the banks into undisturbed areas. Measures taken in 2017 and 2018 to contain the sediment transport were not effective at many locations. Grading did not increase the area of EMPA D17. While grading expanded EMPA D16 by approximately 0.21 ha, there was no additional clearing.

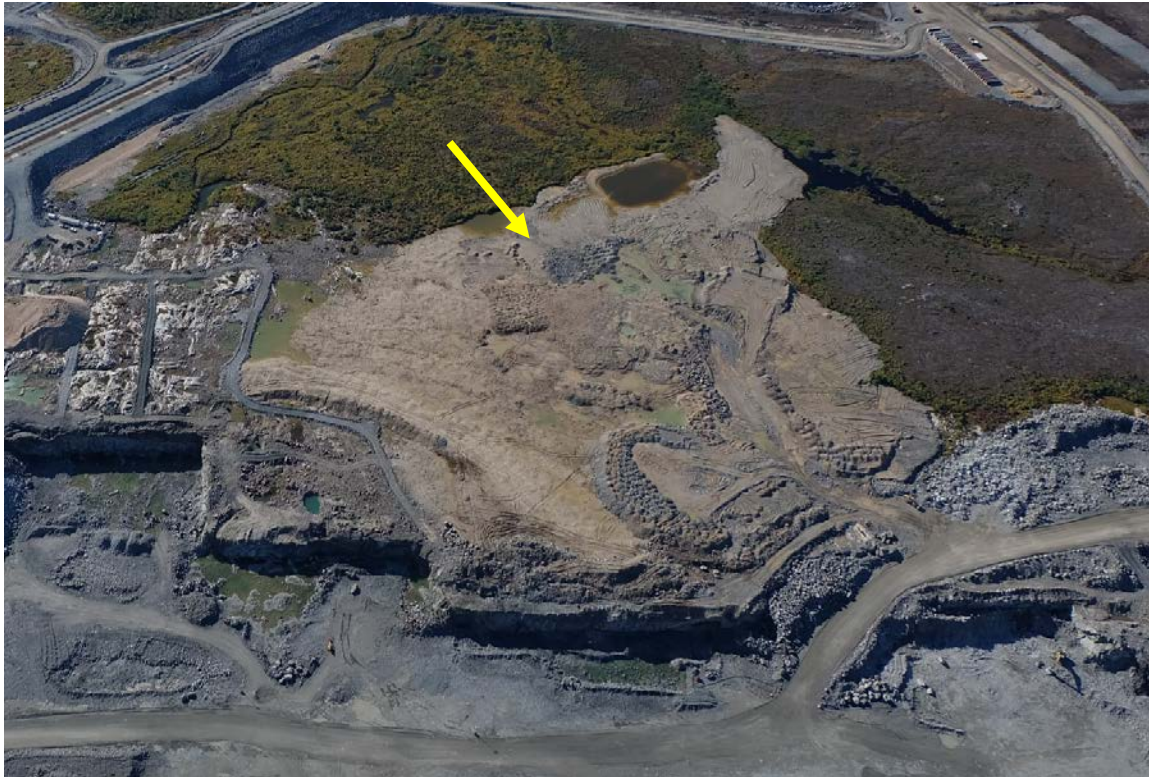
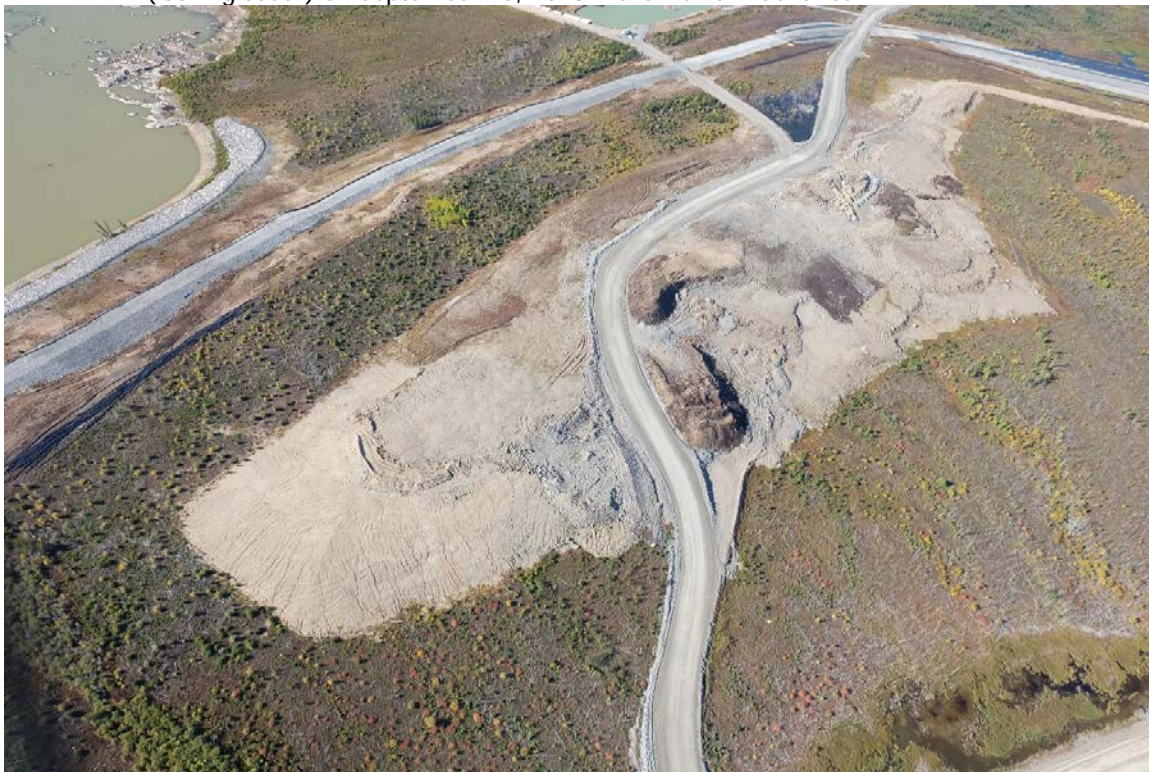
Figure 3–13: Continued...

EMPA D19-I (looking south) on September 15, 2018. Yellow arrow identifies EMPA.

Portion of EMPA D12 (looking southwest) on September 15, 2018

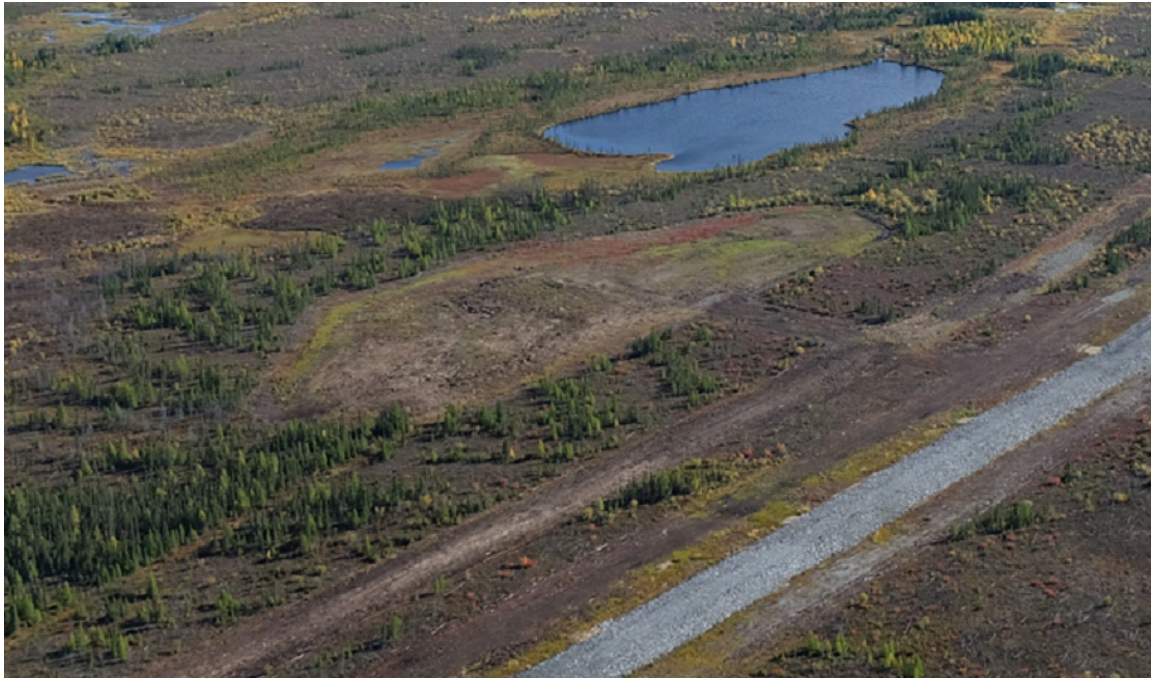
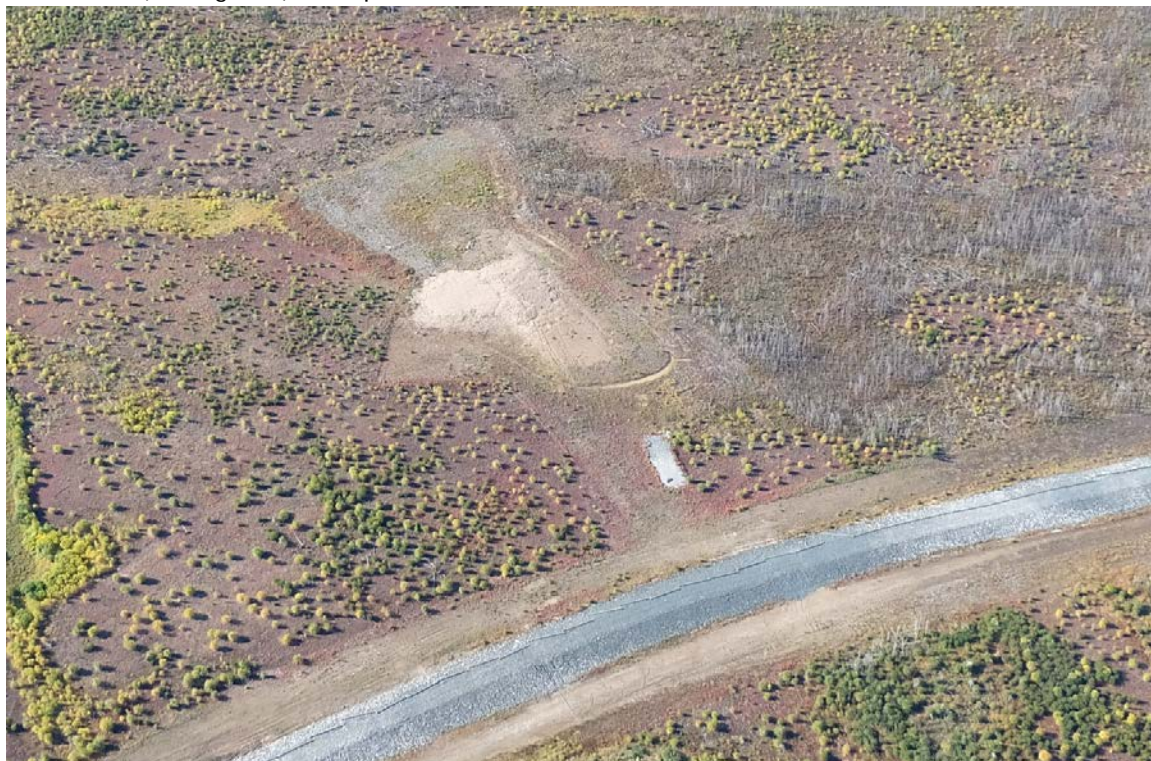
Figure 3–13: Continued...

EMPA D3-E (looking east) on September 15, 2018

EMPA D9-I (looking south) on September 15, 2018

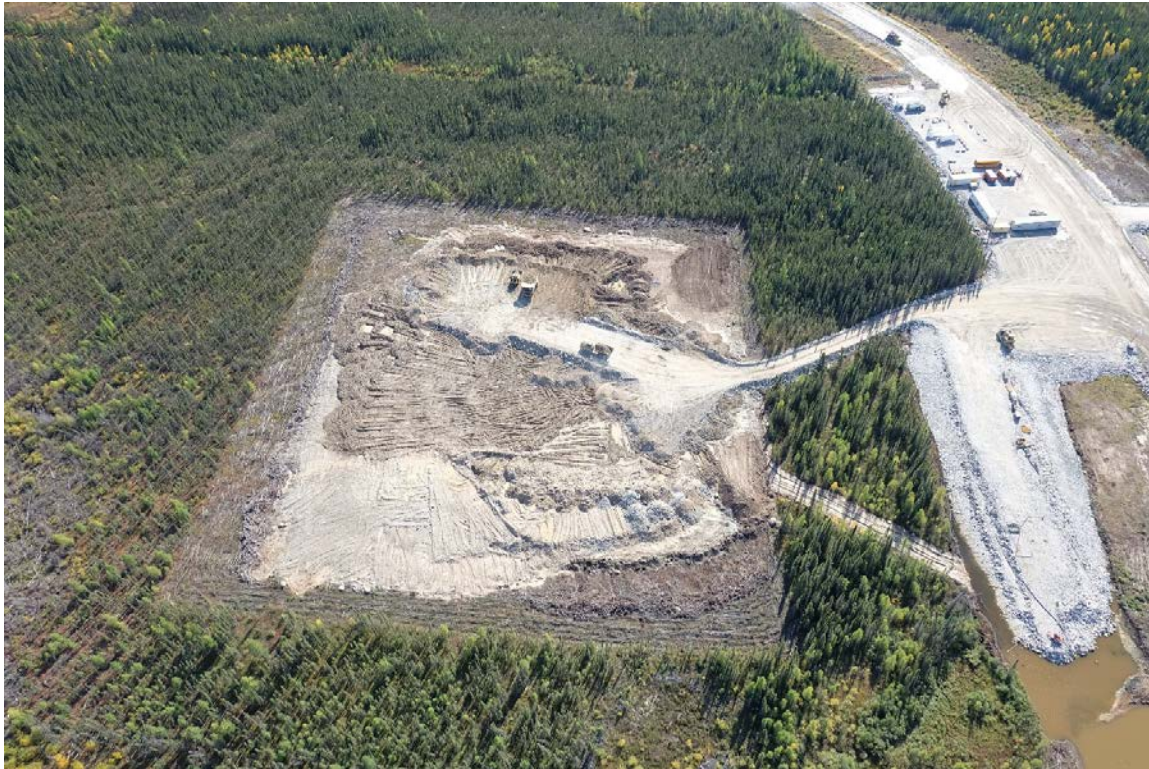
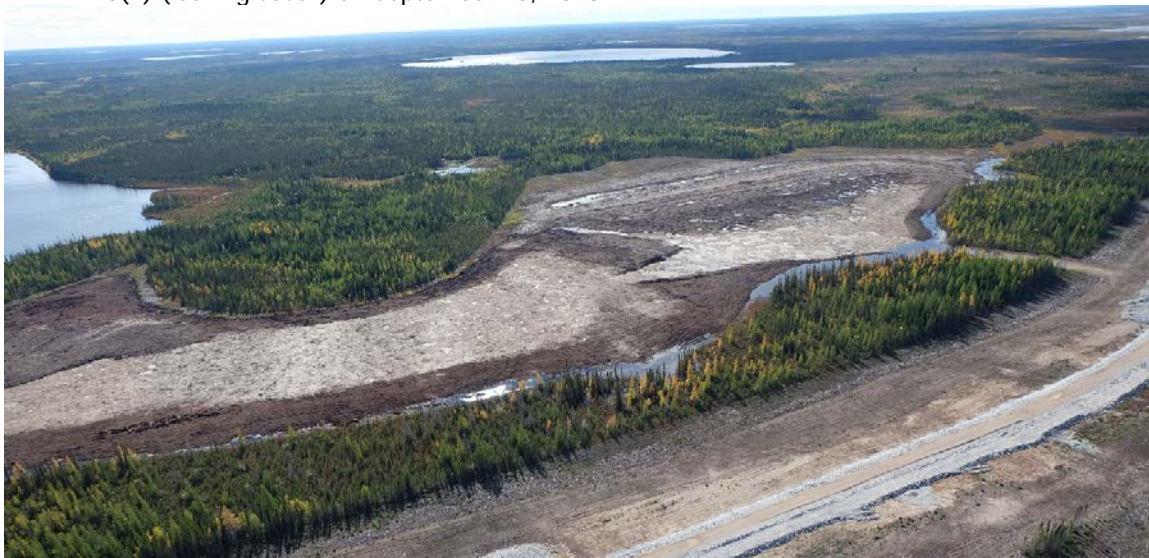
Figure 3–13: Continued...

EMPA D23(2) (looking south) on September 15, 2018

EMPA D27 (looking southwest) on September 15, 2018

EMPAs D27 and D23(1) were in use, but there was no clearing or disturbance outside of the previously cleared boundaries (Figure 3-13). The eastern portion of D23(1) was being utilized as a rock crusher area. By 2018, an additional 3.6 ha had been cleared for EMPA D23(2) on the east side of the SAR (Map 3-2).
