Keeyask Generation Project Terrestrial Effects Monitoring Plan

Habitat Loss and Disturbance Monitoring Report

TEMP-2019-01

By
ECOSTEM Ltd.

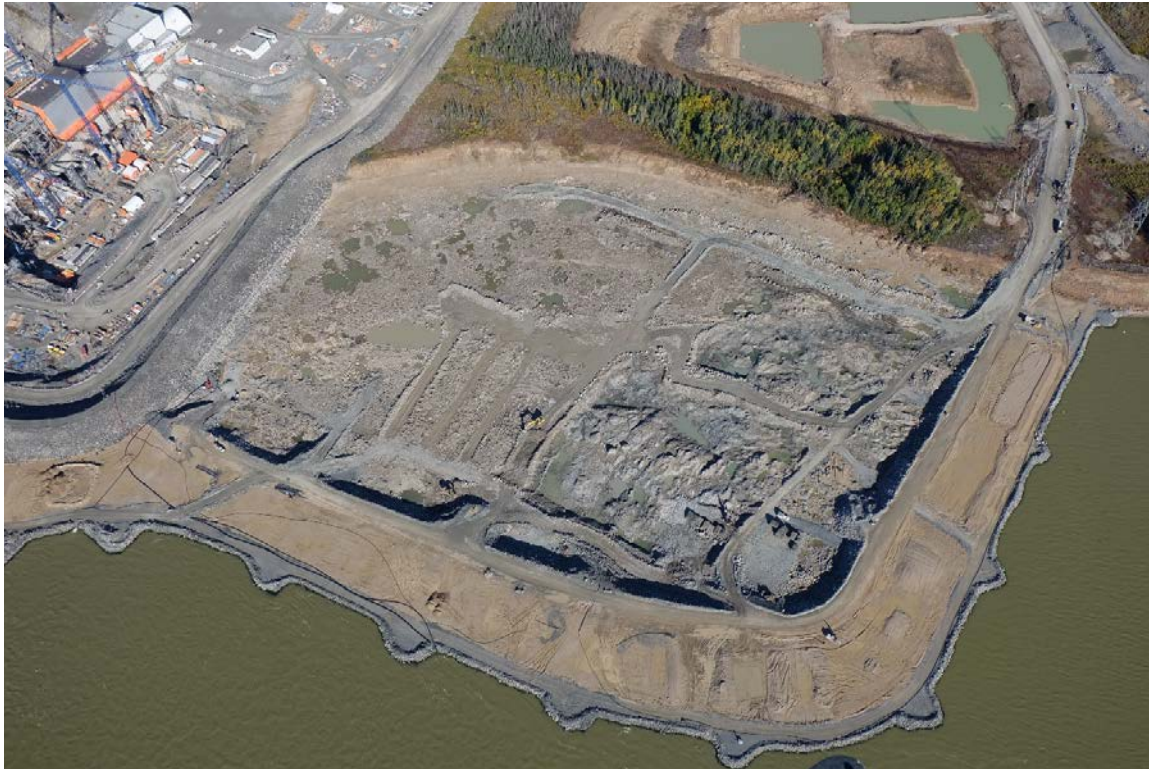
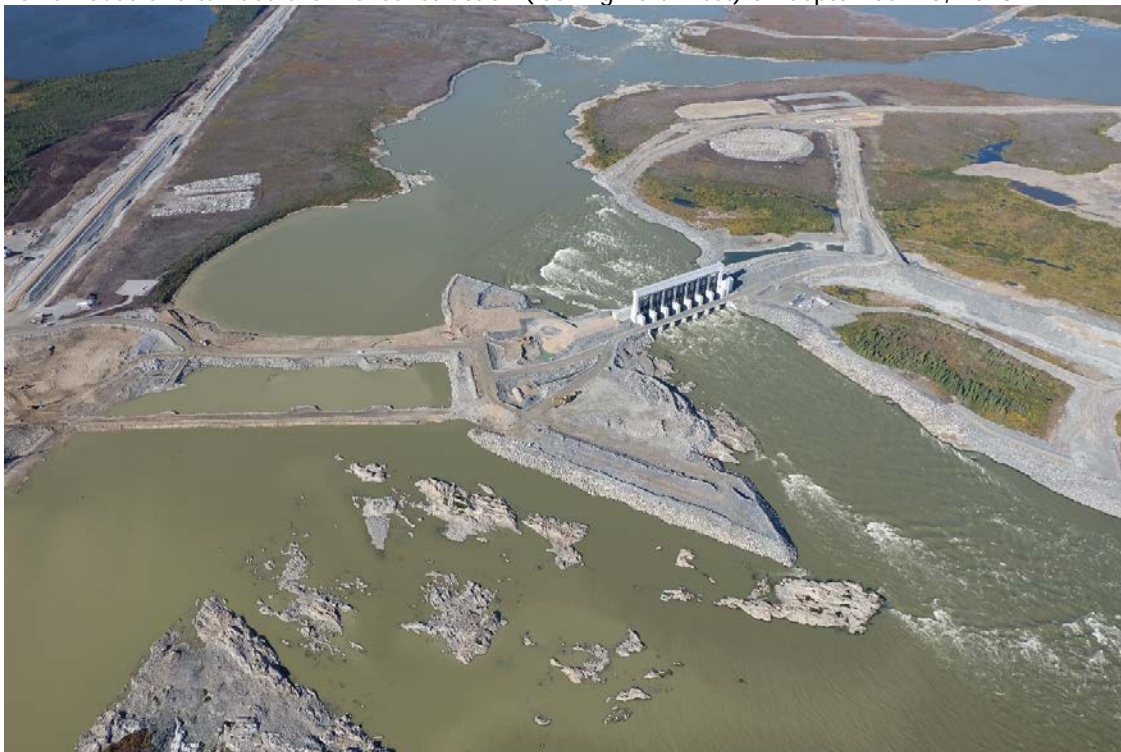
Figure 3-16: Generating station and river works area construction

Powerhouse and tailrace channel construction (looking northwest) on September 15, 2018

Spillway and south dam construction (looking west) on September 15, 2018

Construction of the spillway and tailrace channel summer level cofferdam had been completed prior to September 2018 (Figure 3-16). Following completion of the spillway, the spillway cofferdams were removed, reducing the infrastructure (dewatered area) by approximately 16 ha. Between September 2017 and 2018, an additional 21 ha was dewatered or cleared by new infrastructure in the river works area.

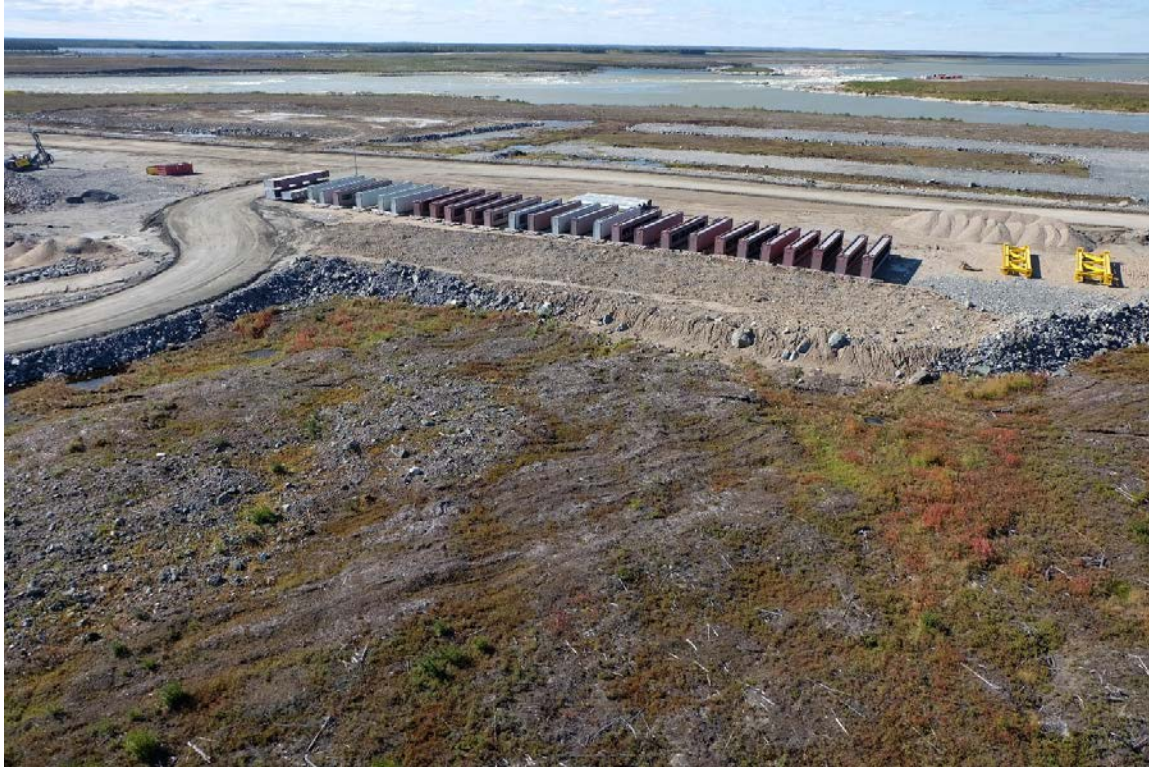
Figure 3–15: Continued...

Spillway laydown area (looking west) on September 15, 2018

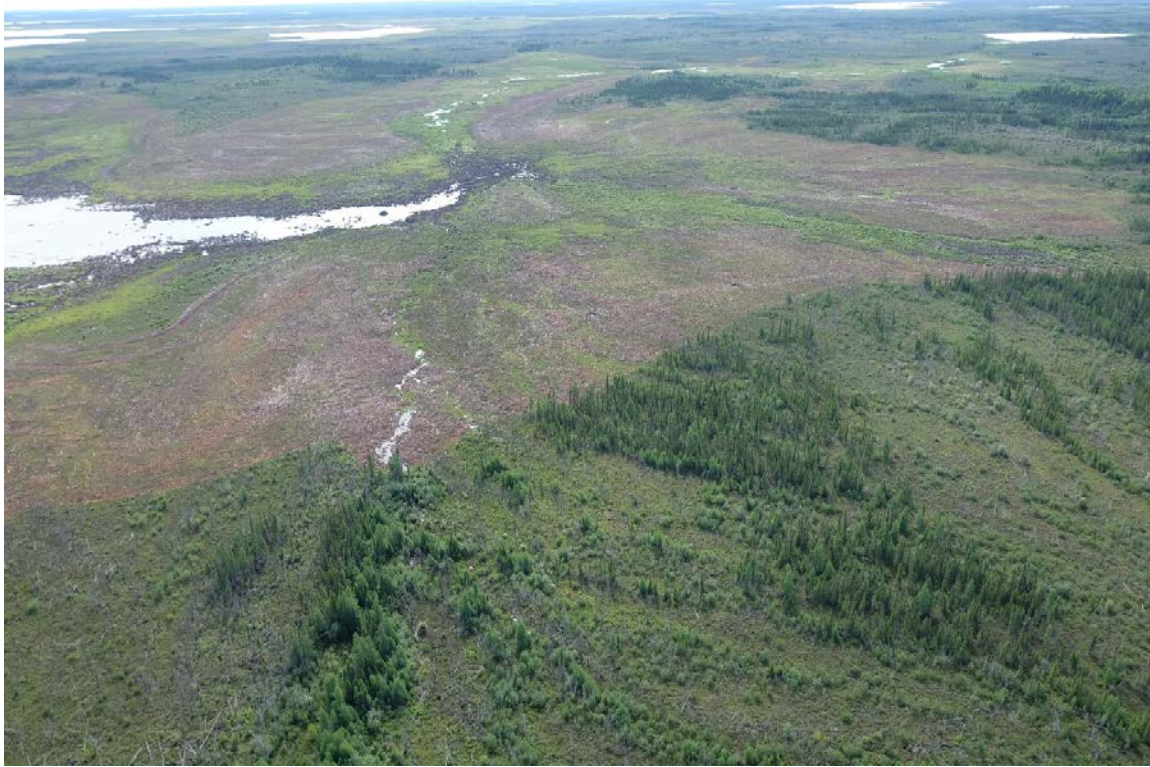
Figure 3-17: Reservoir clearing

Reservoir clearing south of Nelson River (looking east) on July 5, 2018

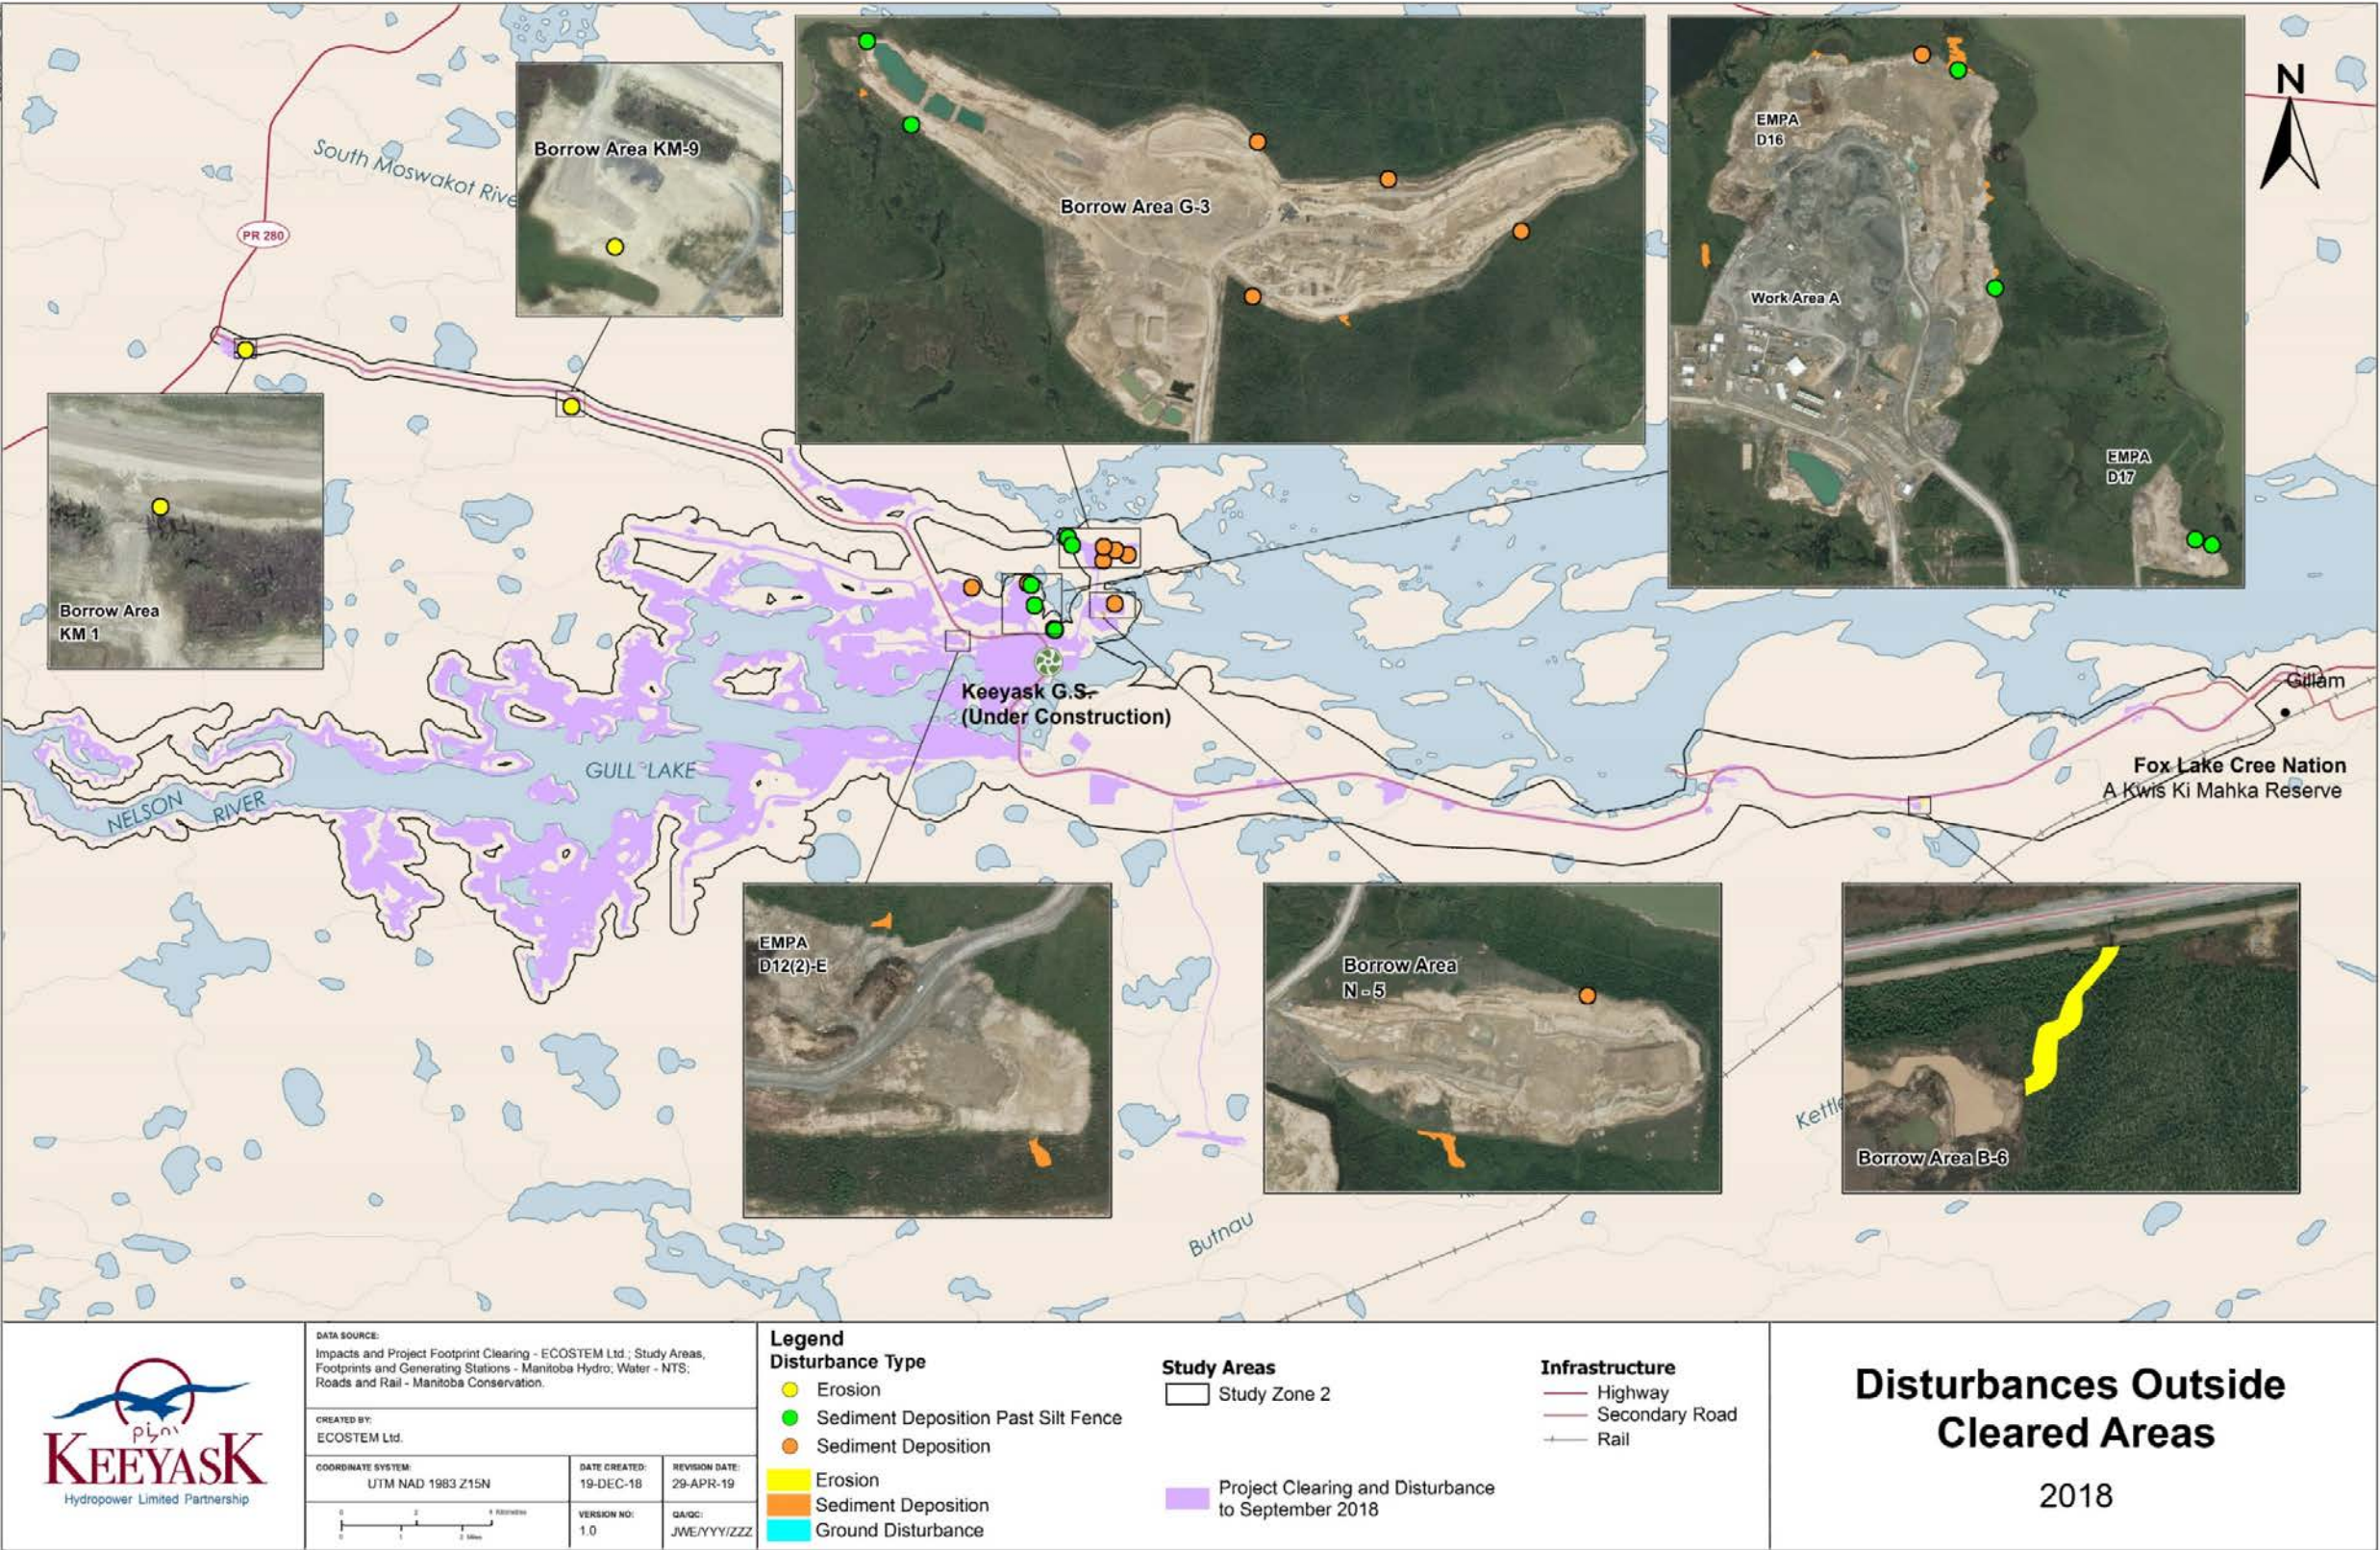
Map 3-3: Disturbances outside of cleared areas in 2018

In Borrow Area B-6, erosion had created a disturbance along a natural drainage channel, affecting approximately 0.28 ha of undisturbed habitat (Figure 3-10; Map 3-3). Water flow from the SAR to the east edge of the pit was undermining the uncleared forest, causing trees to collapse and killing forest floor vegetation. As the erosion appeared to be ongoing, Manitoba Hydro staff were notified after it was discovered.

The 2017 surveys had observed a drainage hose along the north side of Borrow Area N-5 eroding a mineral slope and depositing sediment into the uncleared forest. The field report recommended that erosion barriers be constructed where needed, and that the drainage hose be extended to the base of the slope and secured. Surveys in early July, 2018 found that the hose had been moved to a new location on the slope, a new erosion gully was forming (Figure 3-9) and sediment was being deposited into the adjacent uncleared forest. Manitoba Hydro staff were notified while staff were conducting the July surveys. By the time of the September 2018 surveys, the hose had been extended to the base of the slope, and a sediment bag was attached. However, it was noted that a hole had formed in the sediment bag, and a small amount of sediment was escaping into the uncleared area (Map 3-3).
