Keeyask Generation Project  
Terrestrial Effects Monitoring Plan

Wetland Loss and Disturbance Monitoring Report  
TEMP-2020-03

Prepared for  
Manitoba Hydro

By  
ECOSTEM Ltd.

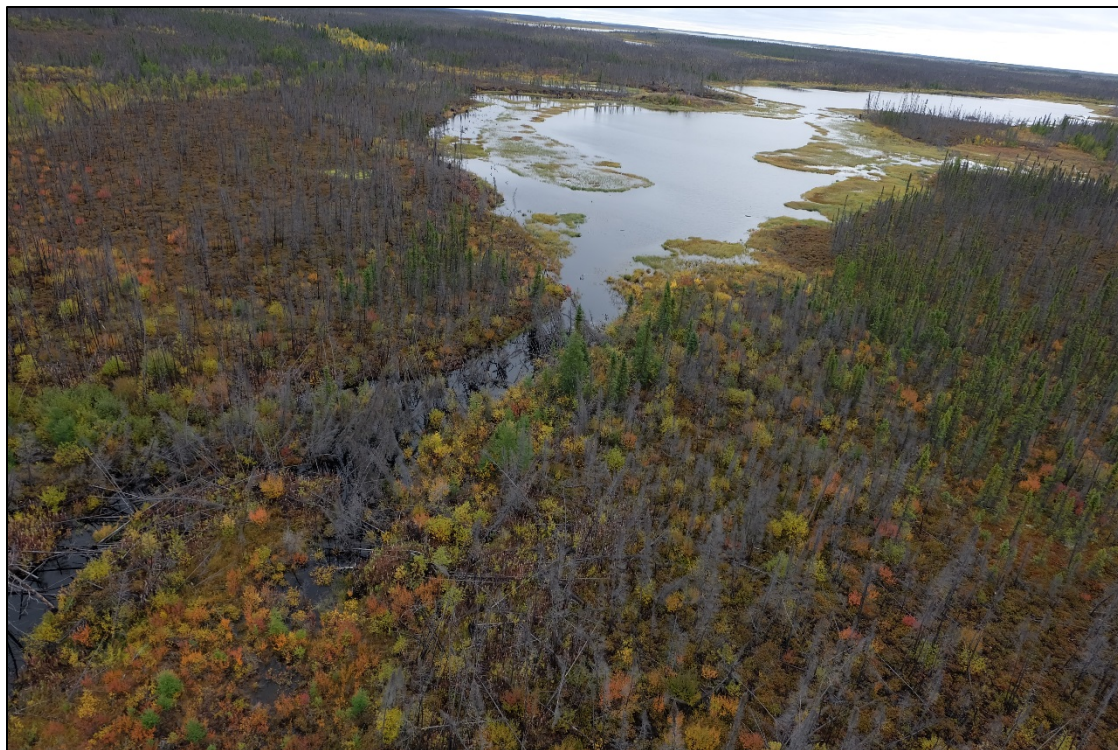
**Photo 3-1: Aerial view of Wetland 3 on September 9, 2019**

Wetland 3 (Photo 3-1) is 5.0 ha in size (Table 3-1), and located about 1 km from the Nelson River, approximately 21 km west of the generating station site (Map 2-2). This wetland has a direct surface water connection to the Nelson River through a lake and then a short stream. Marsh habitat comprised 1.1 ha of the wetland's total area. The 2013 wildfire (see Section 2.0) burned approximately 90% of the marsh habitat buffer (*i.e.*, a 100 m buffer of the marsh habitat) included in Wetland 3.

By 2016, a band of trees ranging from approximately 1 to 10 m wide in the marsh habitat and buffer had been removed by reservoir clearing (Map 3-1; Figure 3-1). This clearing, which was located along the shoreline, impacted 0.36 ha of the total 5.0 ha Wetland 3 area (Table 3-2). Approximately 0.25 ha of this clearing was within the possibly disturbed Project footprint.

Approximately 0.26 ha of the cleared area was in the marsh habitat buffer and 0.10 ha was in the marsh habitat (Table 3-1). Cleared trees were visible where collapsed or collapsing peatlands outside of the planned Project footprint had become part of the marsh habitat (Photo 3-2).

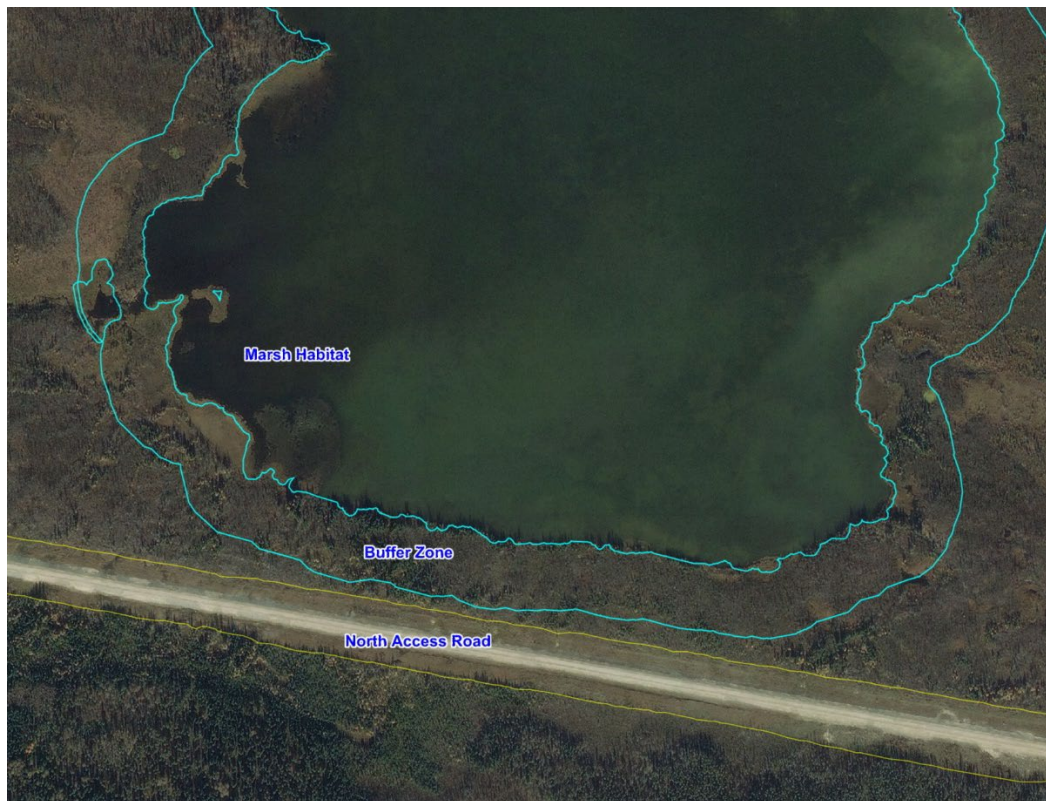
**Figure 3-2: Satellite imagery showing Wetland 17 in relation to the North Access Road in 2019**

Project disturbance or clearing had not been observed within Wetland 17 up to the time of the 2019 surveys (Figure 3-2). Ground surveys conducted from 2015 to 2017 found no incremental changes in the condition of the wetland (Photo 3-4). Ground surveys were not conducted in 2018 and 2019 as the aerial surveys found no new clearing or activity nearby. Details about conditions observed in Wetland 17 in previous survey years are provided in ECOSTEM (2018).

Future surveys will continue to monitor Wetland 17 for signs of change.

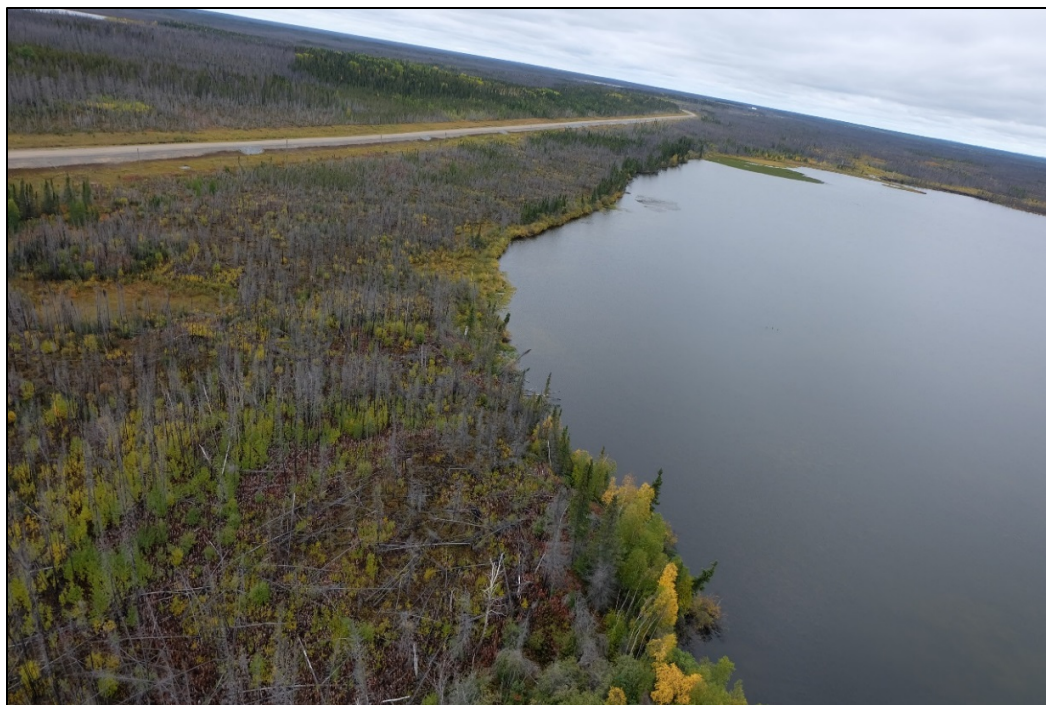
**Photo 3-3: Aerial view of Wetland 17 on September 9, 2019**

Wetland 17 (Photo 3-3) is 135.1 ha in size and located on the southwest shore of a small lake located near the kilometer 6 point of the north access road (NAR) (Map 3.1). Marsh habitat comprised 97.5 ha of the wetland's total area. Approximately 85% of the marsh habitat buffer burned in the 2013 wildfire.

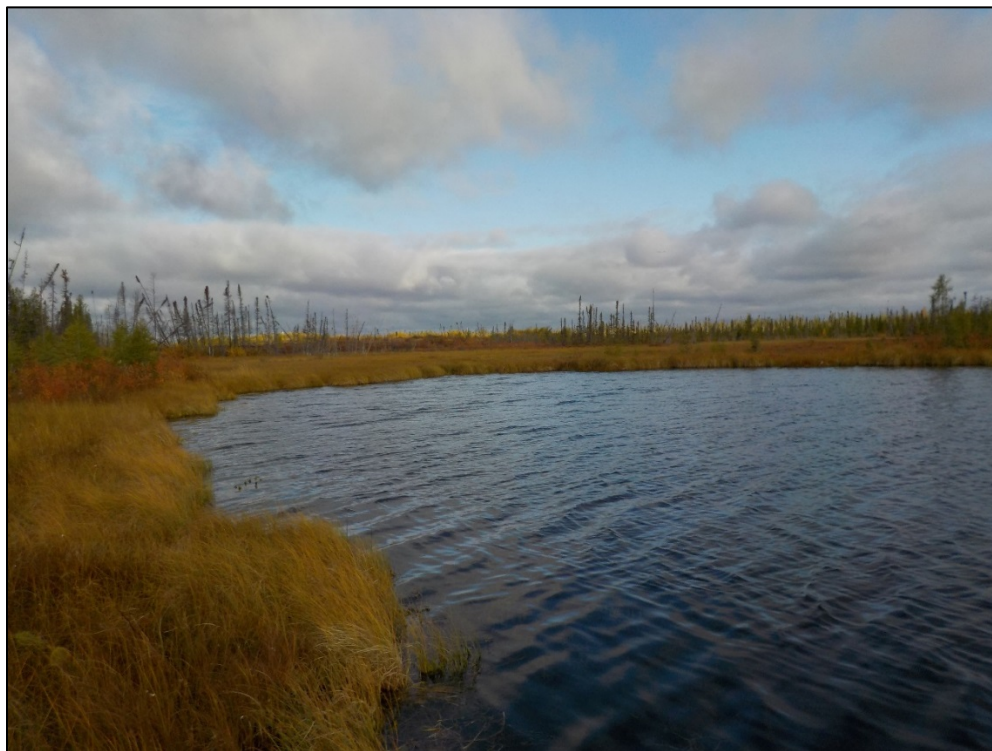
**Photo 3-5: Ground photo of Wetland 37 in 2019**

Wetland 37 (Photo 3-5, Photo 3-6) is 17.0 ha in size, and located near the north dyke, adjacent to EMPA D3-E (Map 3-1). Marsh habitat comprised 4.1 ha of the wetland's total area. Approximately 5% of the marsh habitat buffer burned in the 2013 wildfire.

The 2016 ground survey found that a very small amount of EMPA clearing in the possibly disturbed Project footprint (< 0.01 ha; Table 3-1; Figure 3-3) extended into the buffer portion of the wetland. Ground surveys from 2017 to 2019 found no further changes to the EMPA and no new impacts on the wetland were observed.

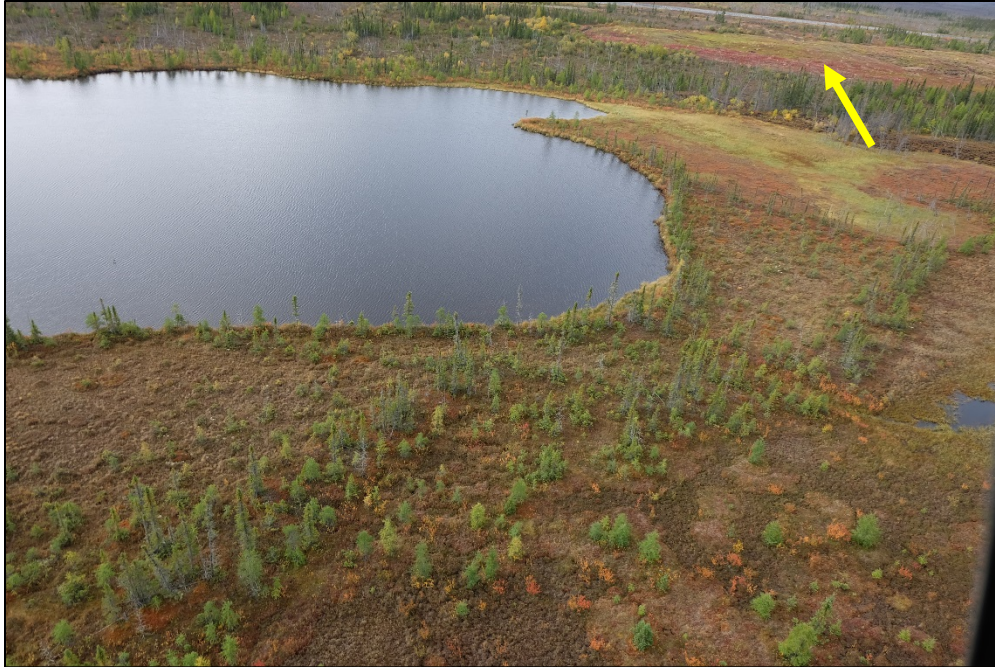
**Photo 3-6: Aerial photo of Wetland 37 in 2019 looking south with EMPA D3-E (yellow arrow) in background**

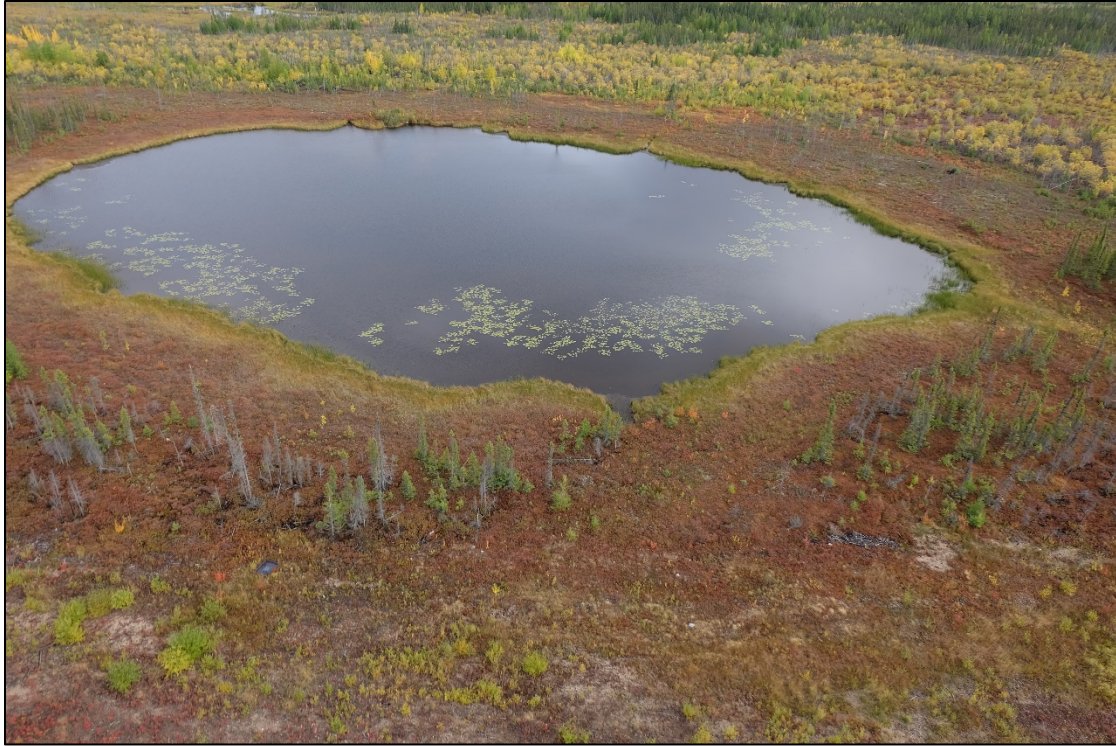
**Photo 3-7: Aerial view of Wetland 40 on September 9, 2019**

There was no Project clearing or disturbance observed within Wetland 40 during the 2015 ground survey.

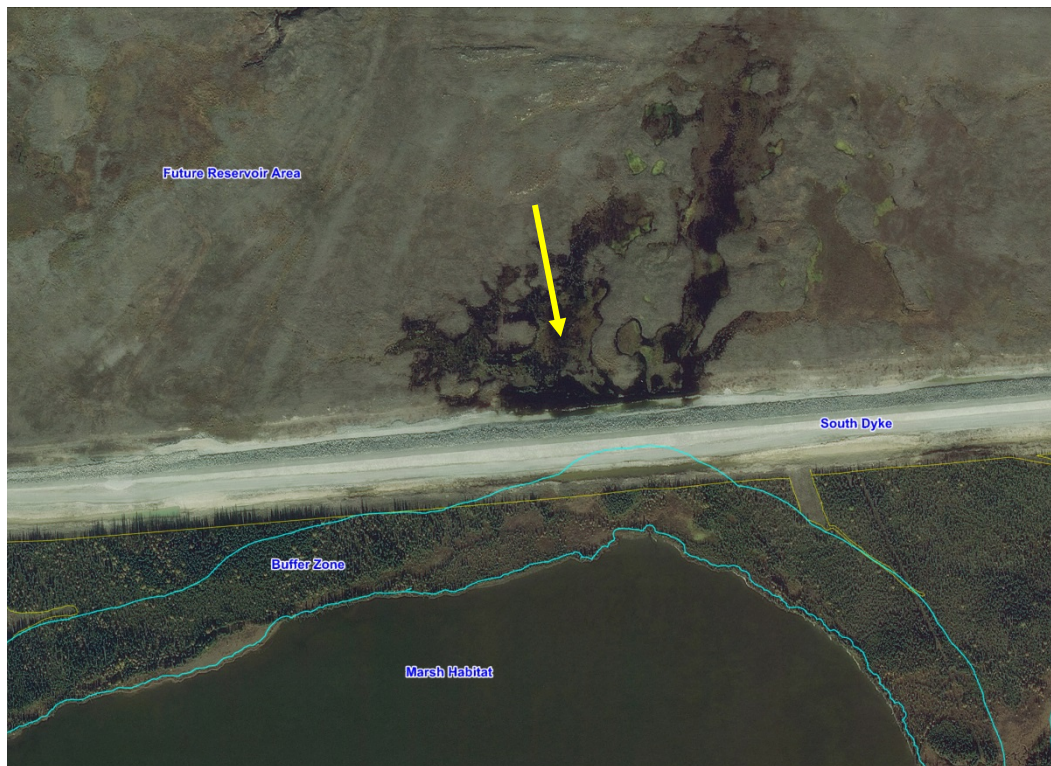
While no further clearing had occurred between the 2017 and 2019 surveys, the South Dyke construction was occurring near the wetland. Aerial surveys found no apparent effects in the marsh habitat due to runoff from the dyke clearing and infrastructure (Figure 3-9). Ground surveys were not conducted in 2019 due to heavy construction activity nearby.

In 2017, it was noted that water levels in the wetland were lower than the median based on the degrees of exposed aquatic vegetation and lake-bottom. In 2018, water levels appeared to be approximately at the median. Aerial surveys in 2019 found that water levels appeared to be lower than in 2018, but not as low as in 2017. Construction of the South Dyke may have altered water inputs into the lake in Wetland 47. The wetland will continue to be monitored for changes in 2020.

**Figure 3-9: Satellite imagery showing water accumulation north of Wetland 47 in the future reservoir area in 2019**

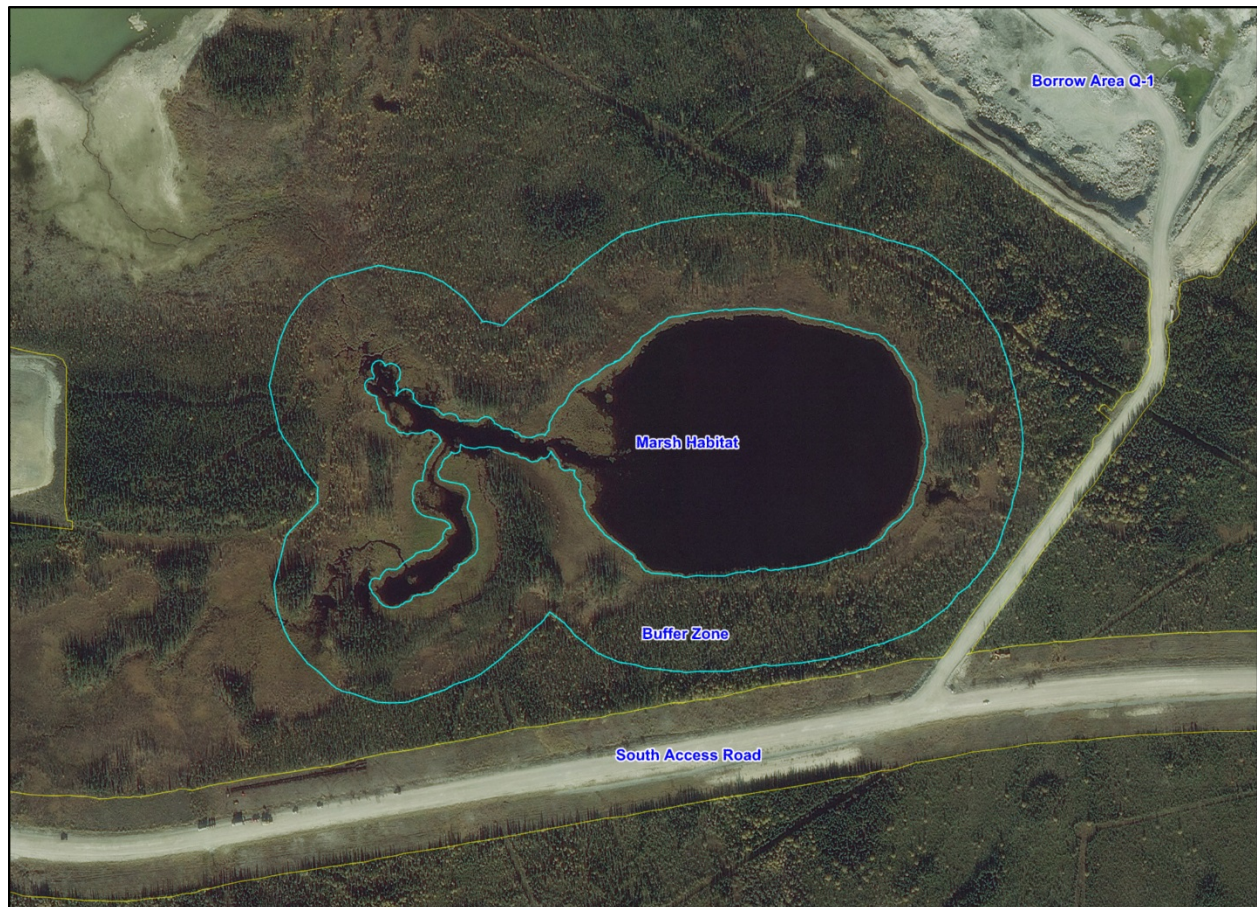
**Figure 3-13: Satellite imagery showing proximity of Project clearing to Wetland 52**

Project clearing or disturbance was not observed within Wetland 52 during the surveys from 2016 to 2019 (Map 3-1). Potential hydrological impacts from the SAR were being monitored, but to date none have been observed. Consequently, ground surveys were not conducted at Wetland 52 in 2019. See ECOSTEM (2018) for specific observations made in previous survey years.

Monitoring for potential Project effects will continue.

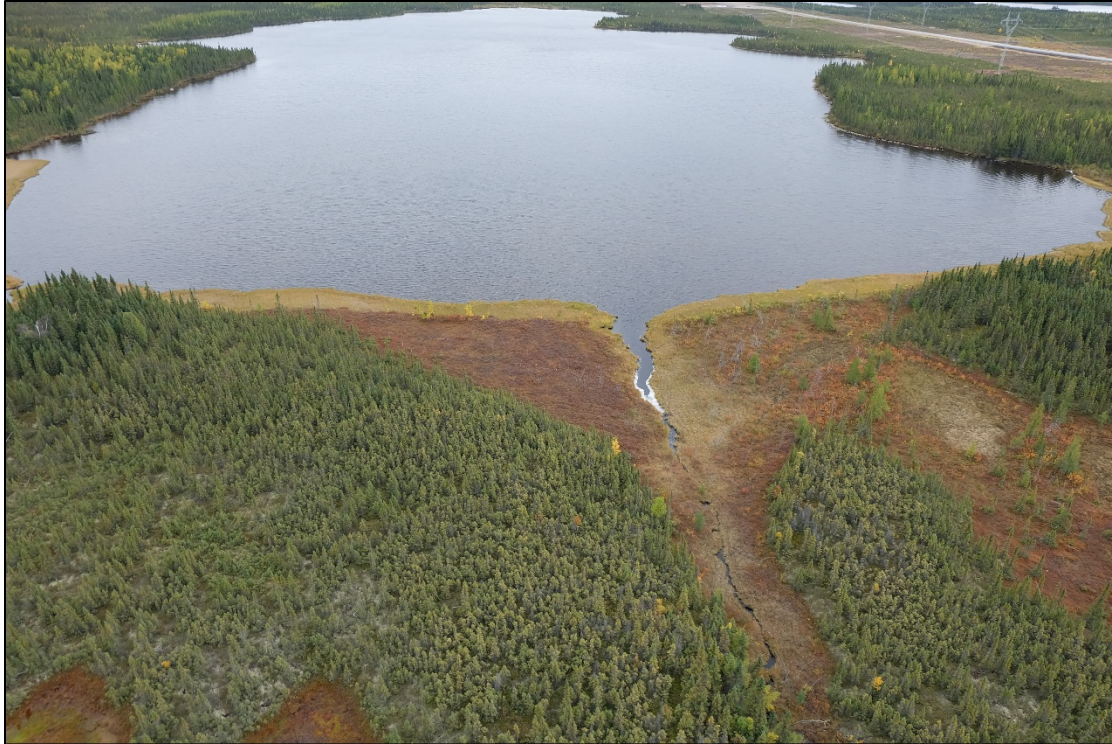
**Photo 3-14: Aerial view of Wetland 54 (west end) on September 9, 2019**

Wetland 54 (Photo 3-14) is 113.1 ha in size, and located along the north side of the SAR, north of Borrow Area S-2b (Map 2-2). Marsh habitat comprised 70.1 ha of the wetland's total area. None of the marsh habitat buffer burned in the 2013 wildfire.

Surveys in 2015 and 2016 found clearing and disturbance in the marsh habitat buffer, but this was for the Keeyask Transmission Project RoW (Figure 3-15). Ground surveys in 2016 and 2017, and aerial surveys in 2018 and 2019 found no expansion of the impacts recorded in 2015 and 2016. The relatively dense existing low vegetation in the cleared areas within 100 m of the marsh should be adequate to stabilize soils and facilitate revegetation. Specific observations regarding the impacts observed in 2015 and 2016 are provided in ECOSTEM (2018).

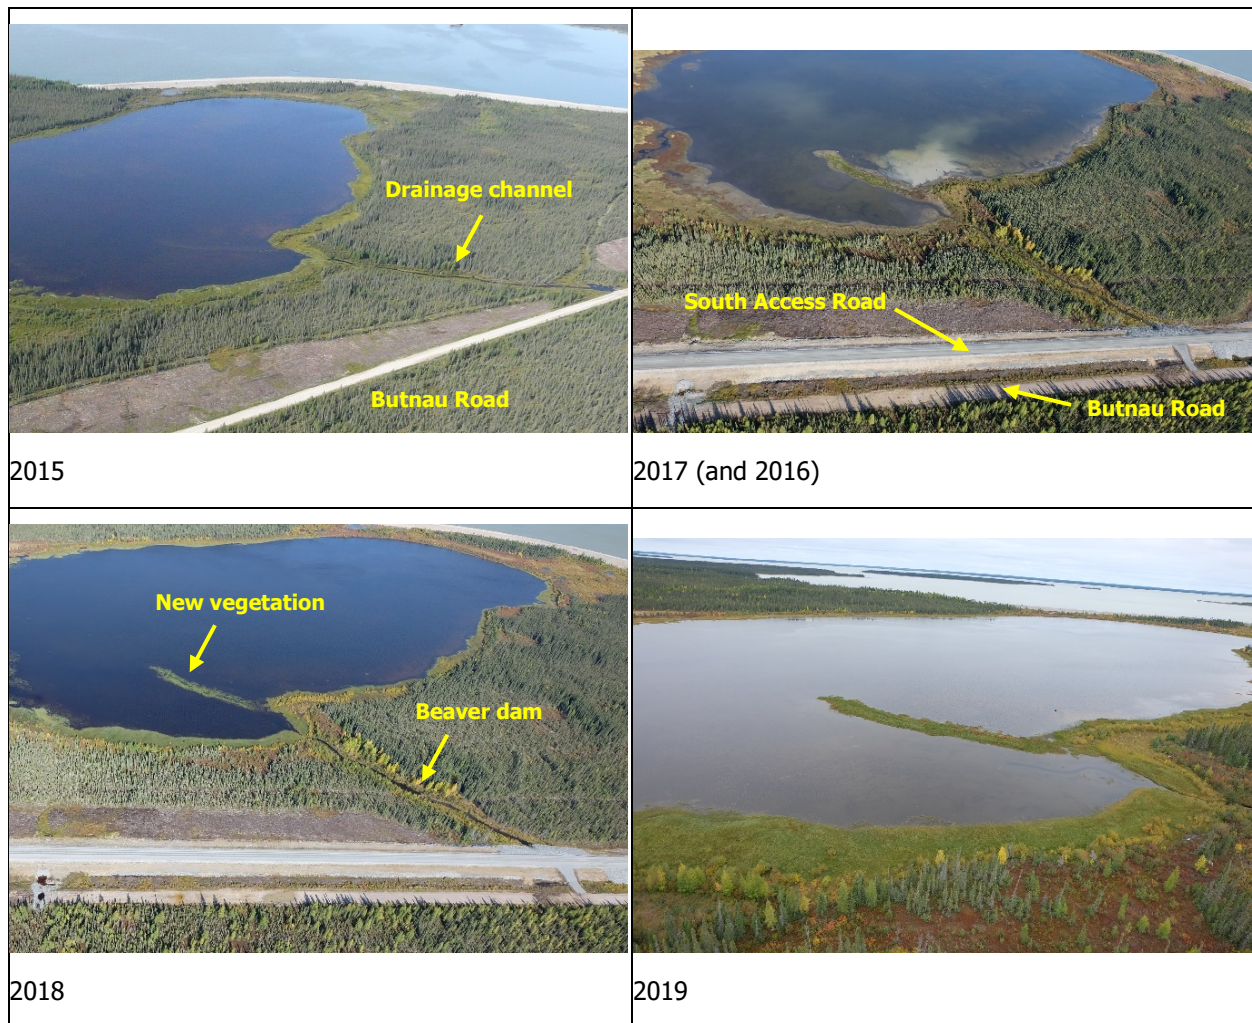
**Figure 3-17: Aerial view of Wetland 57 showing varying water levels from 2015 to 2019**

In terms of other potential Project impacts, the wetland drains through a natural channel into a ditch along the SAR (Figure 3-17). In 2016 and 2017, the observed water levels in the wetland's waterbody were very low compared to those observed in 2015 (Figure 3-17). One possible cause

In 2019, water levels were slightly lower than observed in 2018. Surveys in 2019 showed that the beaver dam had been breached (Photo 3-15) and water was flowing freely from the wetland (Photo 3-16) towards the SAR. The extent of shore zone vegetation remained approximately the same or greater compared to 2018.

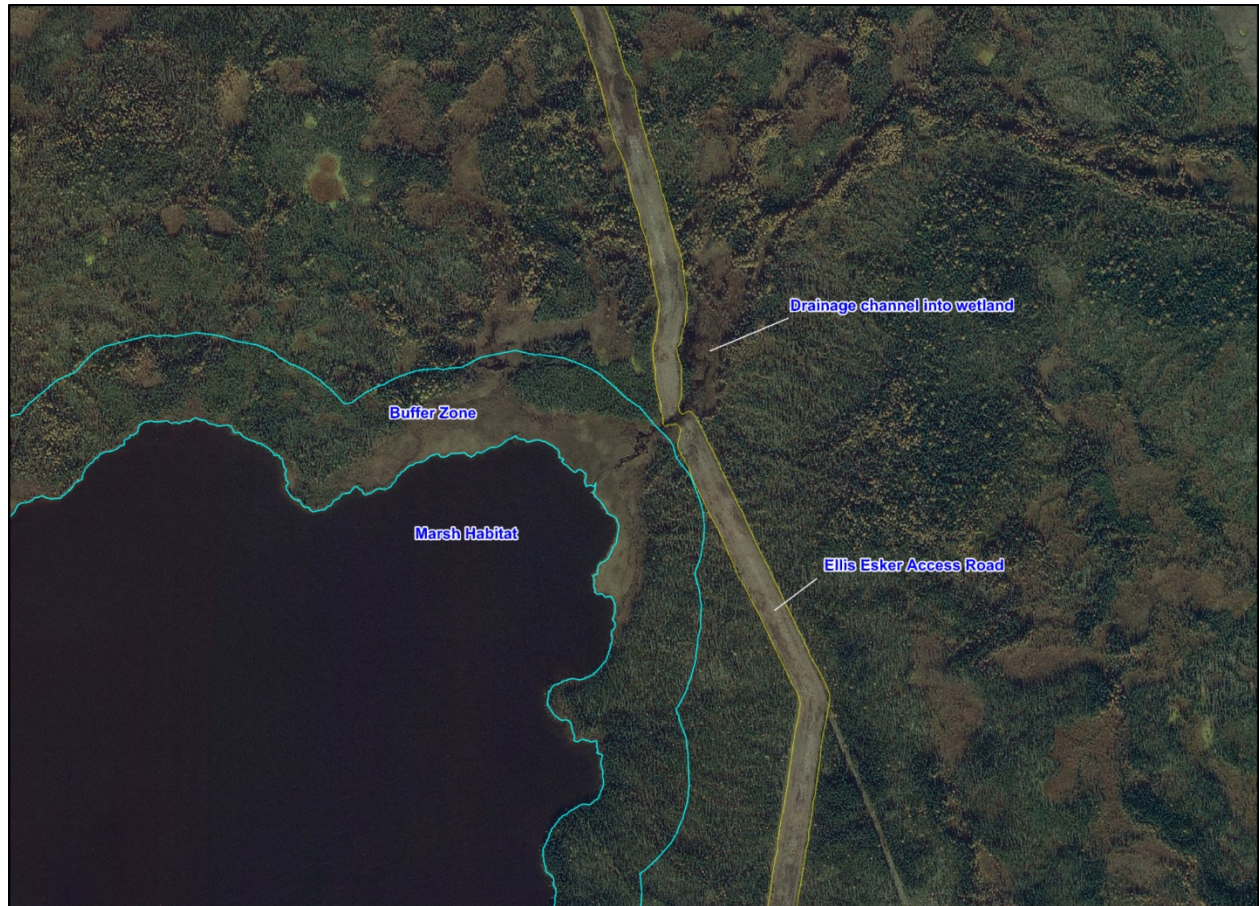
**Figure 3-18: Satellite imagery showing proximity of Project clearing to Wetland 60**

Wetland 60 was added to the wetlands being monitored once the Ellis Esker area was cleared. Mapped Project clearing using the DOI recorded clearing within one meter of the buffer zone, which was likely within less than the positional error range of the DOI (Figure 3-18).

Surveys in 2018 and 2019 did not find any apparent effects of Project clearing on the marsh vegetation or hydrology. Impacts from the clearing were minimal, presumably because the road clearing and construction activity took place in the winter when the ground was frozen.

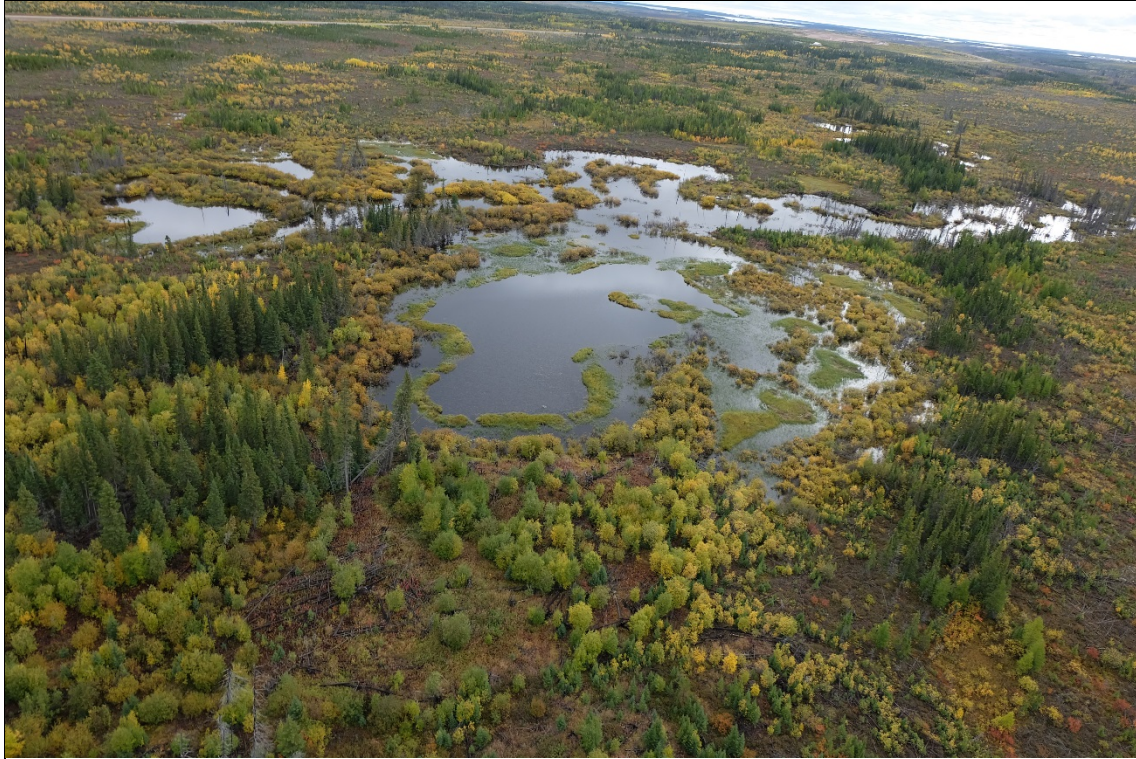
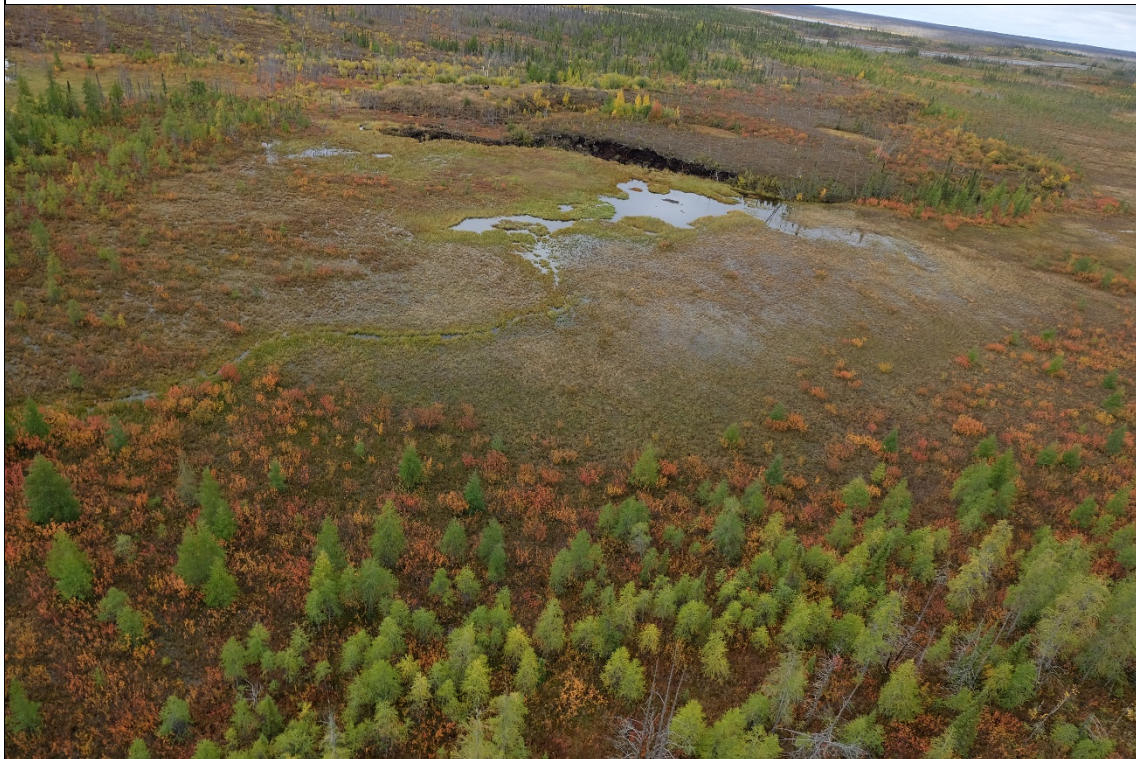
**Figure 3-20: Aerial photos of Wetlands 38 and 36 on September 9, 2019**

As an example, Figure 3-20 shows the state of two of the remaining 31 wetlands visited during the aerial surveys. These wetlands were not closely surveyed because they were more than 100 m from existing Project clearing or disturbance, and there were no visible Project effects in them.

Monitoring in 2020 will determine if any of these 31 wetlands have been impacted by the Project since the 2019 surveys.
