Keeyask Generation Project
Terrestrial Effects Monitoring Plan

Habitat Loss and Disturbance Monitoring Report

TEMP-2021-01

By
ECOSTEM Ltd.

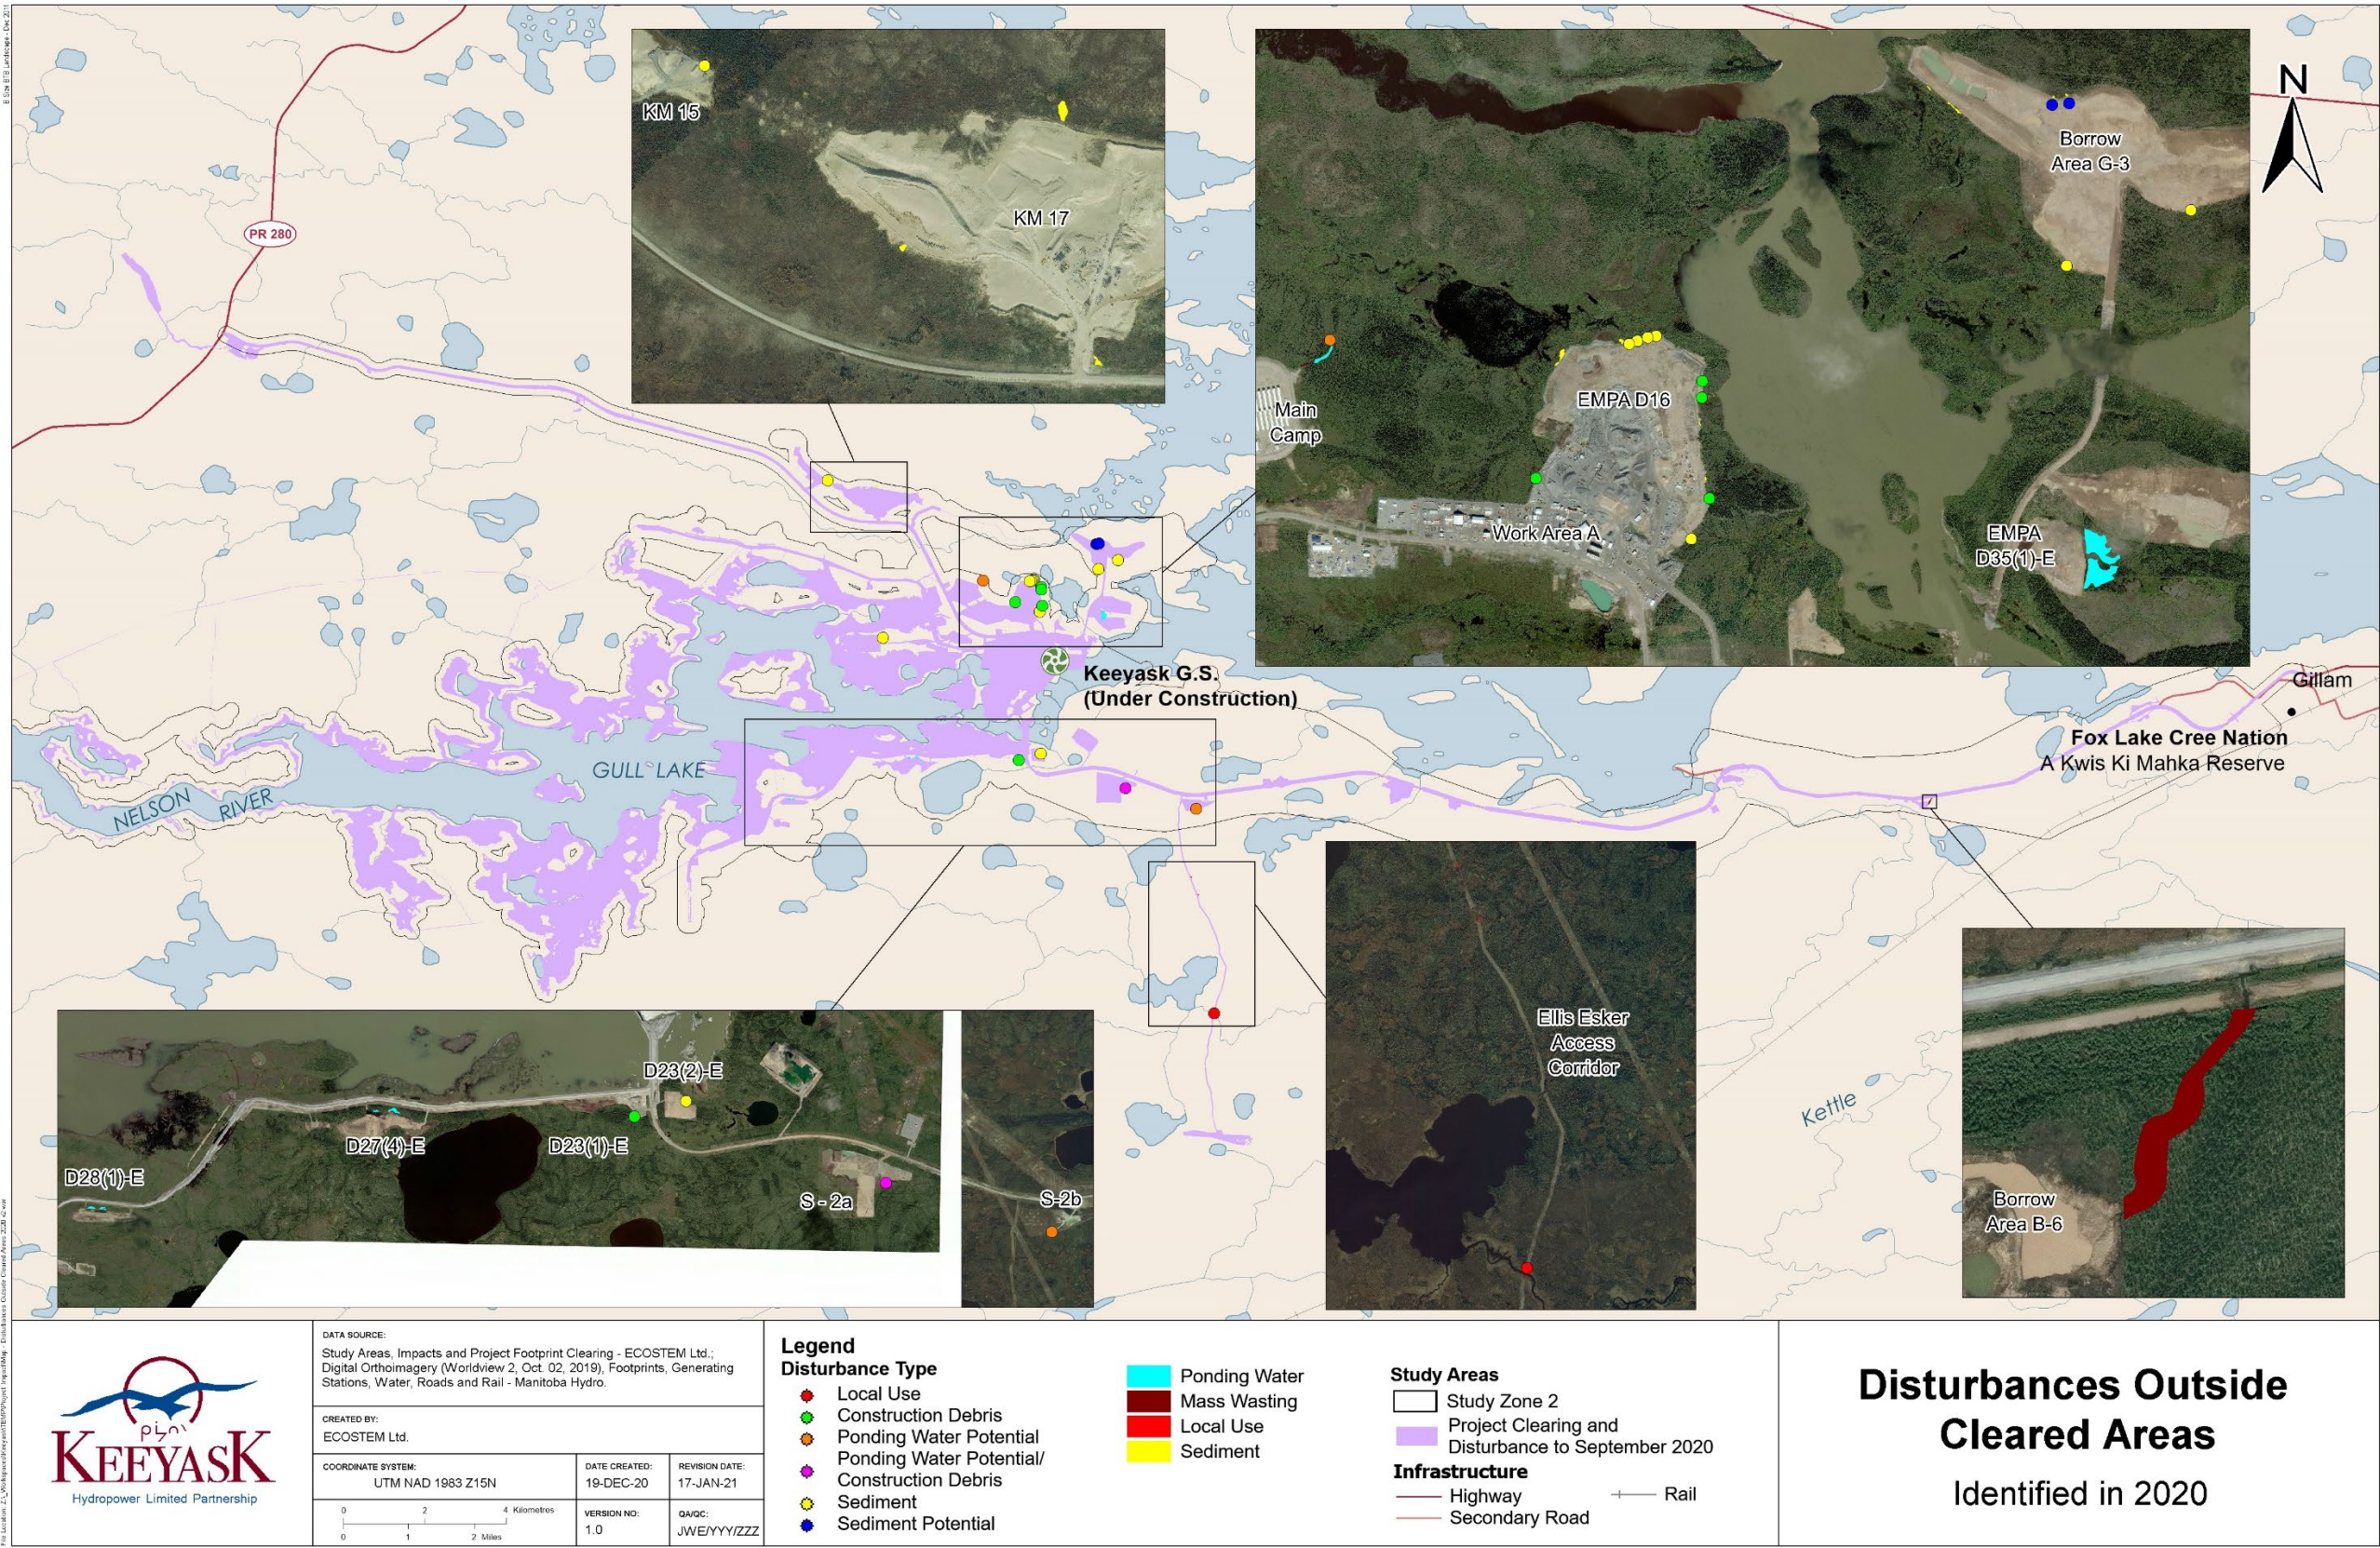
Map 3-2: Disturbances outside of cleared areas identified in September 2020

Erosion disturbance on the south ditch bank of the NAR adjacent to Borrow Area KM-1 had created a gully since it was first identified during 2016 surveys. Erosion had expanded the gully between the ditch and the borrow area between 2016 and 2018 (Map 3-2). Field surveys in 2019 found that the area had since been remediated by filling the eroded area. Some minor erosion and sediment deposition around the eastern fringes of the remediated area was noted in 2019. The bank was subsequently covered with organic material. The 2020 monitoring recorded new but minor erosion on the ditch slope (Photo 3-1). The site will be monitored for substantive changes in 2021.

At the northeast corner of the Main Camp, a disturbance created by water outflow from a culvert extended approximately 160 m into the uncleared forest in 2020 (Map 3-2; Figure 3-1). This was an increase of 80 m since September 2019. The associated disturbed area expanded by 0.05 ha in the possibly disturbed Project area, and by 0.06 ha outside of the planned and possibly disturbed Project footprint area. At the time of the 2020 survey, this disturbance extended more than 75 metres past the approved Project footprint boundary.
