Keeyask Generation Project Terrestrial Effects Monitoring Plan

Habitat Loss and Disturbance Monitoring Report

TEMP-2022-01

By
ECOSTEM Ltd.
June 2022

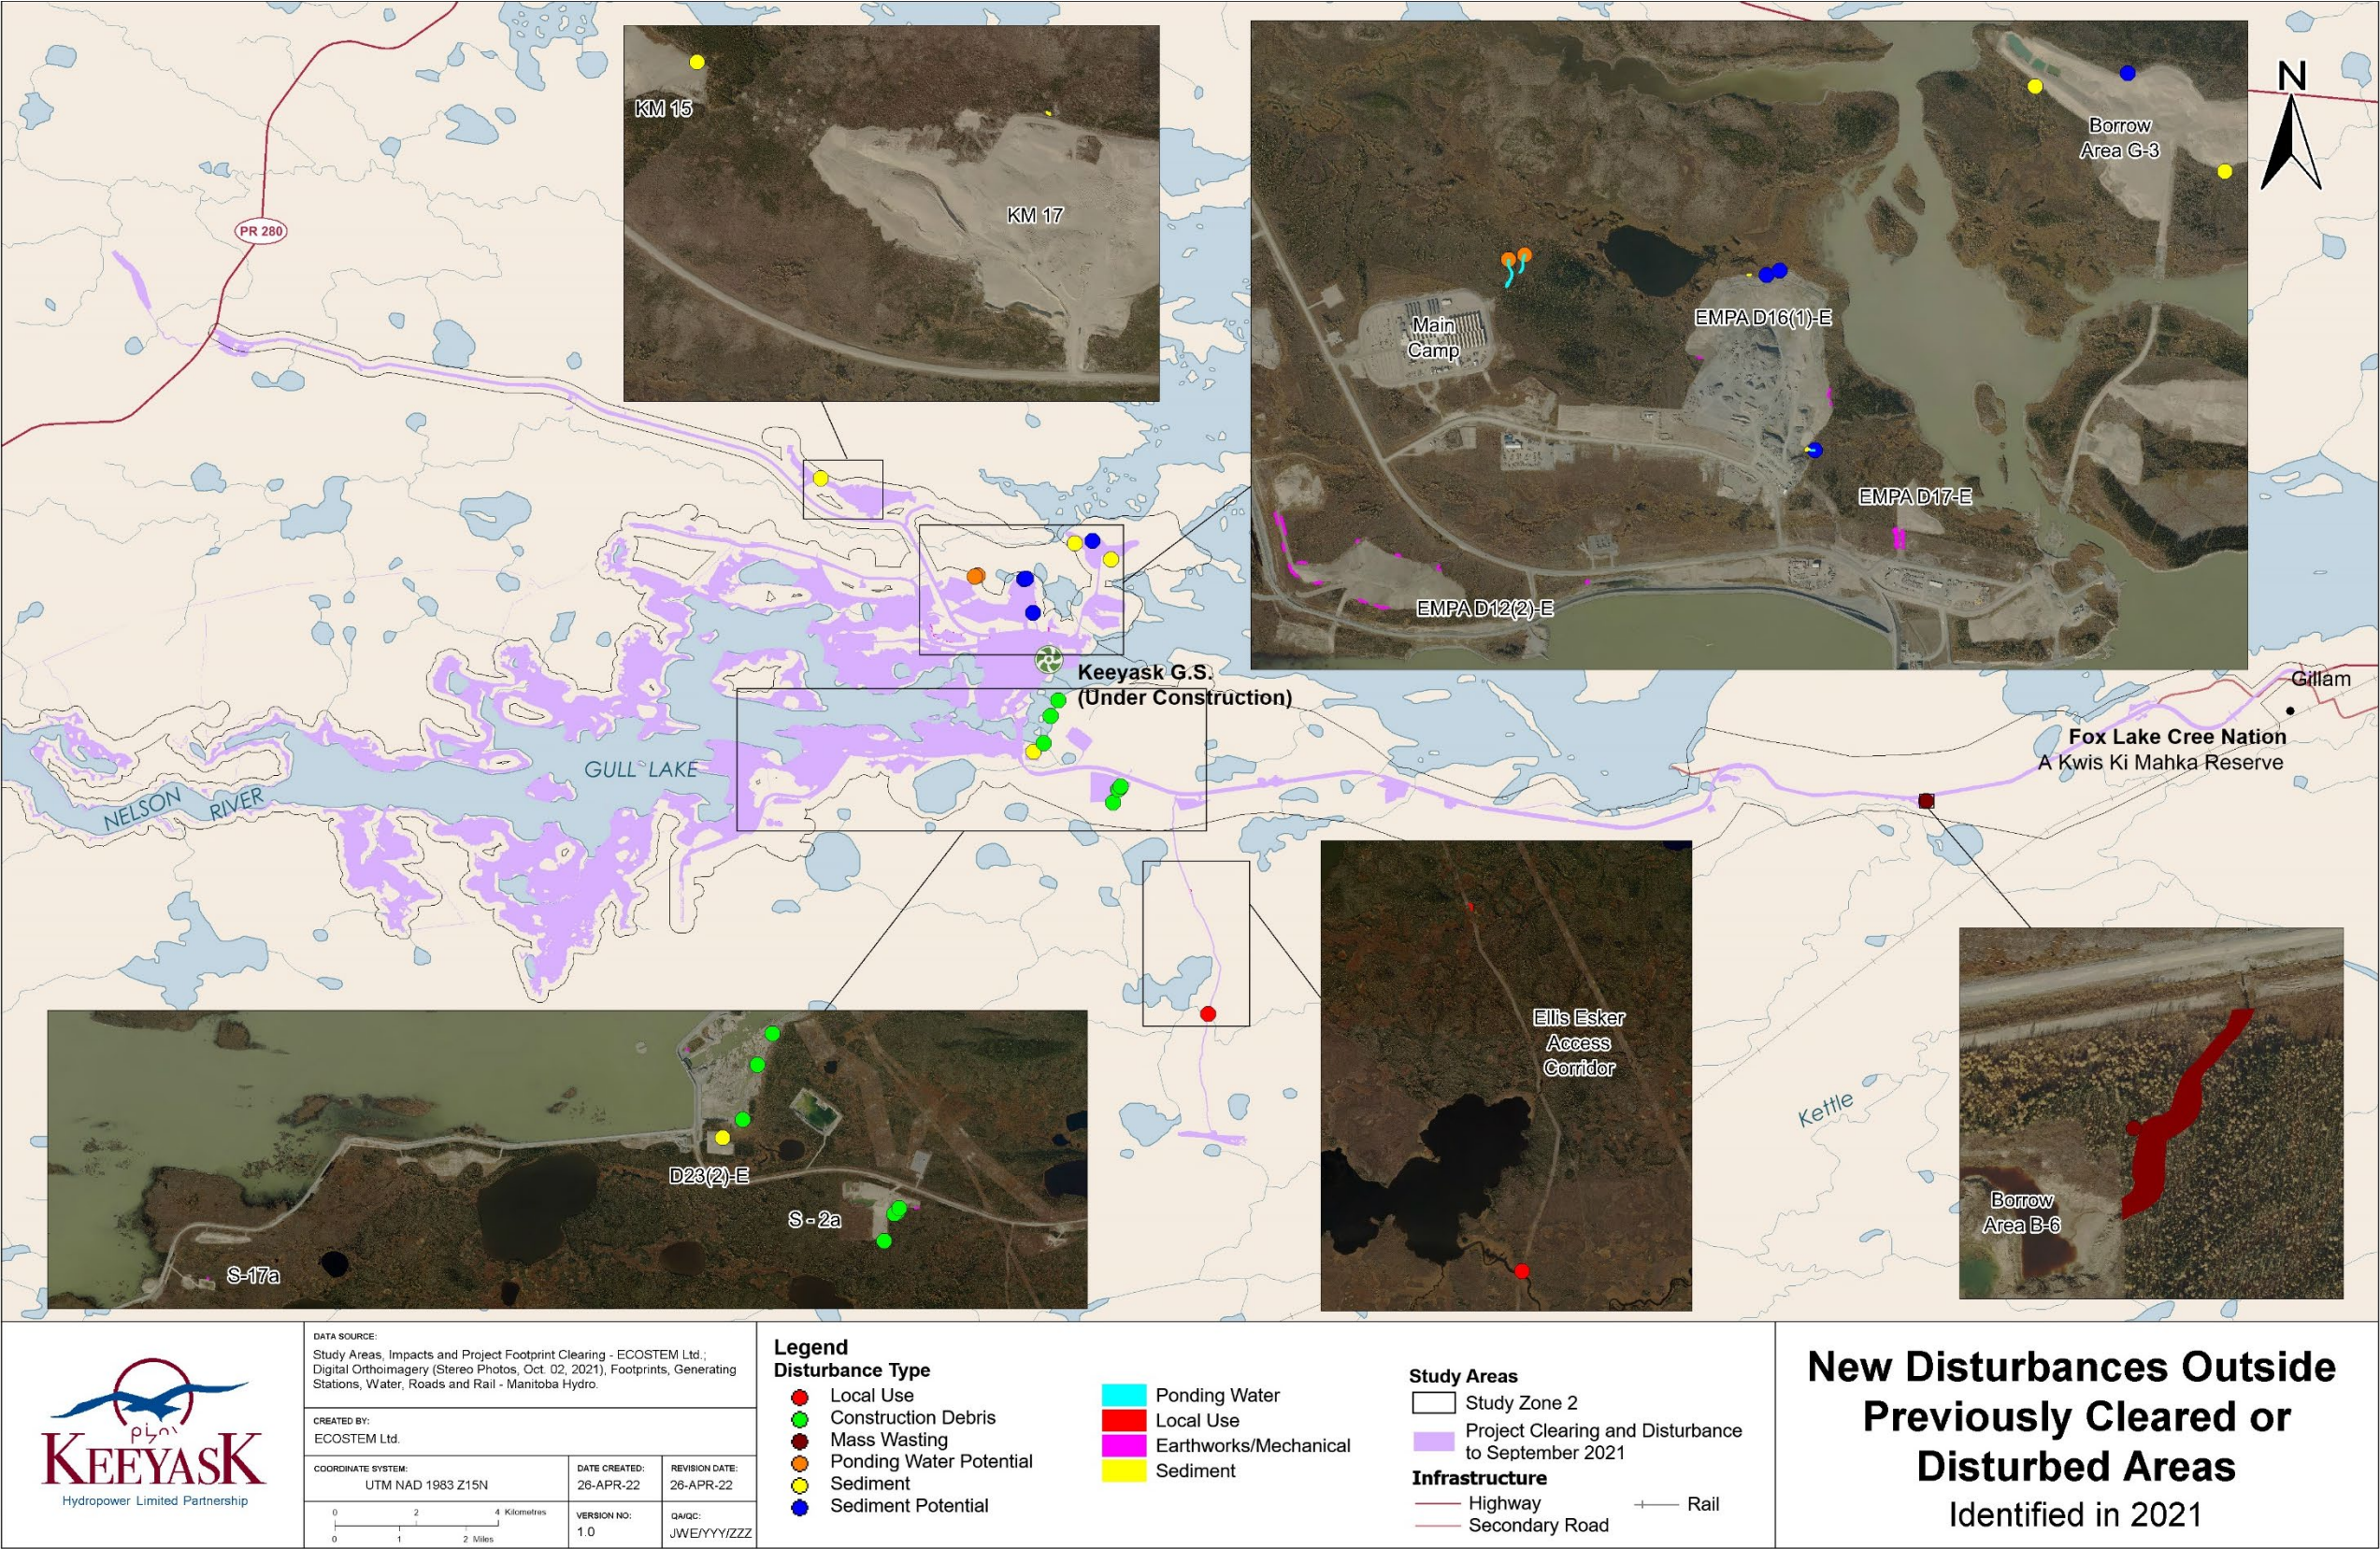
Map 3-2: New disturbances outside of previously cleared or disturbed areas identified in September 2021

At the northeast corner of the Main Camp, a disturbance in the form of outflow from a drainage culvert, produced a channel of water that flowed through previously undisturbed vegetation. By September 2021, the flowing water extended approximately 250 m into the undisturbed forest (Map 3-2; Figure 3-1). This was an increase of 90 m since September 2020 and an increase of 170 m since September 2019. Water percolating up from the ground, depositing sediment and forming an additional channel of flowing water, was identified during surveys in 2021 (Photo 3-2 and Photo 3-3). This new channel extended 130 m into the previously undisturbed forest. The total associated disturbed area expanded by 0.02 ha in the possibly disturbed Project area, and by 0.08 ha outside of the planned and possibly disturbed Project footprint area. At the time of the 2021 survey, this disturbance extended more than 160 metres past the approved Project footprint boundary, which was an increase of 85 m since September 2020.

New clearing within the possibly disturbed Project footprint was also identified adjacent to the transmission sub-station totaling approximately 0.15 ha in 2021 (Map 3-2). This was due to transmission tower repairs.
