Keeyask Generation Project Terrestrial Effects Monitoring Plan

Habitat Rehabilitation Implementation and Success Monitoring Report

TEMP-2022-06

June 2022

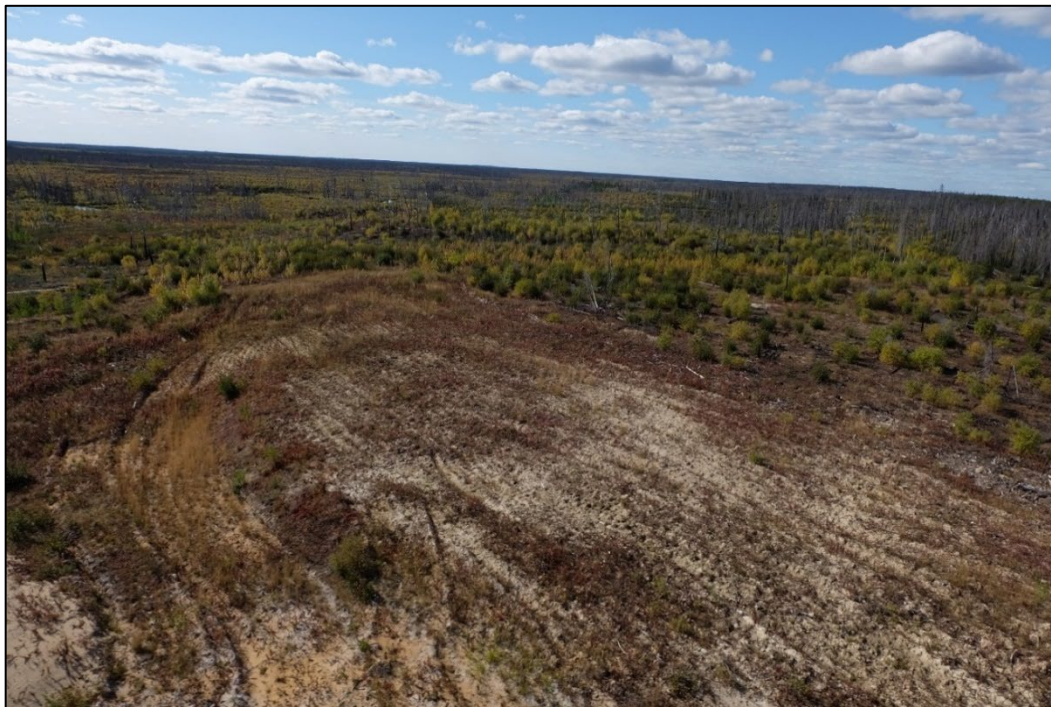
Photo 2-2: Treatment area 09 in Borrow Area KM-9 that was prepared with a discer

Rehabilitation treatments in 2016 consisted of tree planting in all of the target locations, as well as one or more other measures in some areas. These measures included grading to reduce slopes to less than 4:1 where needed in borrow areas. In some areas, a Rome TRCW16 discer (Photo 2-1 and Photo 2-2) pulled behind a tractor loosened compacted surface material. Site preparation generally occurred on exposed mineral substrates. Areas where the original surface organic layer was intact were not treated (see examples Figure 2-1). See Table 2-1 for details.

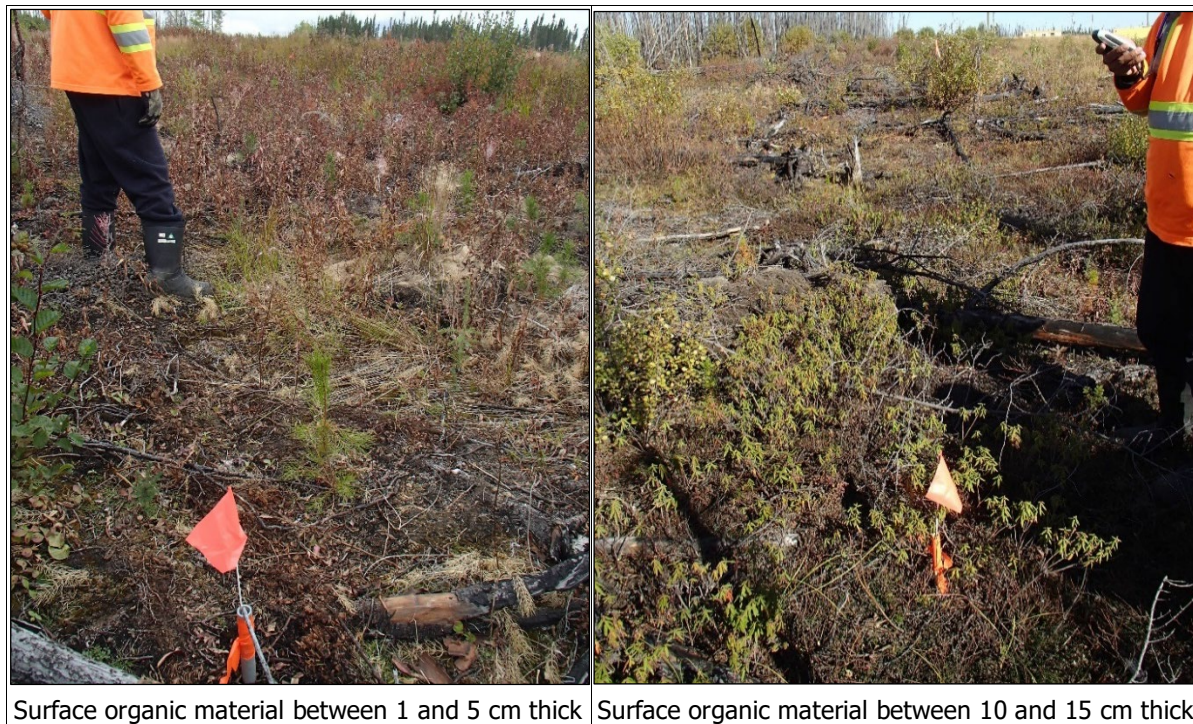
Figure 2-1: Examples of undisturbed surface organic material along transects in 2017

Surface organic material between 1 and 5 cm thick Surface organic material between 10 and 15 cm thick

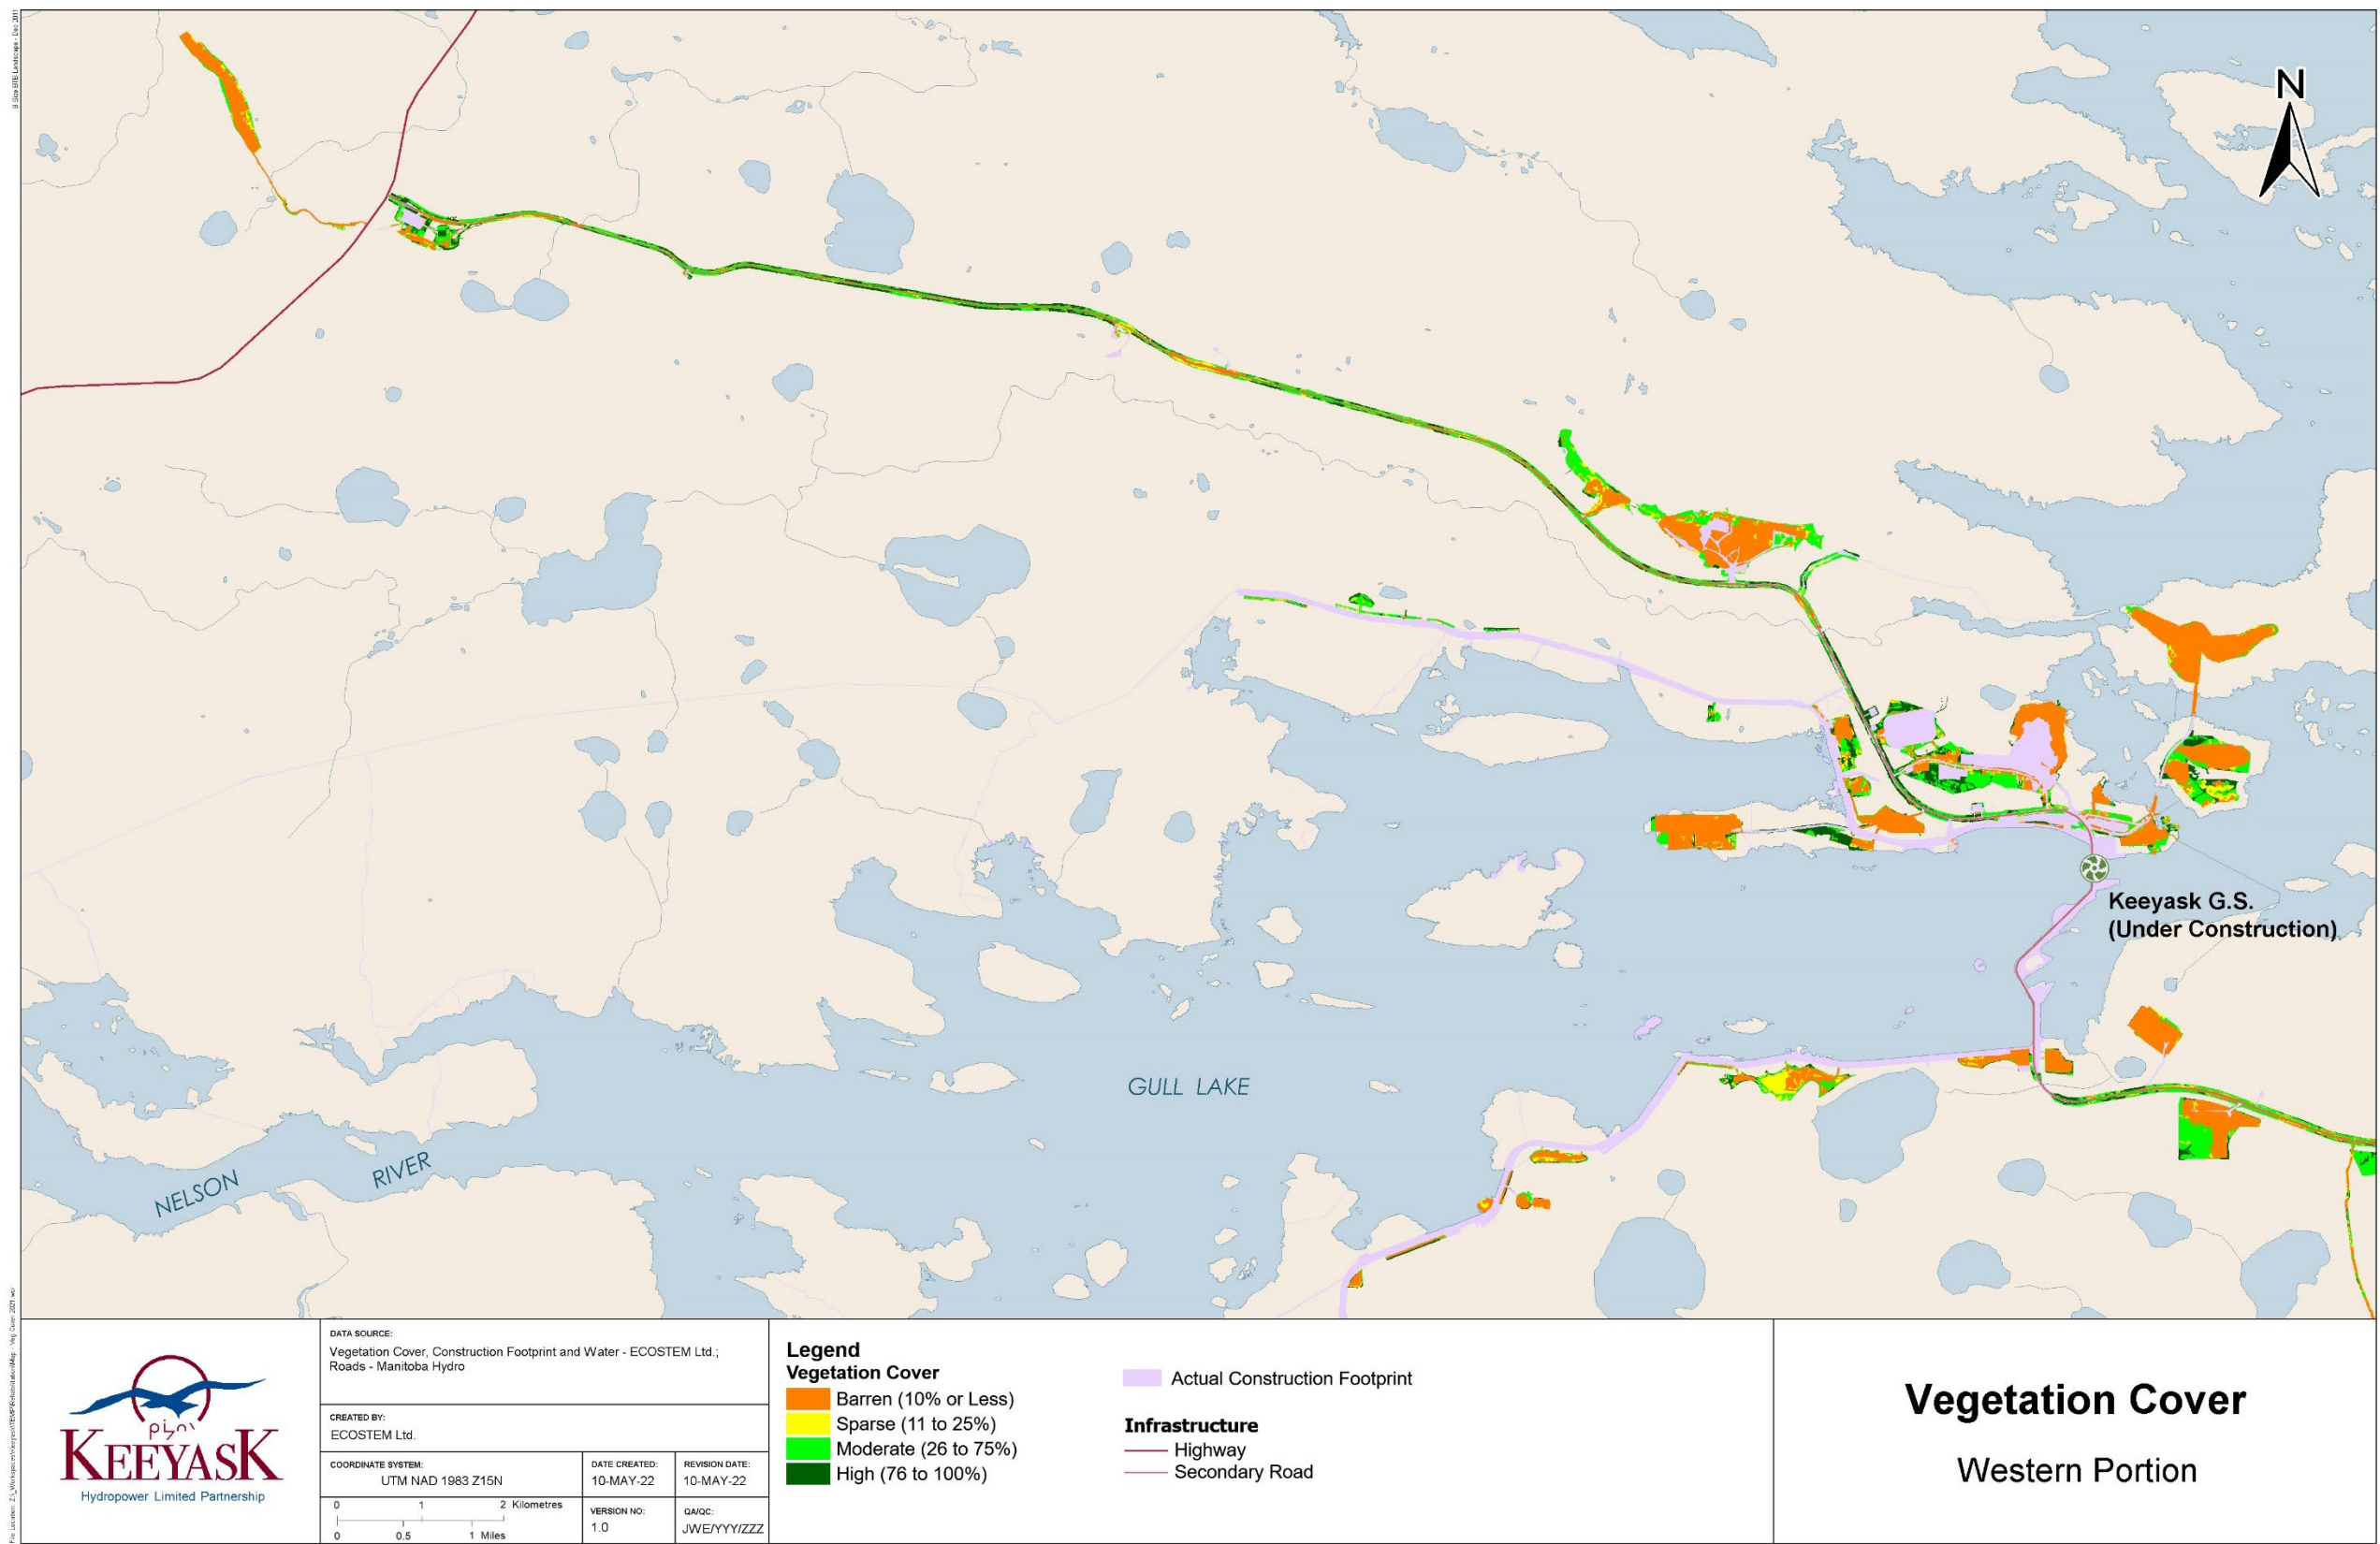
Map 4-1: Vegetation cover in the western portions of the Construction Footprint as of September 2021

Outside of the access roads, 61% of the mapped temporary Project area was barren. This was expected as construction was still active or had only recently ended in a number of the areas. Most of the barren and sparse vegetation cover was found in the active or recently active portions of these areas. In contrast, most of the area that was not barren had moderate to high vegetation cover, which was mostly low shrub and/or graminoid and/or bryoid cover. Natural regeneration was quickly establishing in areas where there was little to no disturbance after they were cleared.

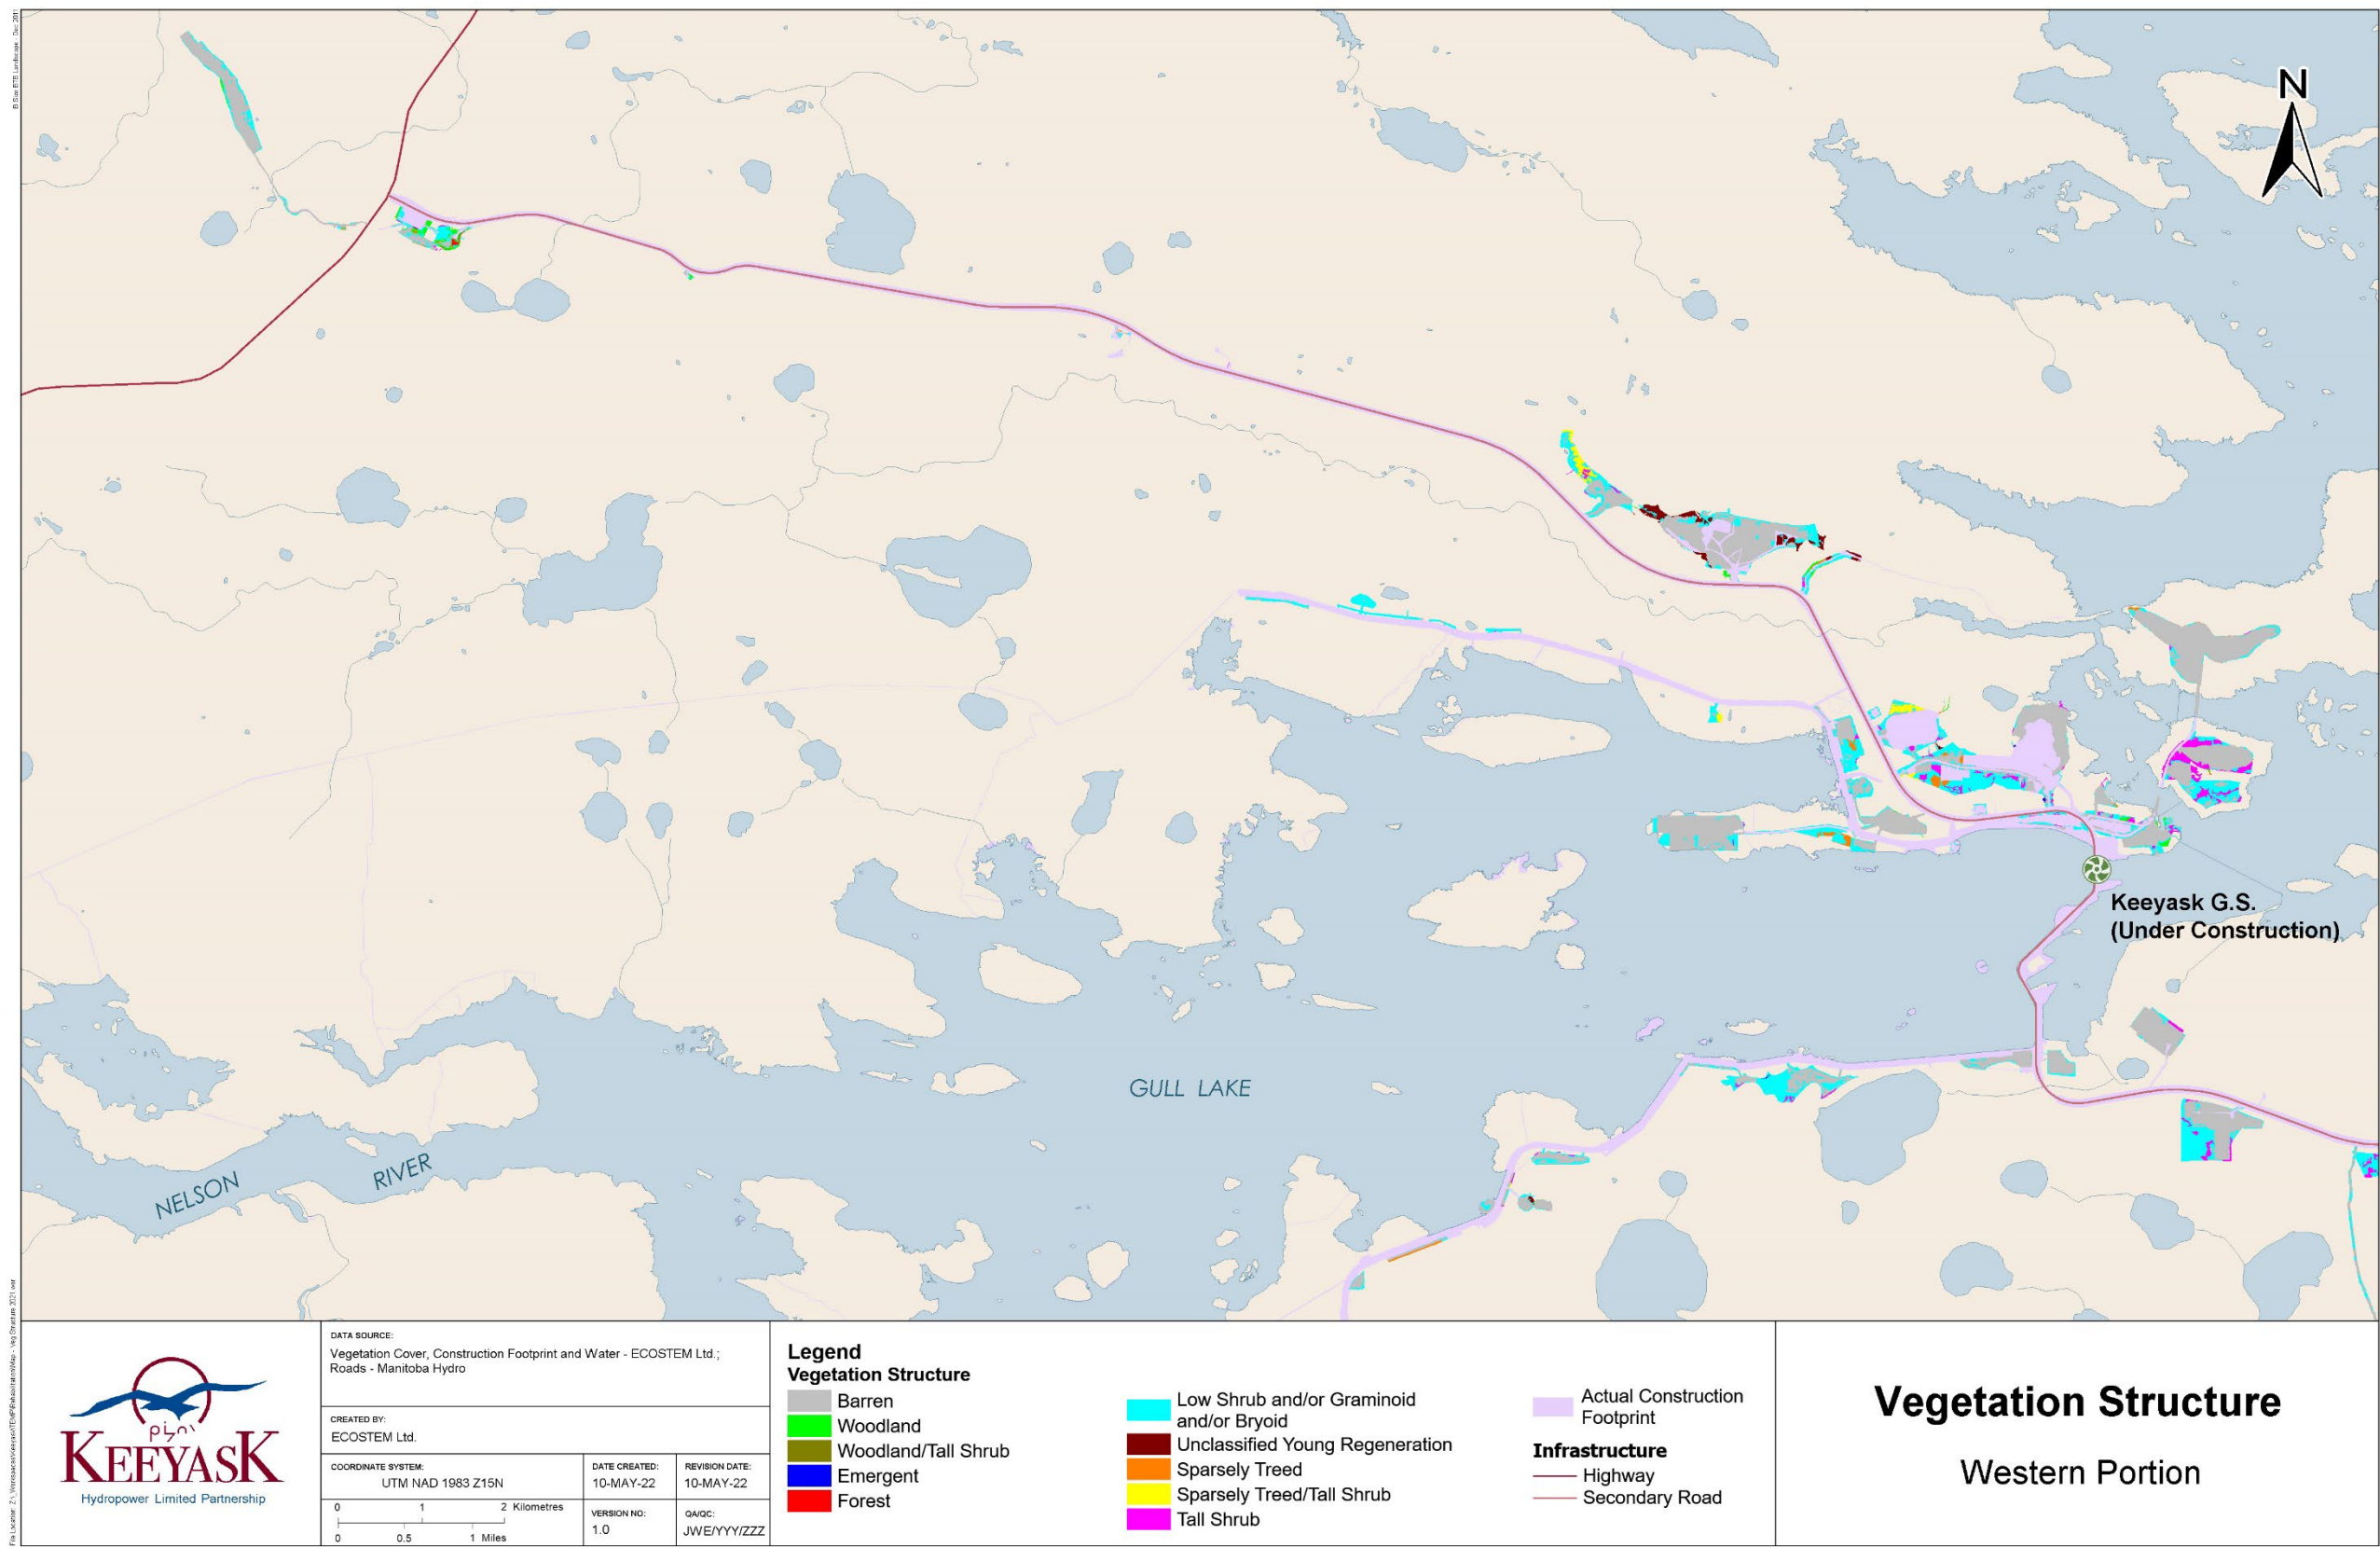
Map 4-3: Vegetation structure in the western portions of the temporary Project areas as of September 2021

Work areas covered 78 ha. Low shrub/graminoid/bryoid and none vegetation structure types accounted for 45.6% and 38.5%, respectively. Tall shrub, sparsely treed, woodland and unclassified young regeneration each accounted for between 1% and 10% of the work area coverage. Sparsely treed/tall shrub and emergent together accounted for less than 1% of the area. The barren and sparse portions of the work area were found mainly in portions of Work Area A and Work Area C. The portions of Work Area A that were cleared and not used were generally covered by moderate to high vegetation cover (Photo 4-10). Small portions of the well road ditch had sparse vegetation, however the majority had moderate to high cover.

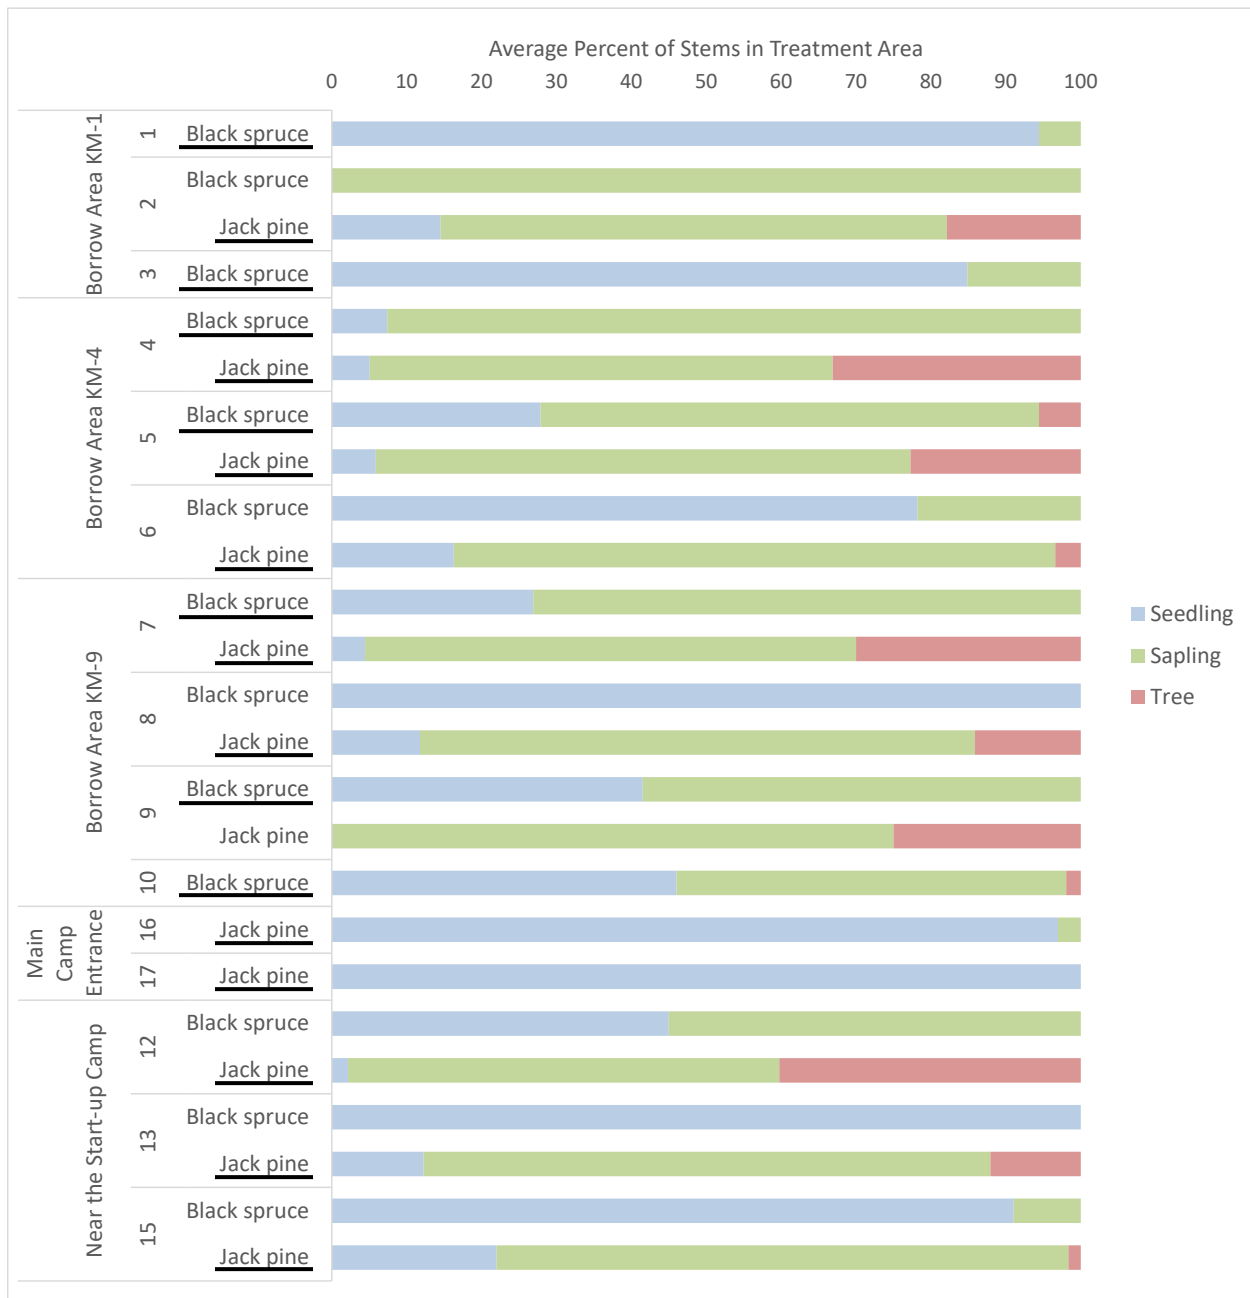
Figure 4-2: Average percent of stems in different height classes by planting area and species

Average tree height varied across the planting areas and species. In planting areas where jack pine was a planned species, the average percent of jack pine stems in the seedling height class ranged from 2.2% to 100%, 0% to 80.3% in the sapling height class, and 0% to 40.3% in the tree height class (Figure 4-2). The percentage of stems that were seedlings was highest by far in both planting areas at the Main Camp entrance (100% and 97% of tallied trees). Stems with the highest average percent in the tree size class were tallied in PA-12 near the Start-up Camp (40.3%), PA-4 in Borrow Area KM-4 (33.1%) and PA-7 in Borrow Area KM-9 (30.0%). Saplings were the dominant size class in all jack pine planting areas, except for the two at the Main Camp entrance.

The average percent of black spruce stems in the seedling height class ranged from 7.4% to 94.4%, from 5.6% to 92.6% in the sapling height class, and from 0% to 5.6% in the tree class (Figure 4-2). Saplings were the dominant height class in all the areas planted with black spruce, except for the two (PA-1 and PA-3) in Borrow Area KM-1, where most of the tallied stems (94.4% and 84.8%, respectively) were seedlings.
