Keeyask Generation Project Terrestrial Effects Monitoring Plan

Habitat Loss and Disturbance Monitoring Report

TEMP-2023-01

HABITAT LOSS AND DISTURBANCE MONITORING YEAR 1 OPERATION 2022

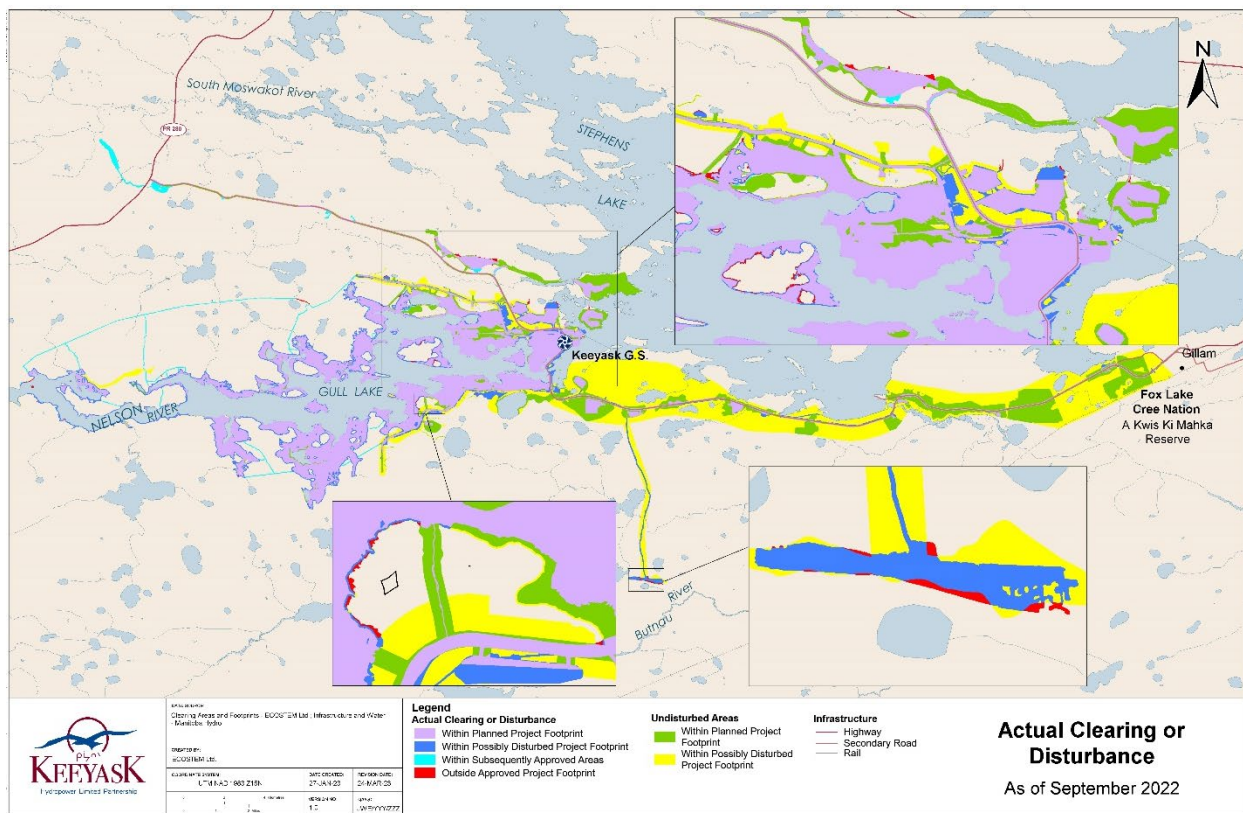
Monitoring in 2022 found that Project clearing and physical disturbance increased by 0.4 ha in total between September 2021 and September 2022 (see map below). Clearing accounted for about 58% of this increase. This clearing occurred on the southern edge of Work Area C, where safety fencing was installed.

Approximately 0.2 ha of the new clearing or disturbance was outside of the approved Project footprint.

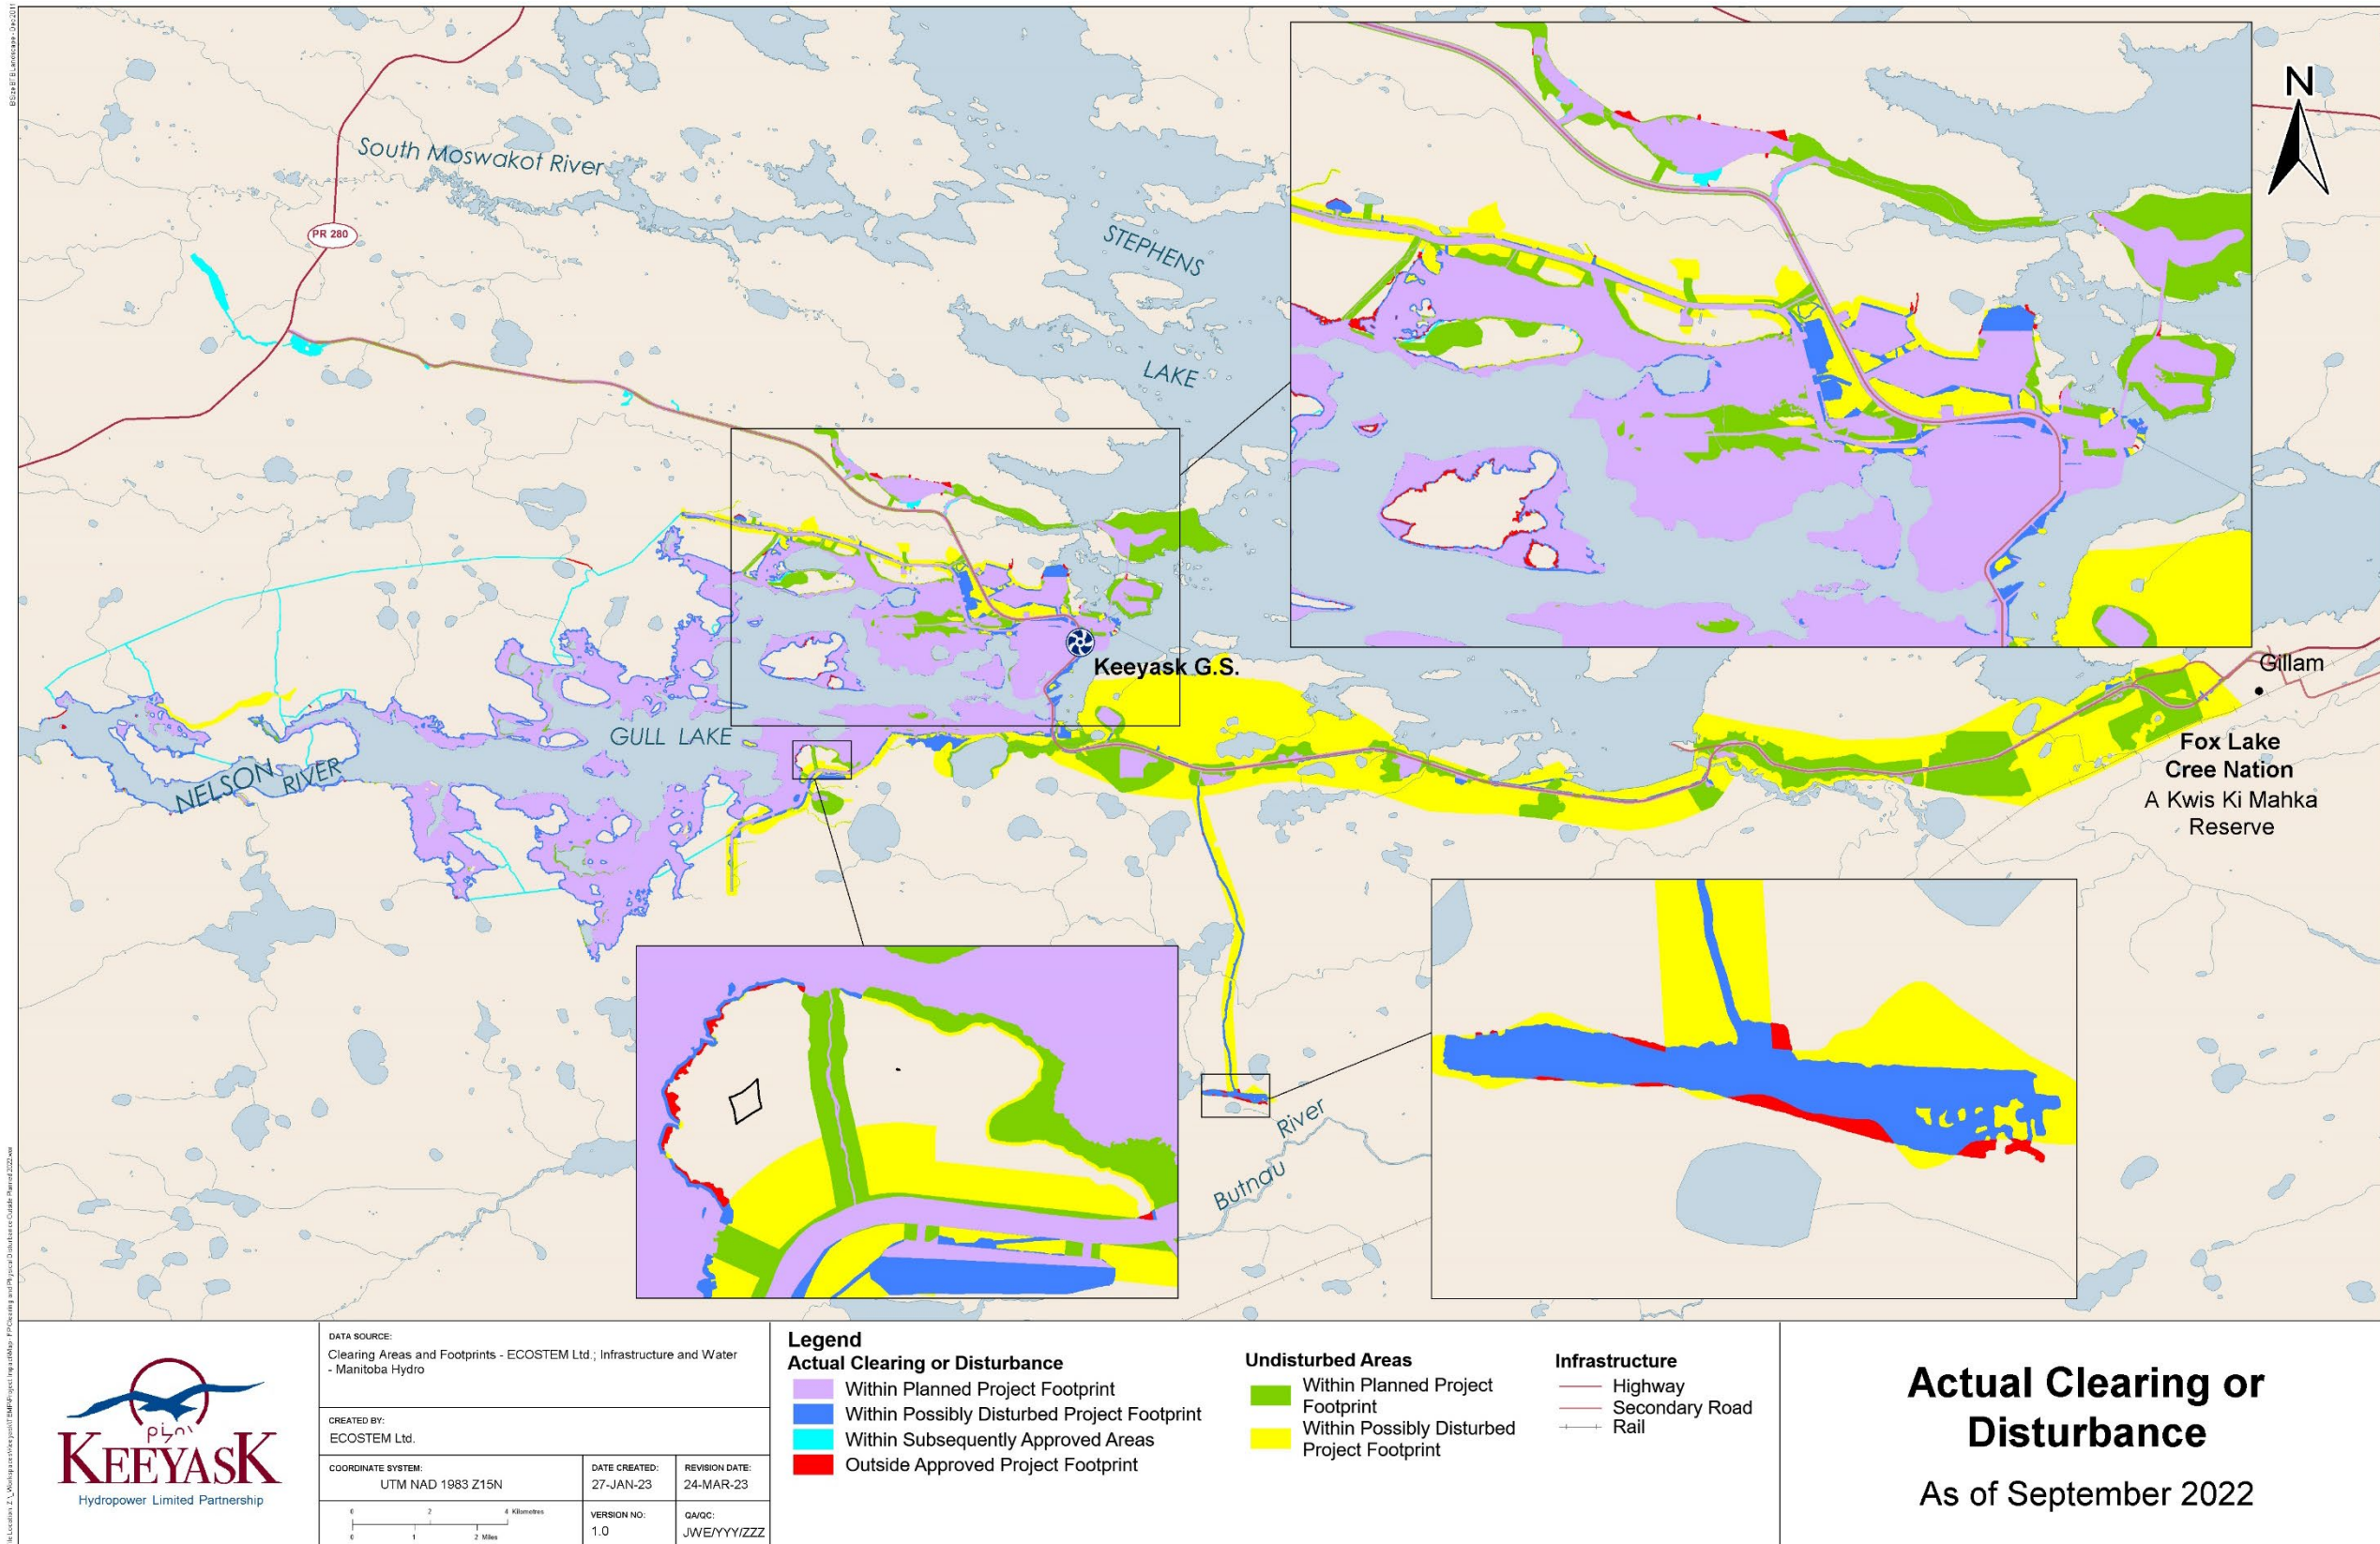
Map 3-1: Actual Project clearing or physical disturbance as of September 2022

Clearing accounted for the majority (58.4%) of the 0.4 ha increase in impacts (Table 3-1). Clearing mainly consisted of vegetation removal for placement of safety fencing along the southern edge of Work Area C. The Project disturbance that accounted for the remainder of the above noted area increase included ponding and mass wasting due to altered water flows.

Surveys in 2022 found that sediment deposition on mineral slopes around the perimeter was ongoing in several spots (Map 3-1; Map 3-2). Sediment deposition into an adjacent marsh on the southwestern edge of the borrow area was also ongoing but had not increased since September 2021 (Photo 3-9).

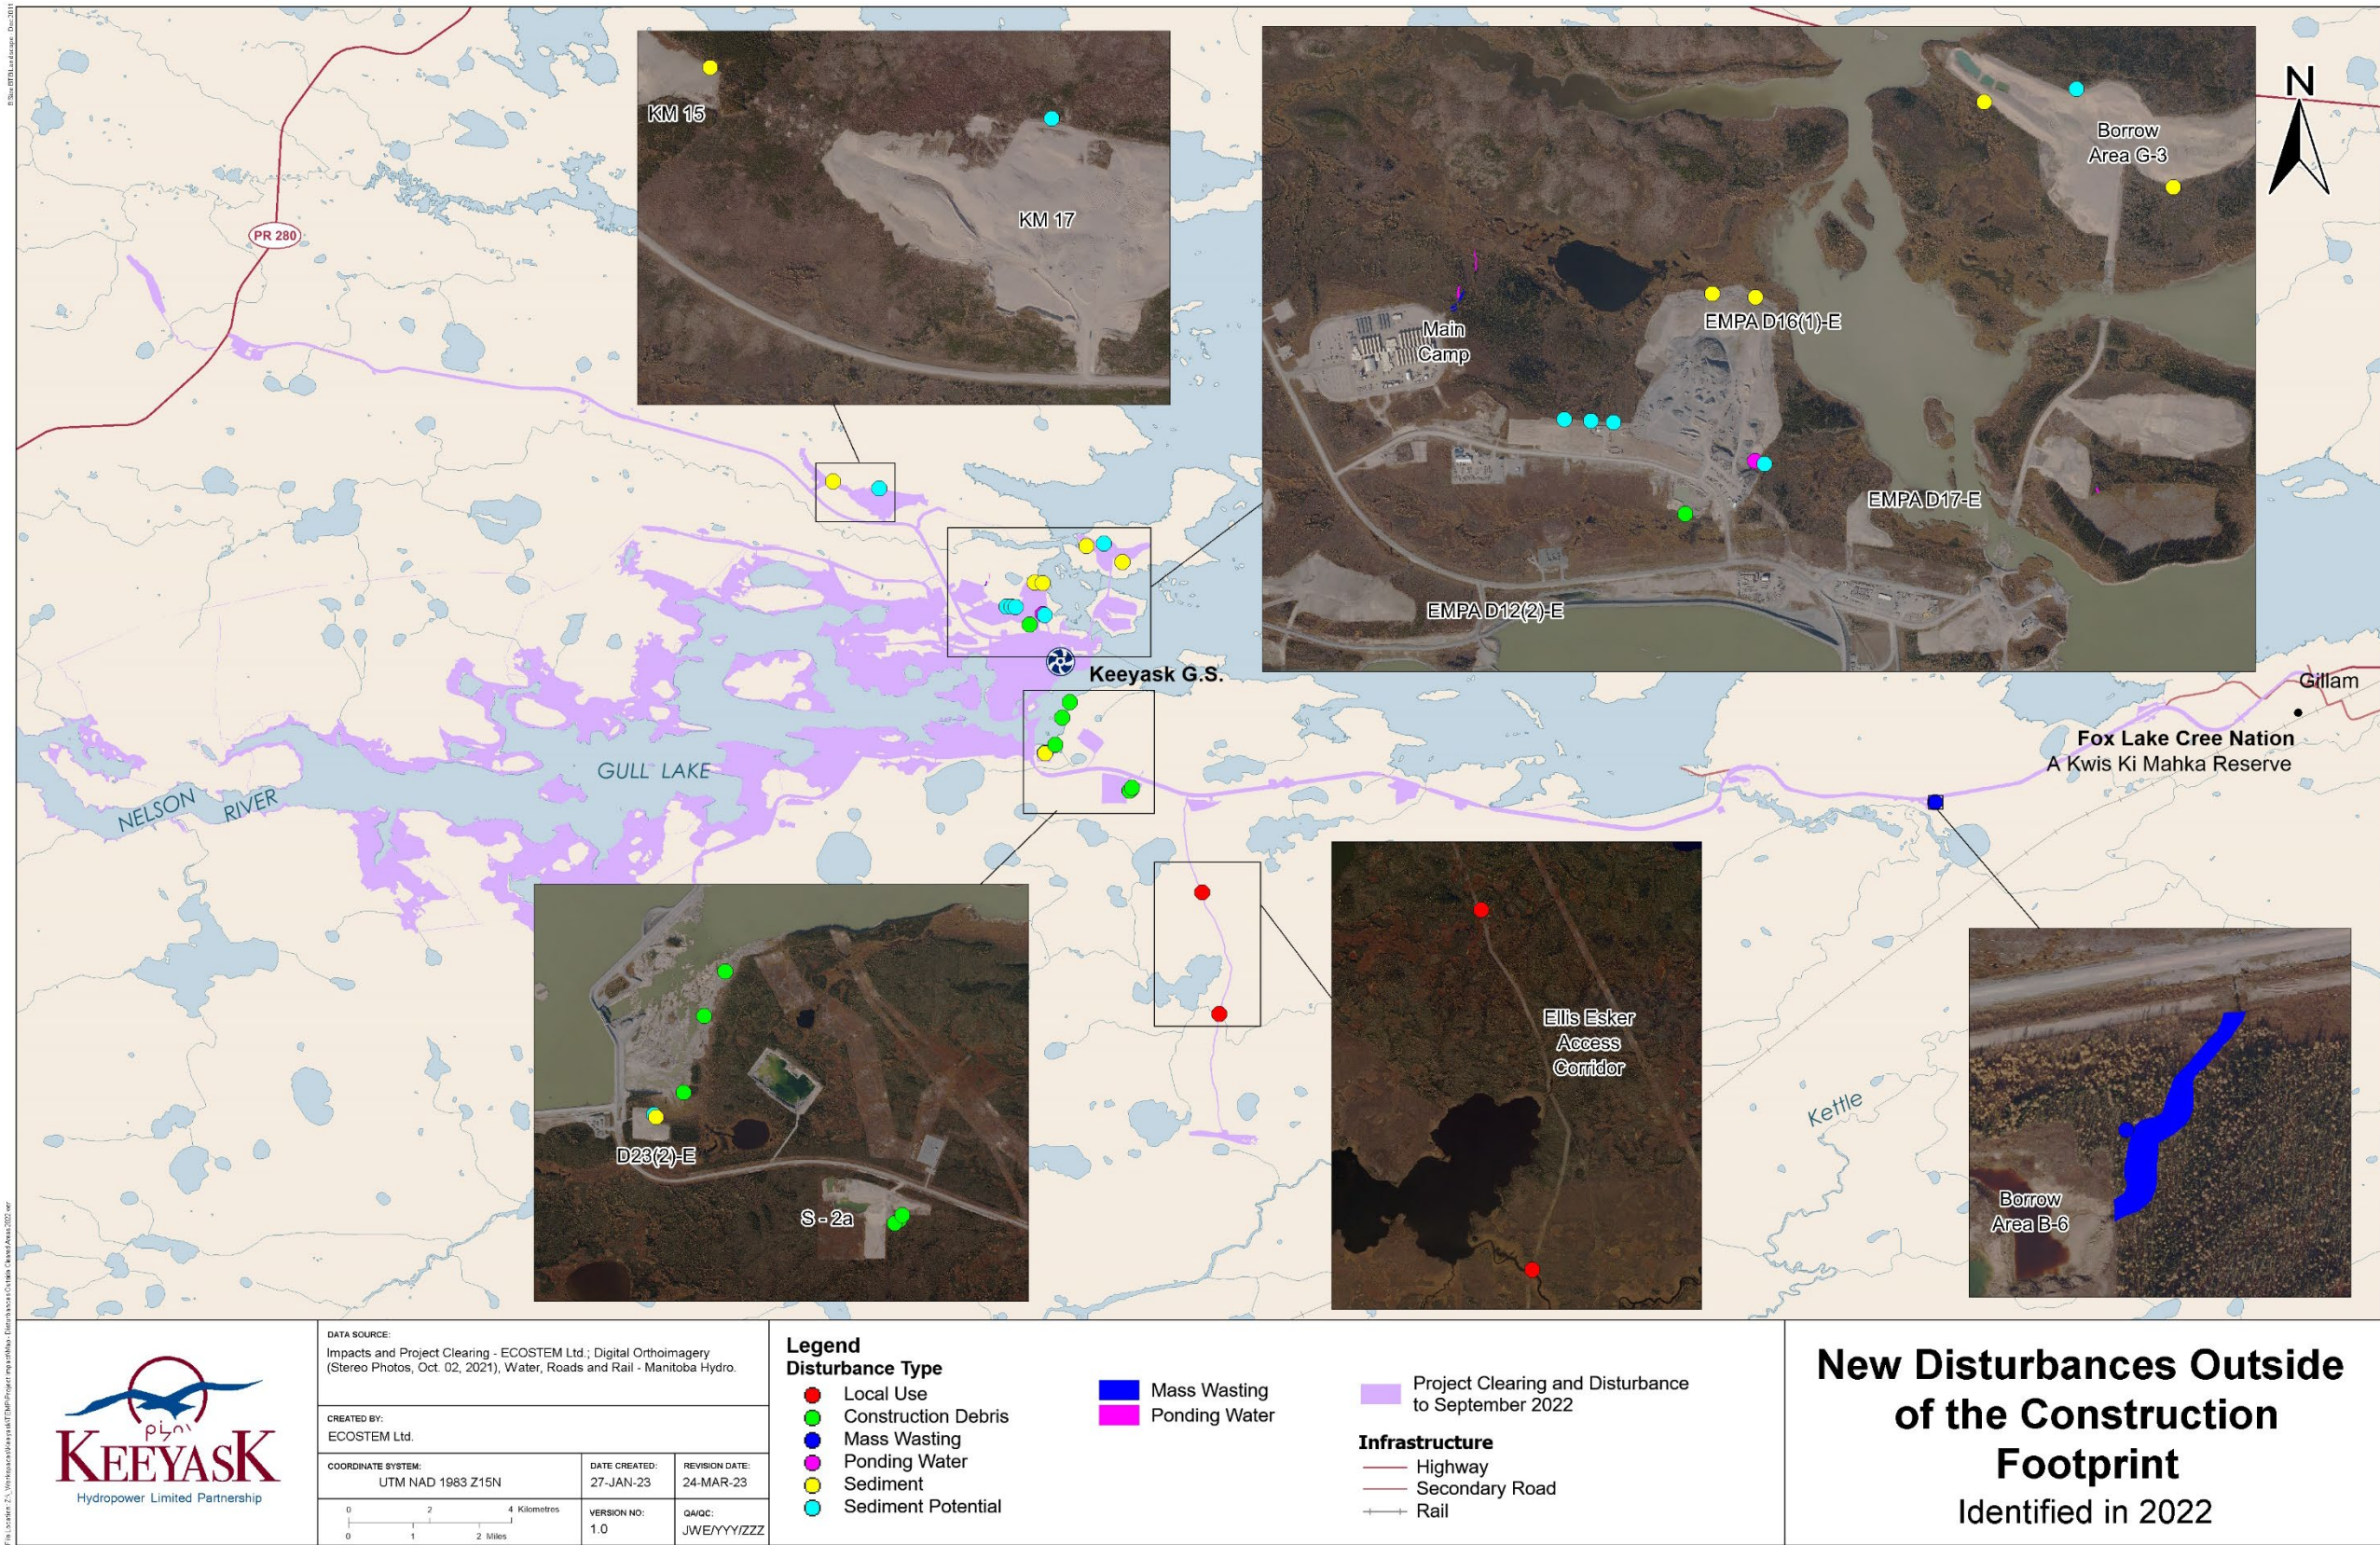
Map 3-2: New disturbances outside of the Construction Footprint as of September 2022

New locations of erosion at the northern edge of Work Area A were observed during the 2022 survey (Map 3-2; Photo 3-5). These locations had the potential to deposit sediment into the adjacent undisturbed vegetation.

Approximately 0.2 ha of new clearing was identified during 2022 surveys in Work Area C (Map 3-2; Photo 3-6). About 64% of the additional clearing was within the planned Project Footprint and the remainder was outside of the planned and possibly affected portions of the Project Footprint. This clearing was the result of new safety fencing installed on the southern edge of the work area.
