Keeyask Generation Project  
Terrestrial Effects Monitoring Plan

**Habitat Rehabilitation Implementation and Success  
Monitoring Report**

TEMP-2023-07

#### **YEAR 1 OPERATION**

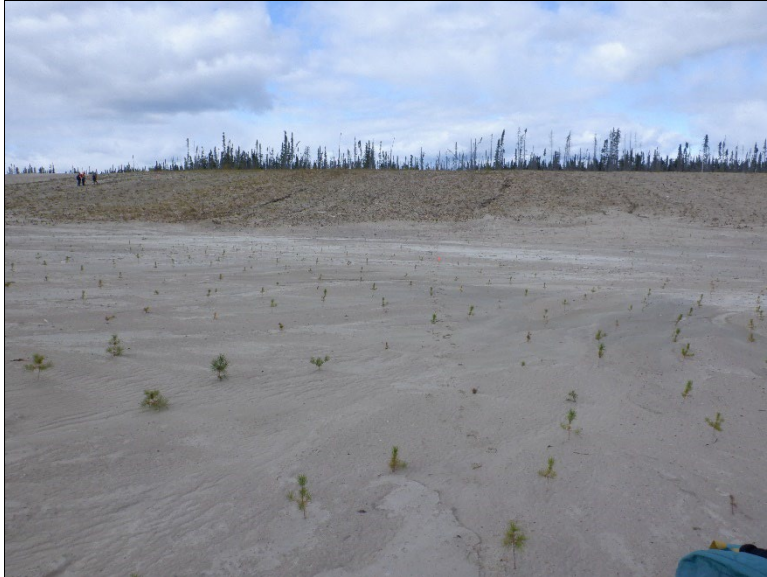
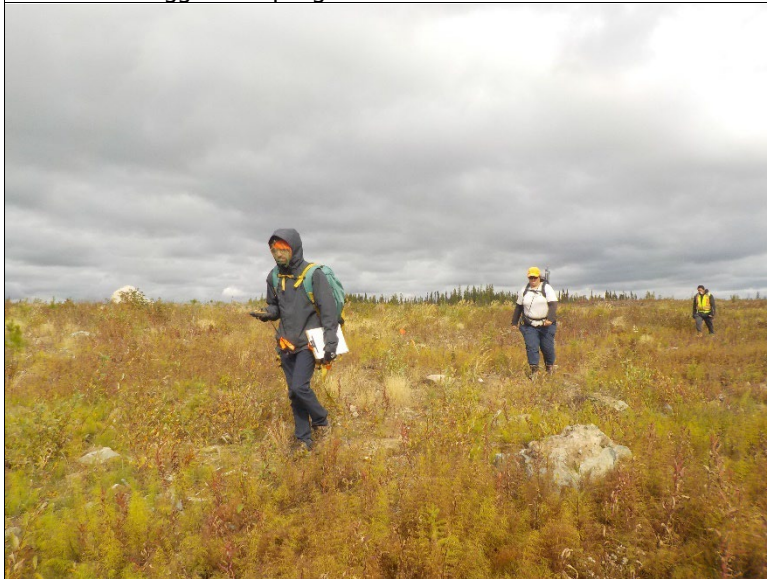
**Figure 3-1: Tree regeneration sampling in 2022**

Flagged sampling transect in Borrow Area G-3

Sampling a transect in EMPA 27-4

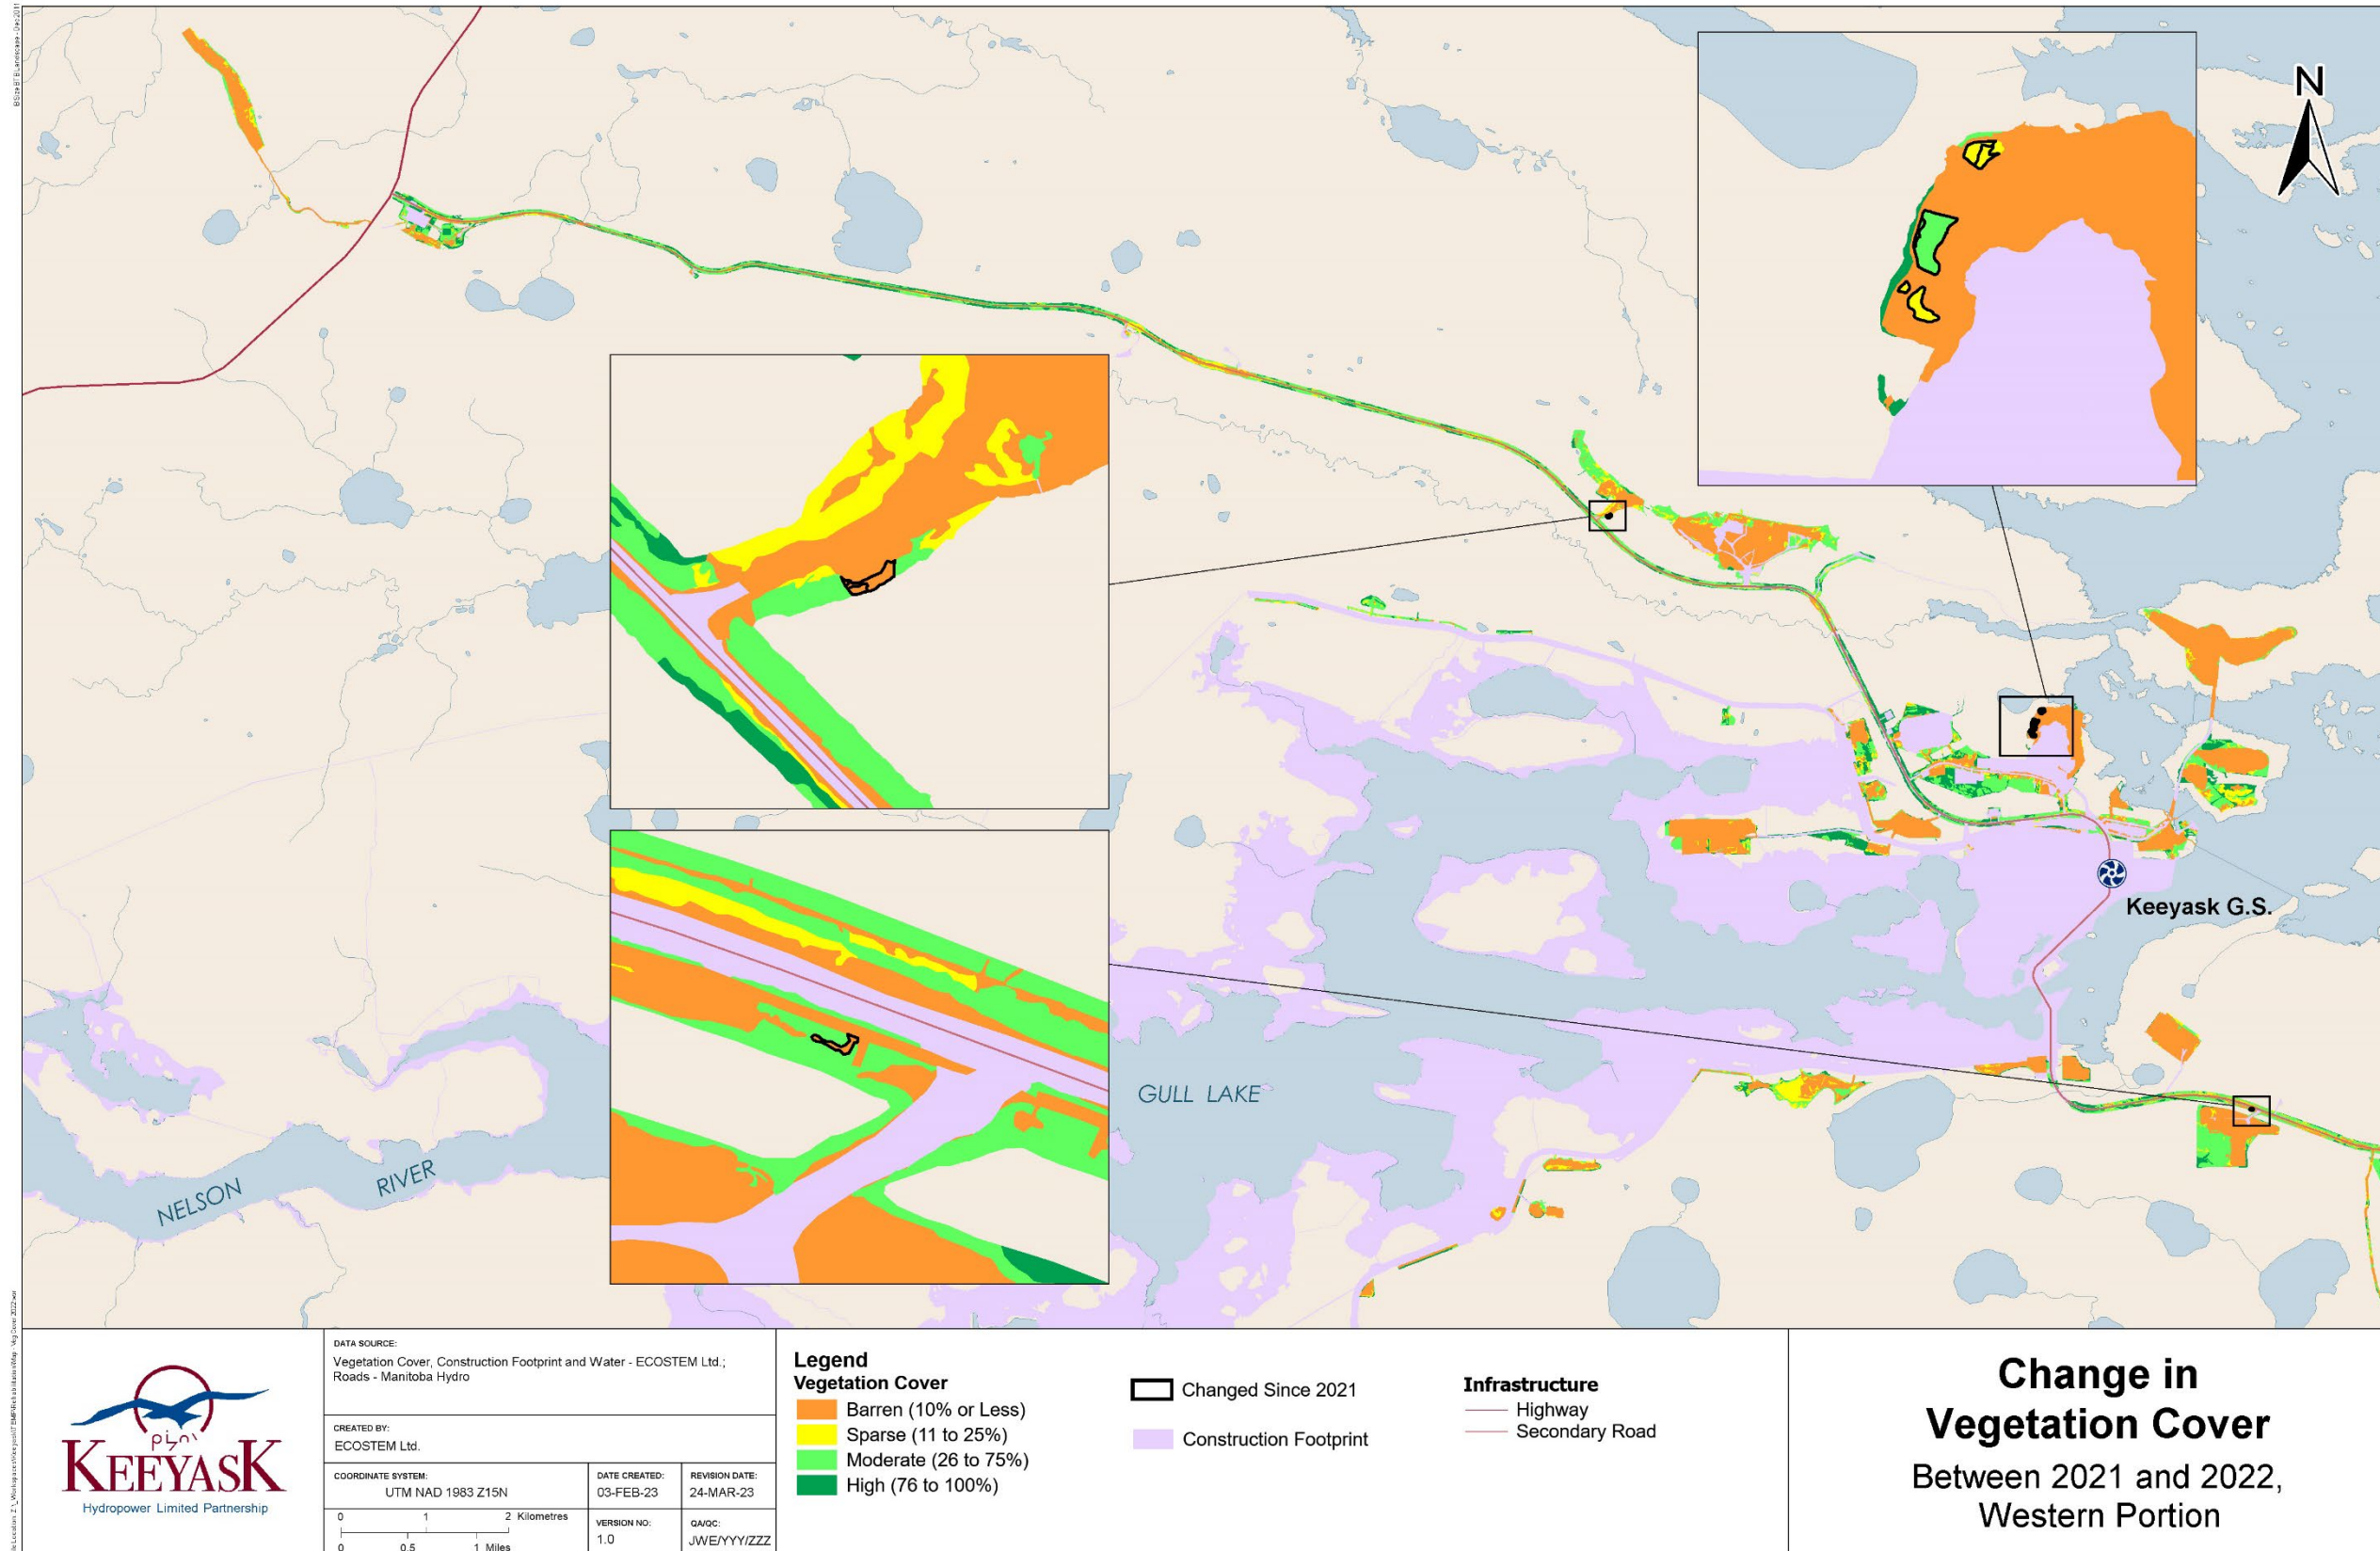
At one location in Borrow Area G-1 at KM-15, approximately 50 m<sup>2</sup> of vegetation cover changed from Moderate with a Low structure type to Barren (Map 4-1). This was due to low regenerating vegetation being removed during site preparation for habitat rehabilitation activities (Photo 4-1).

**Map 4-1: Locations where vegetation cover and structure changed between 2021 and 2022 in the western portions of the Construction Footprint as of September 2022**

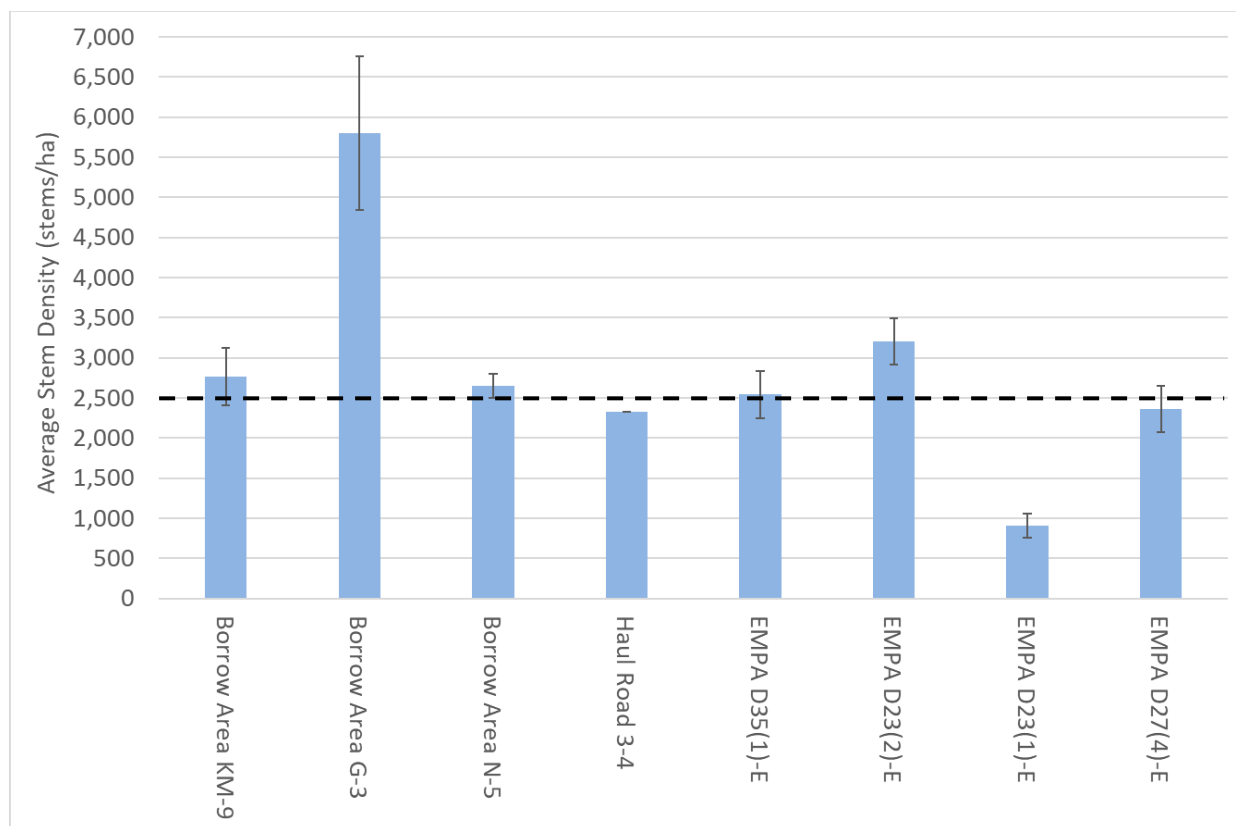
Based on the combined living stem density (includes natural regeneration), Borrow Area G-3 was the only rehabilitation location planted in 2020 and 2021 that had an estimated live stem density in 2022 that was significantly greater than 2,499 stems/ha (Figure 4-1; Table 4-7). Four of the remaining seven rehabilitation locations, including Borrow Areas KM-9 and N-5, and EMPAs D35(1)-E and D23(2)-E, had overall estimated live stem densities higher than 2,500 stems/ha, but the difference was not significant. The live stem density for EMPA D23(1)-E was significantly lower than the target stem density, with an average live stem density of just over 900 stems/ha.

**Figure 4-1: Overall live stem density as of 2022 for the rehabilitation locations planted in 2020 and 2021. Error bars represent standard error of the mean, and the dashed line represents the target stem density for a woodland (2,500 stems/ha)**

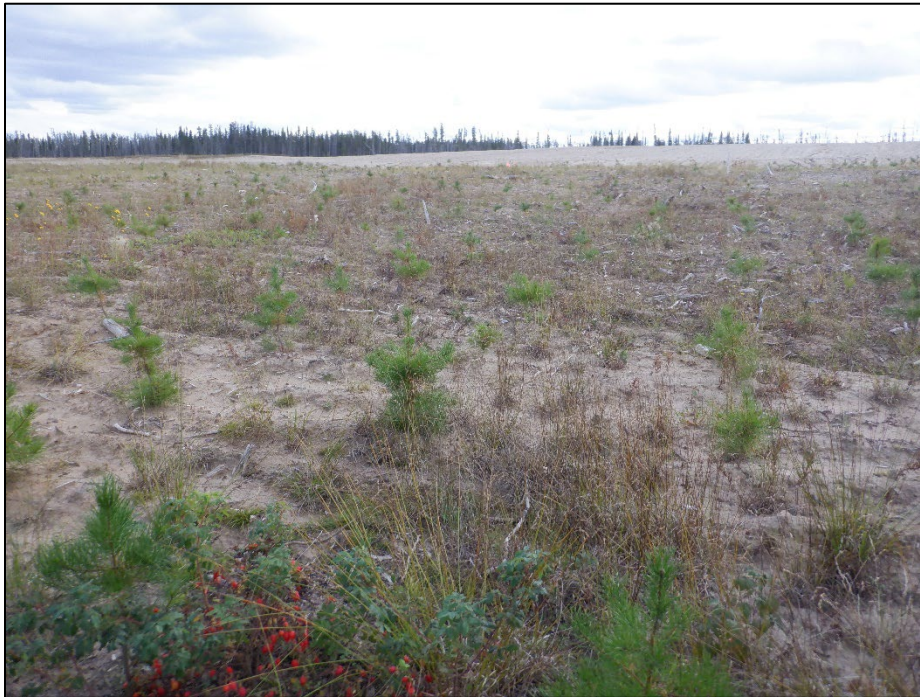
As of September 2022, live planted and/or naturally regenerating jack pine was present in 31 of the 32 areas planted in 2020 and 2021 (Figure 4-2). The average live stem density for planted and naturally regenerating jack pine in these areas ranged from 41 to 4,425 stems/ha (Table 4-8). The planting areas that had the highest average live jack pine stem densities occurred in Borrow Area G-3 (PA-6, PA-8, and PA-11; Photo 4-3; Table 4-8). The planting areas with the lowest jack pine live stem densities were mostly in EMPA D27(4)-E. Six of the eight planting areas in that location had live jack pine stem densities below 1,000 stems/ha, with only one planting area exceeding 2,500 stems/ha.

**Photo 4-3: Jack pine regeneration in a planting area with advanced regeneration in PA-5 in Borrow Area G-3 in 2022**

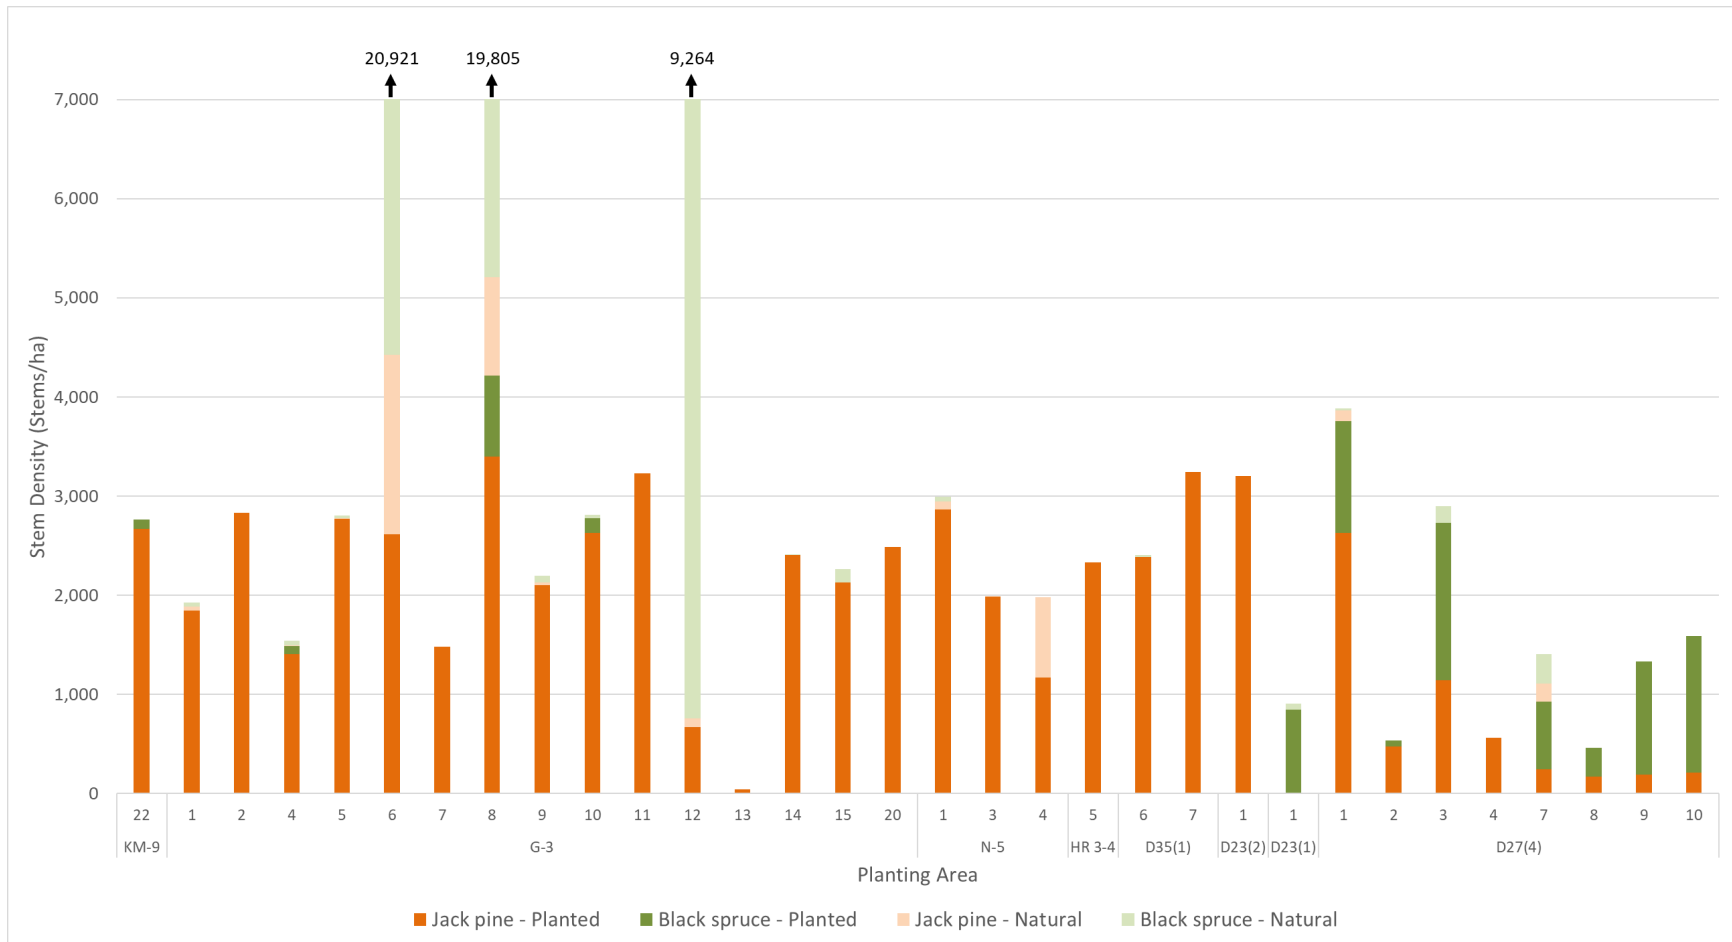
Figure 4-2: Composition of jack pine and black spruce regeneration in the 2020 and 2021 planting areas

Natural black spruce and/or jack pine regeneration was present in 16 of the 32 planting areas surveyed (Figure 4-2). Overall, jack pine made up a smaller portion of the naturally regenerating stems than black spruce and occurred in fewer planting areas (11 of the 32) than naturally regenerating black spruce (Table 4-9). Where present, naturally regenerating jack pine comprised from 0.3% to 43.5% of the average live stem density in a planting area. The planting areas with the highest percent of jack pine regeneration were PA-6 and PA-8 in Borrow Area G-3, and PA-7 in EMPA D27(4)-E where naturally regenerated jack pine stems accounted for 43.0%, 24.4% and 33.3% of the live stems, respectively.

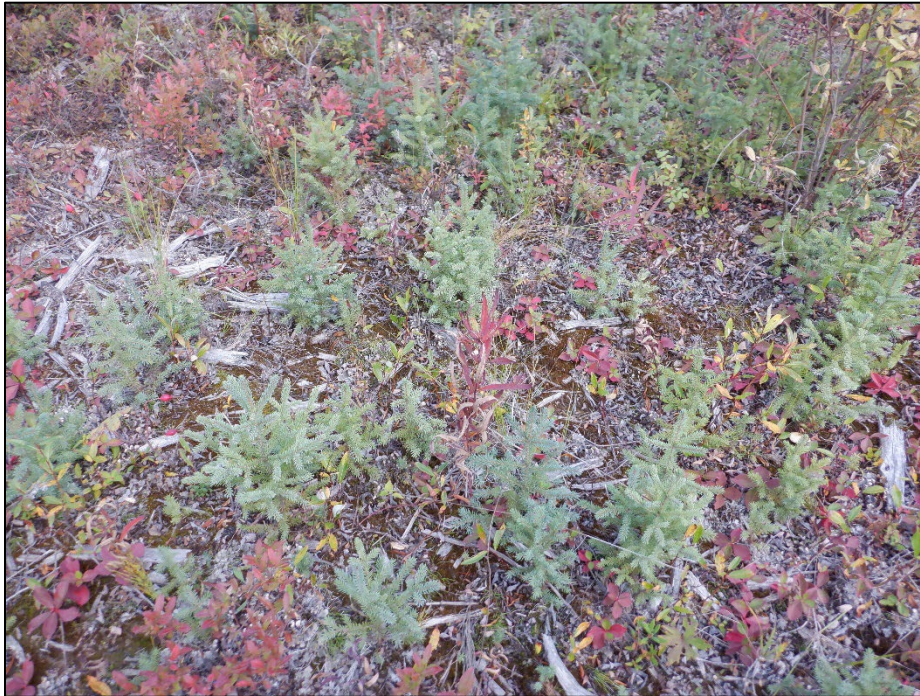
Black spruce natural regeneration was present in 15 of the 32 planting areas, and in all rehabilitation locations except Haul Roads 3-4, and EMPAs D35(1)-E and D23(1)-E (Table 4-9). Naturally regenerating black spruce made up most of the black spruce stem density in the Borrow Area G-3 planting areas (Photo 4-4), including those where black spruce was planted. The exception was PA-4, where natural regeneration made up just over one-third of the tallied black spruce stems.

**Photo 4-4: Naturally regenerating black spruce growing in Borrow Area G-3 (PA-12) in 2022**

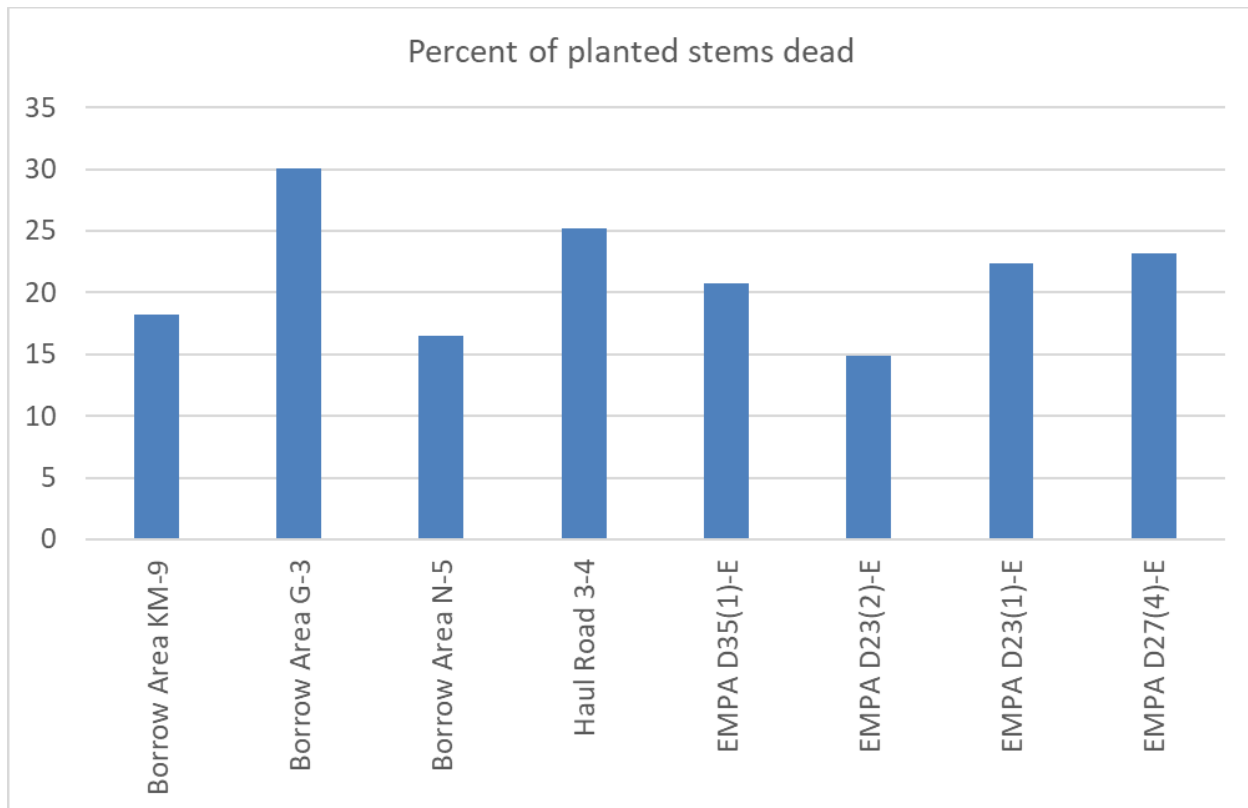
Pooling all planted stems tallied in 2022 for each rehabilitation location, overall mortality (Photo 4-5) was highest in Borrow Area G-3, with 30.0% of tallied stems dead (Figure 4-3). This was followed by Haul Roads 3-4 (25.2%) and EMPA 27(4)-E (23.2%). Mortality was lowest overall in EMPA D23(2)-E (14.9%).

**Figure 4-3: Percent of tallied planted jack pine and black spruce stems that were dead in 2022, for all planting areas pooled by rehabilitation location**

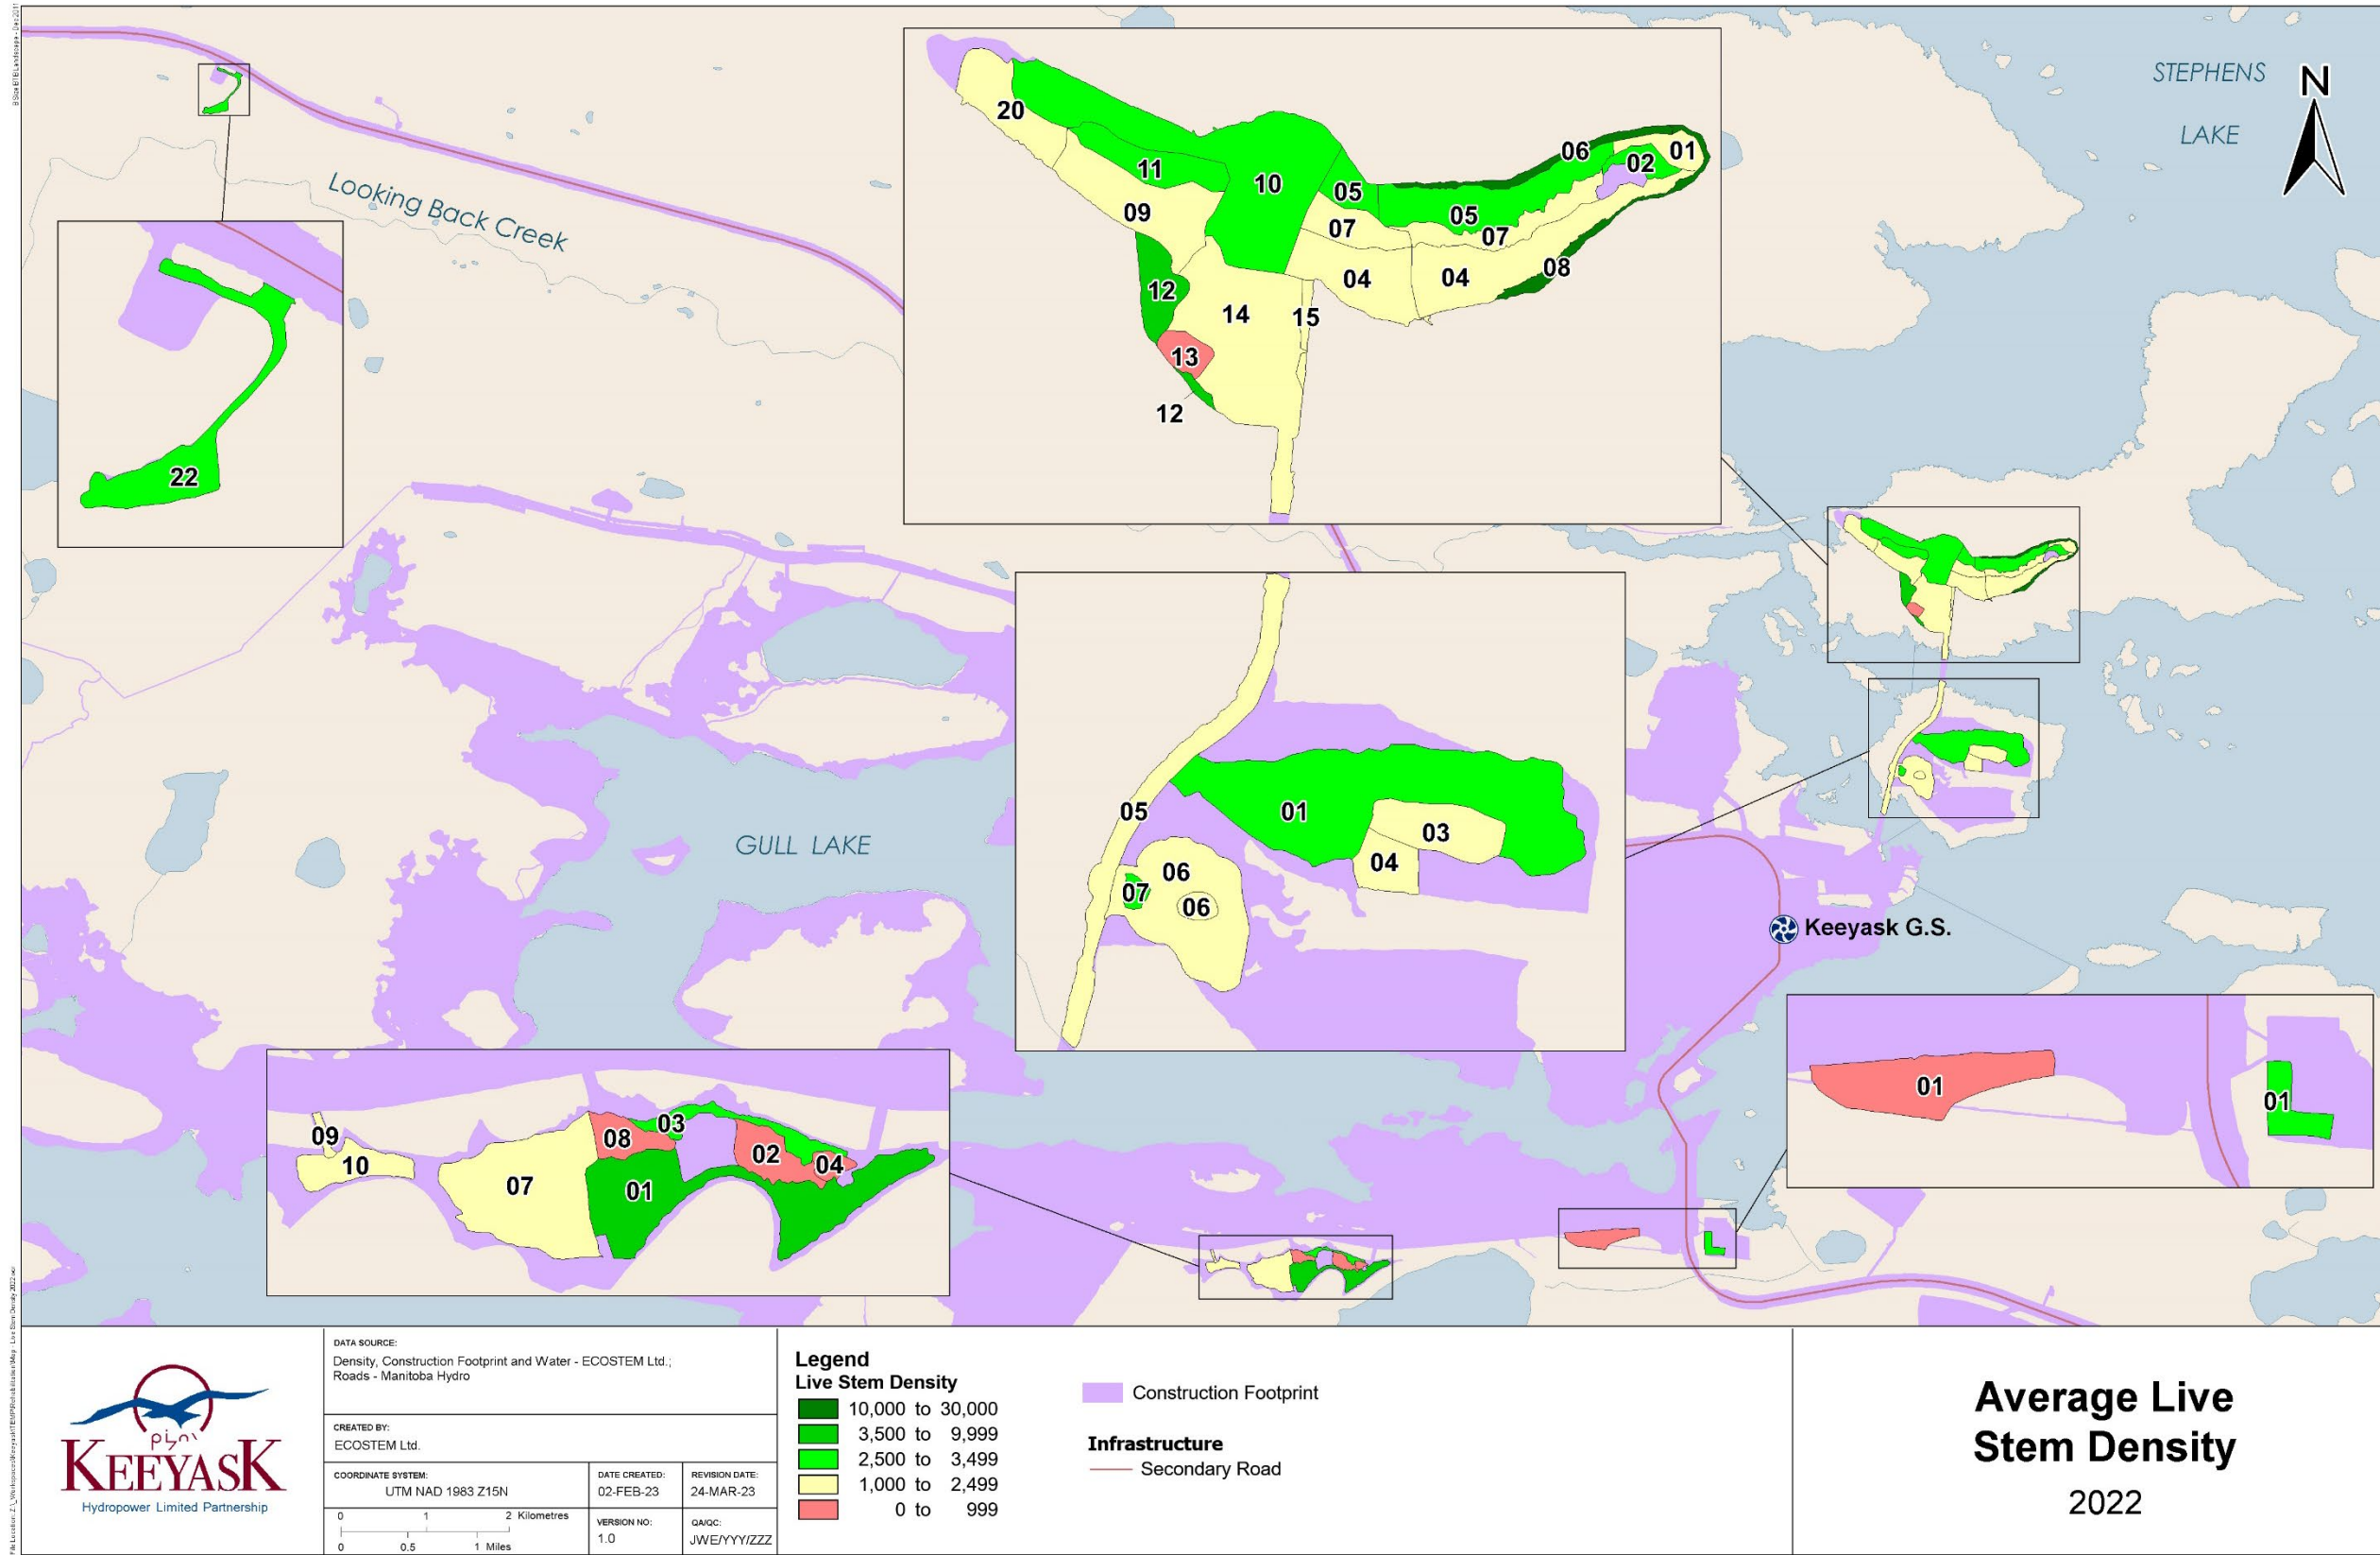
Nineteen of the 32 planting areas treated in 2020 and 2021 had a combined live jack pine and black spruce stem density below 2,500 stems/ha as of September 2022. These planting areas were distributed through all rehabilitation locations except for Borrow Area KM-9 and EMPA D23(2)-E (Table 4-8; Map 4-3).

Map 4-3: Average total live stem density for areas planted in 2020 and 2021 as of September 2022

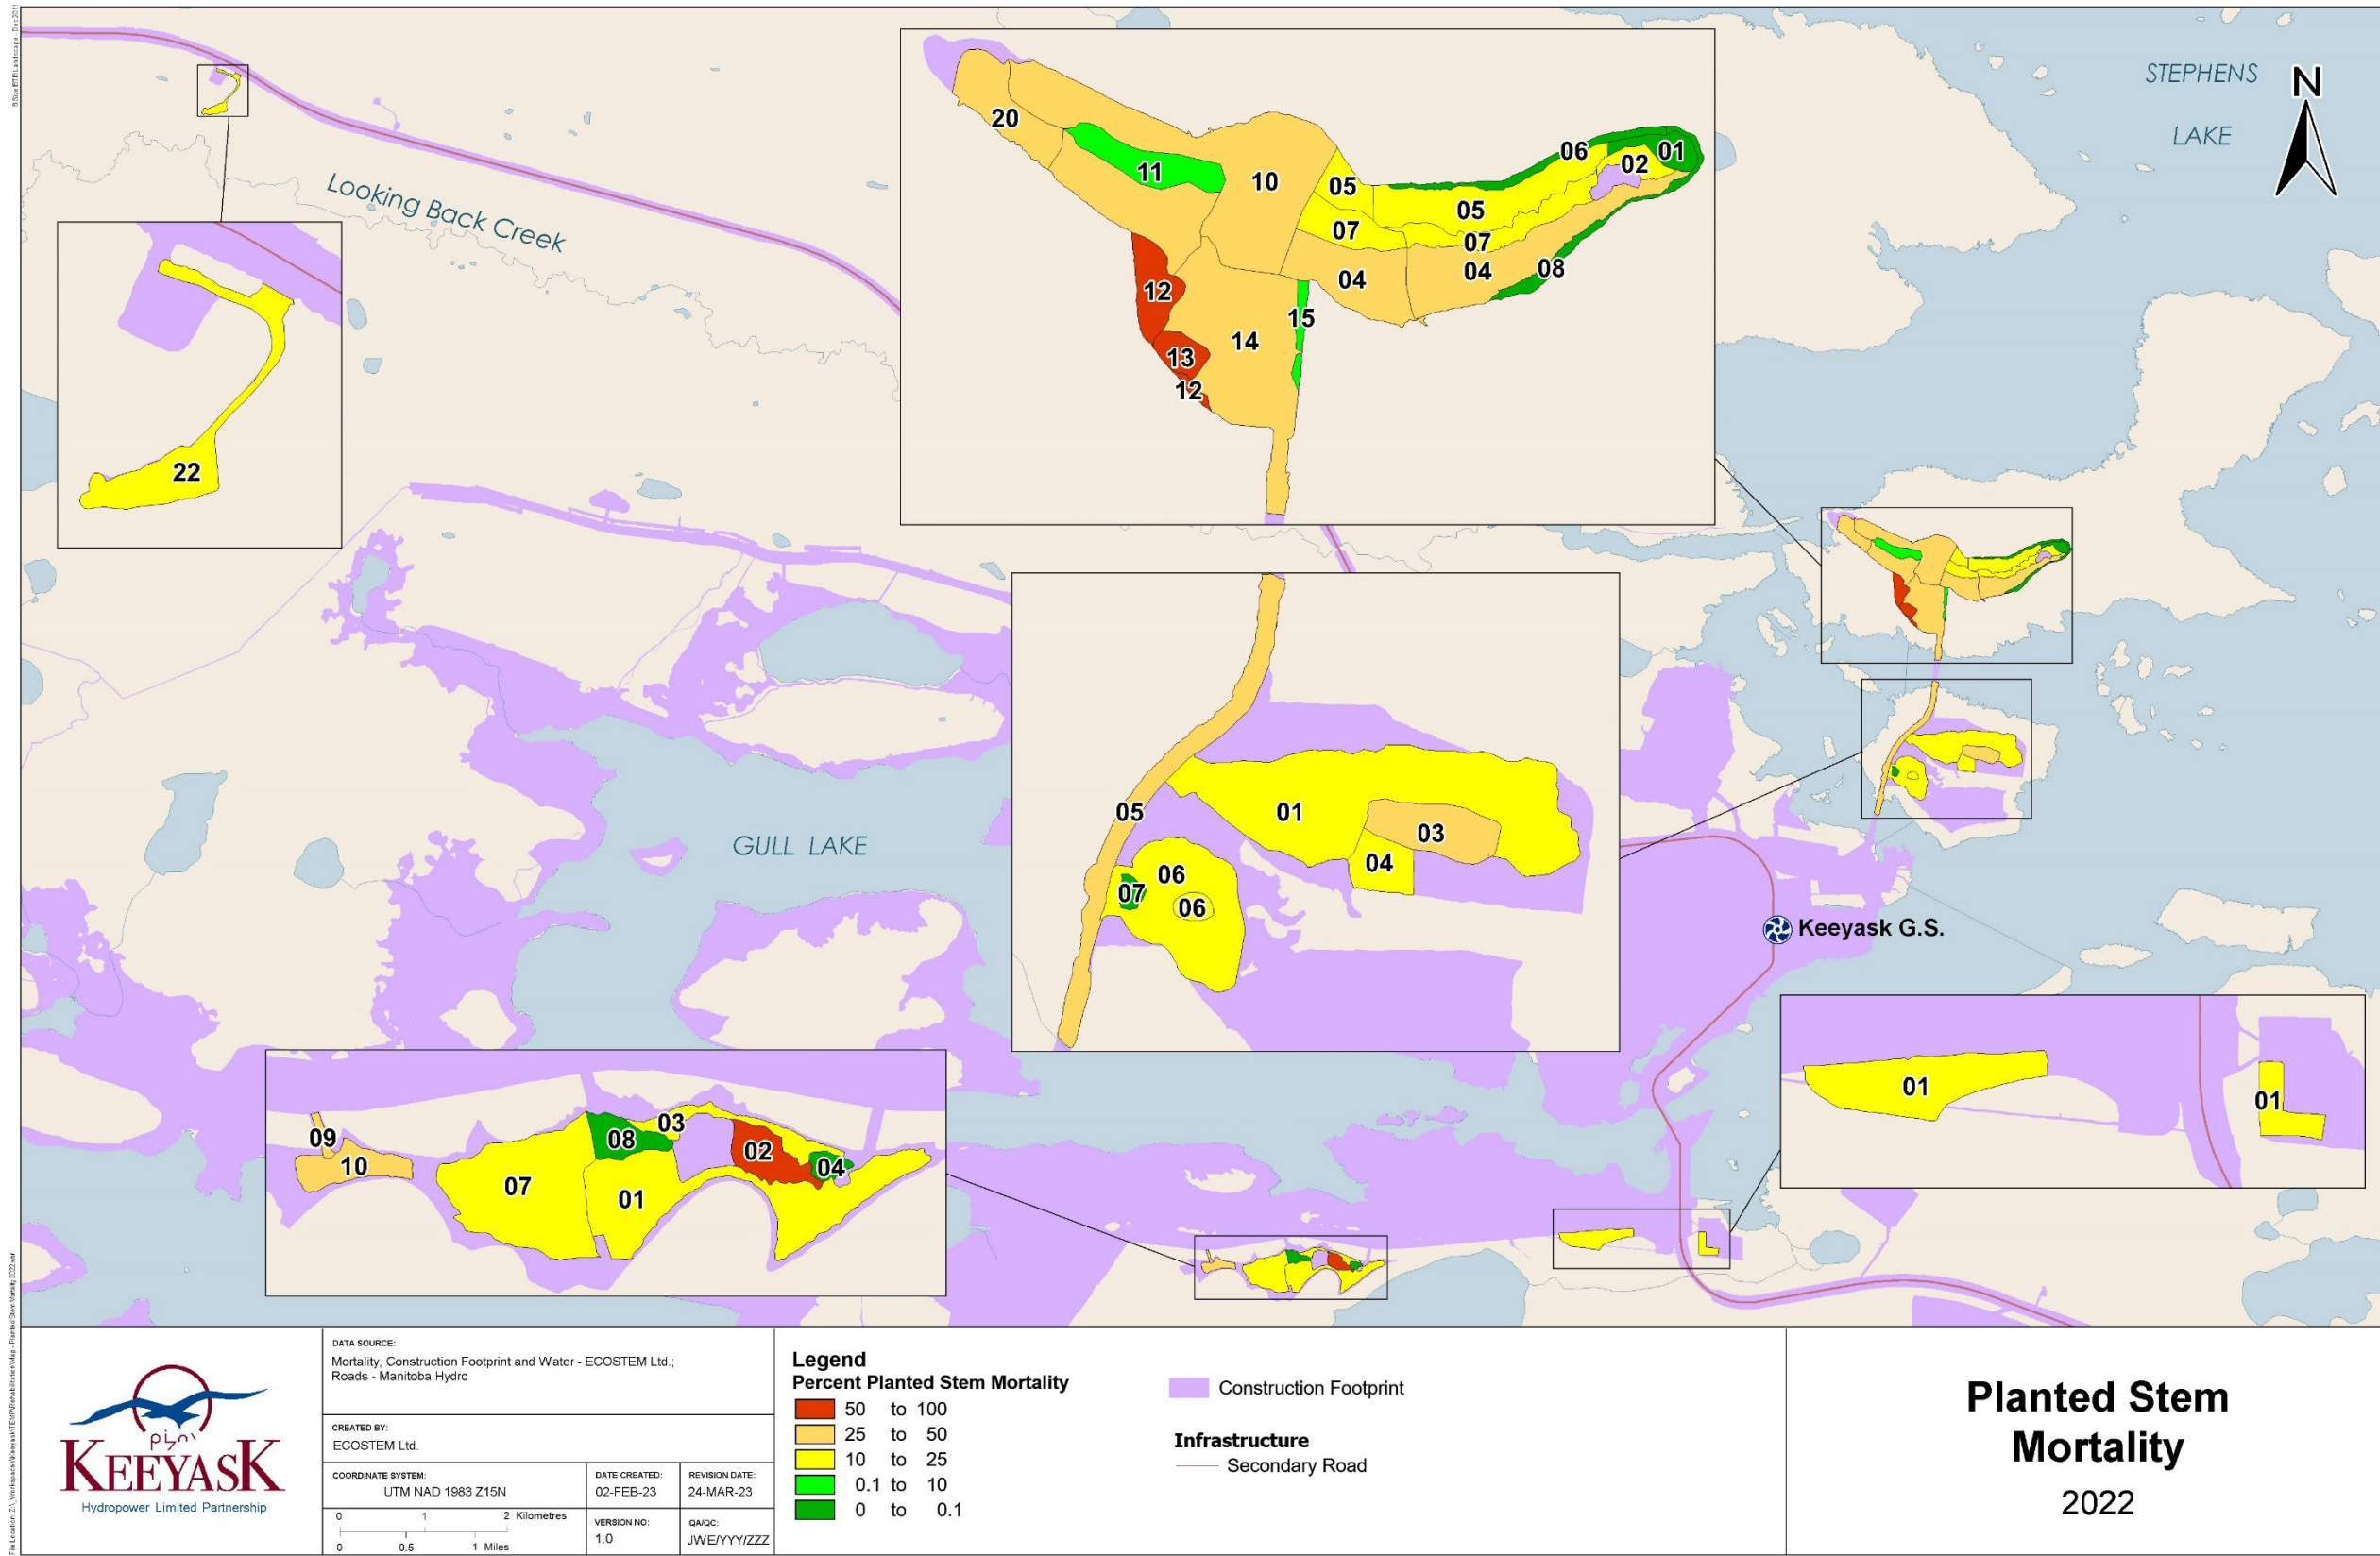
Planted jack pine mortality by planting area ranged from 0% to 80% (Table 4-10; Map 4-4). While Planting Area 13 in Borrow Area G-3 had the highest percent mortality, this was based on only five tallied jack pine stems for the planting area. Planting Area 2 in EMPA D27(4)-E had the next highest mortality at 72.7%, followed by PA-12, PA-4, PA-20 and PA-9 in Borrow Area G-3, and PA-7 and PA-10 in EMPA D27(4)-E, all of which had more than 40% planted stem mortality for jack pine. The planting areas with the lowest planted jack pine stem mortality were in PA-5, PA-11 and PA-15 of Borrow Area G-3, and PA-4 and PA-8 of EMPA D27(4)-E, all of which had less than 10% mortality (Table 4-10).

Map 4-4: Percent stem mortality of planted stems for areas planted in 2020 and 2021 as of September 2022

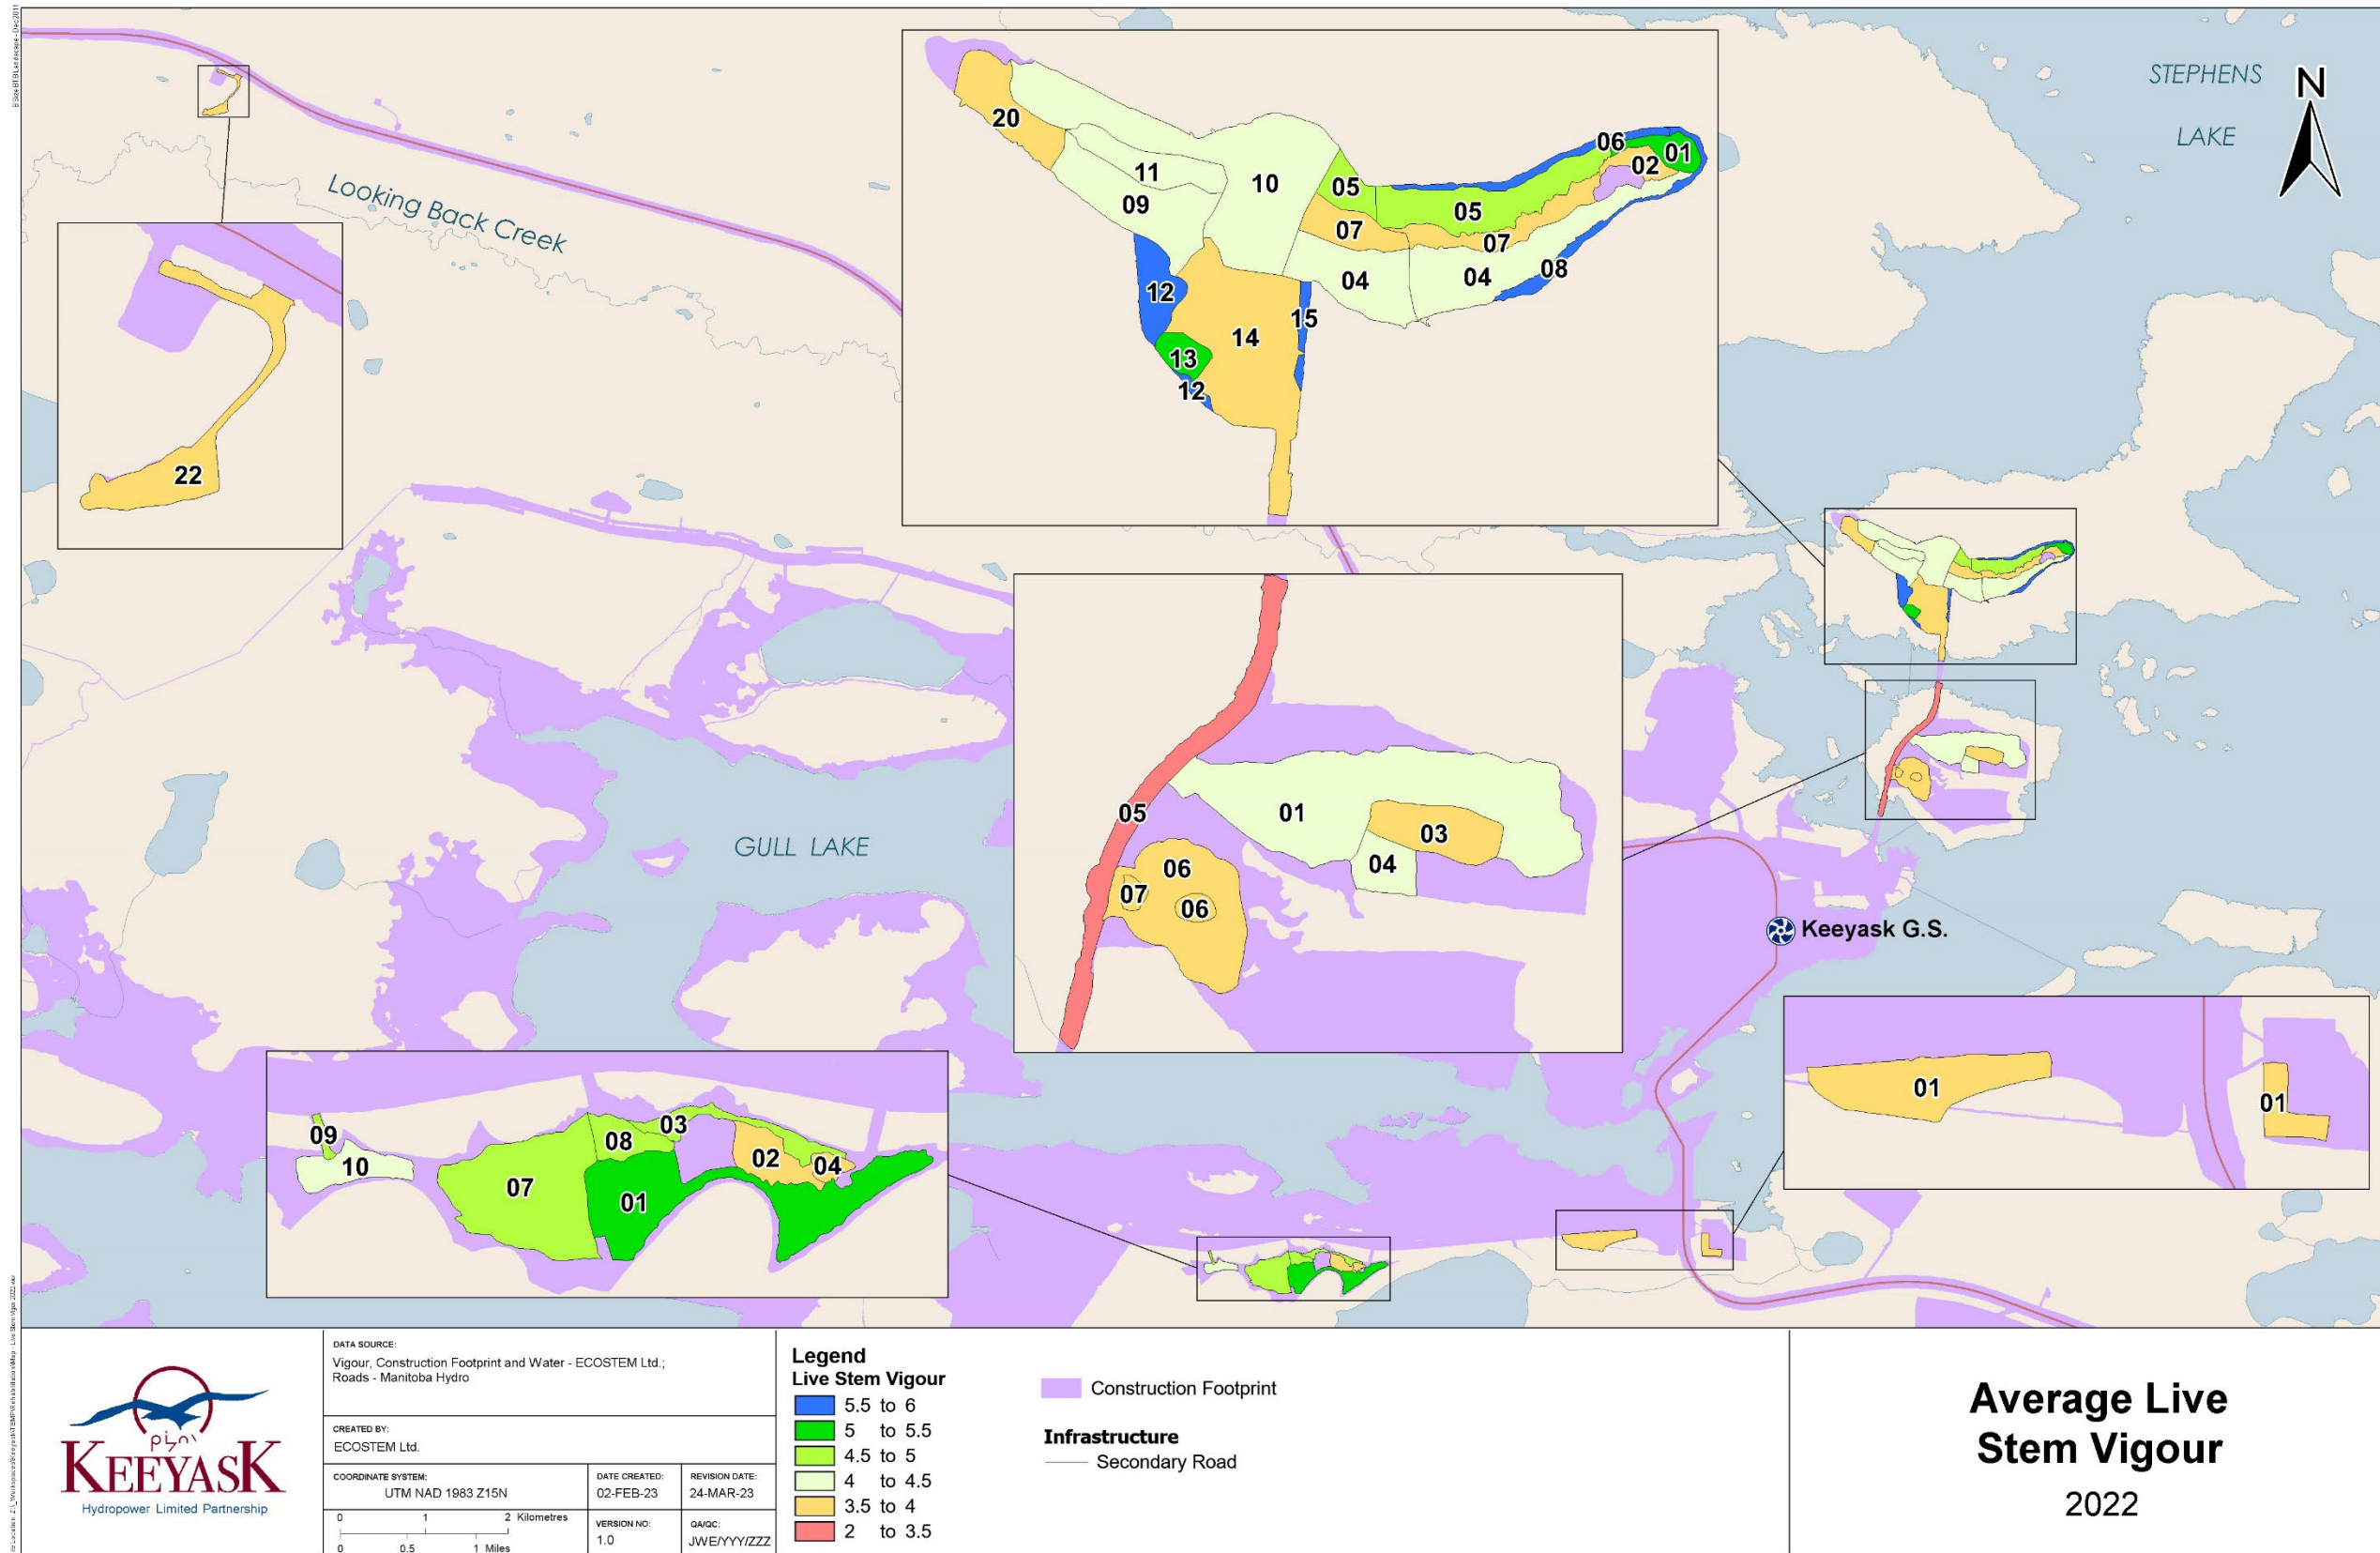
Vigour class was variable for live jack pine stems in the planting areas (Map 4-5). In general, planting areas where average vigour was less than 4 was dominated by stems with poorer condition and health (Photo 4-6), more often having a dead leader (Photo 4-7), or only a few living

Map 4-5: Average live stem vigour for areas planted in 2020 and 2021 as of September 2022
