Keeyask Generation Project  
Terrestrial Effects Monitoring Plan

**Habitat Rehabilitation Implementation and Success  
Monitoring Report**

TEMP-2023-07

#### **YEAR 1 OPERATION**

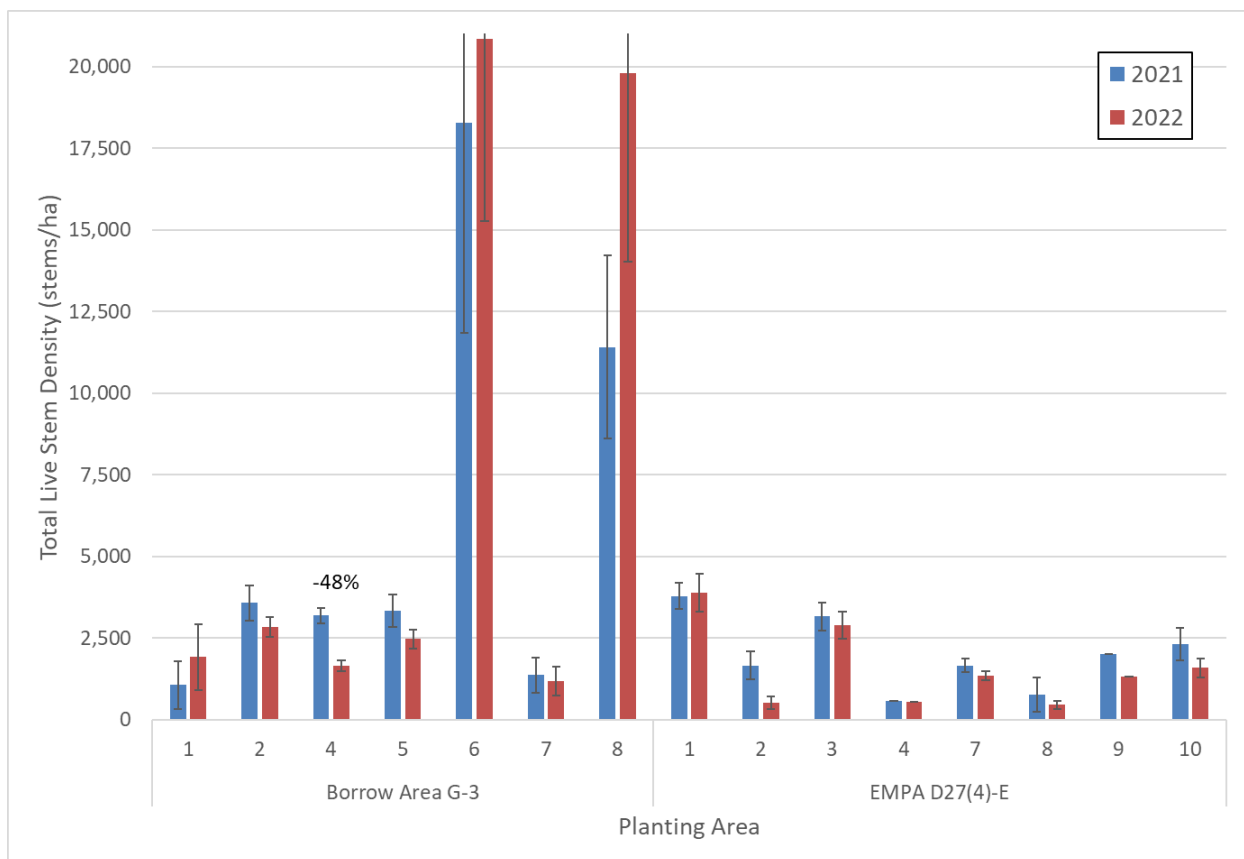
For areas planted in 2020, average live stem density differed to varying degrees for the planting areas when comparing data from the 2021 and 2022 surveys. Based on an ANOVA, average live stem density significantly differed for a single planting area, PA-4 in Borrow Area G-3 (Figure 4-4). In this planting area there was a statistically significant 48% decrease in live stem density between 2021 and 2022.

**Figure 4-4: Total live stem density and standard error of the mean for 2020 planting areas in 2021 and 2022**
