Keeyask Generation Project
Terrestrial Effects Monitoring Plan

Habitat Rehabilitation Implementation and Success
Monitoring Report

TEMP-2024-05

YEAR 2 OPERATION

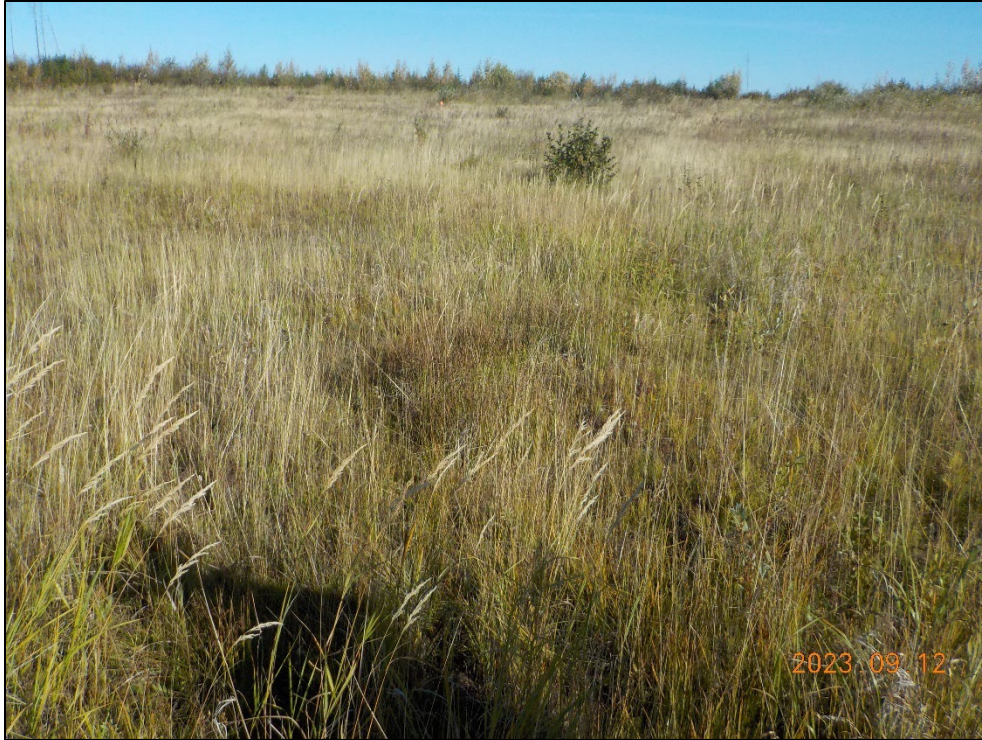
Moderate to high cover (Photo 4-1) made up 36.6% of the Borrow Areas.

Photo 4-1: High vegetation cover in Borrow Area G-3.

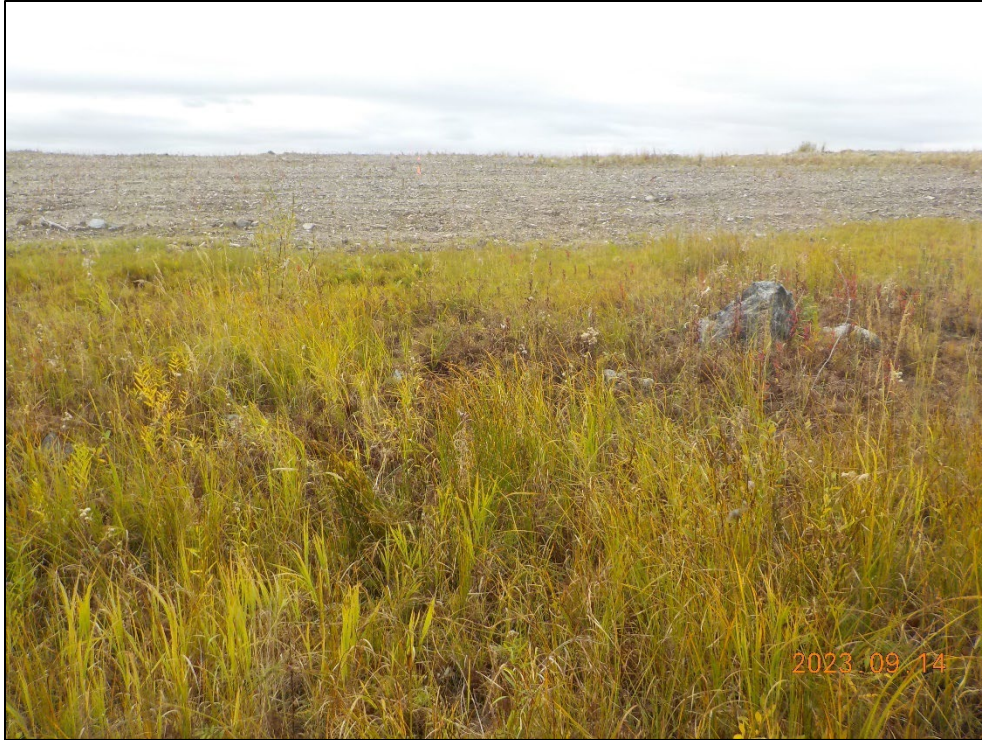
Of the vegetated portions of the Borrow Areas, low vegetation was by far the most common structure type, covering 32.4% of the total area (Photo 4-3; Table 4-4). Tall shrub (6.3%), woodland (2.8%) and sparsely treed (2.7%) were the next most common types.

Photo 4-3: Low vegetation structure type along the edge of EMPA D12(1)-E.

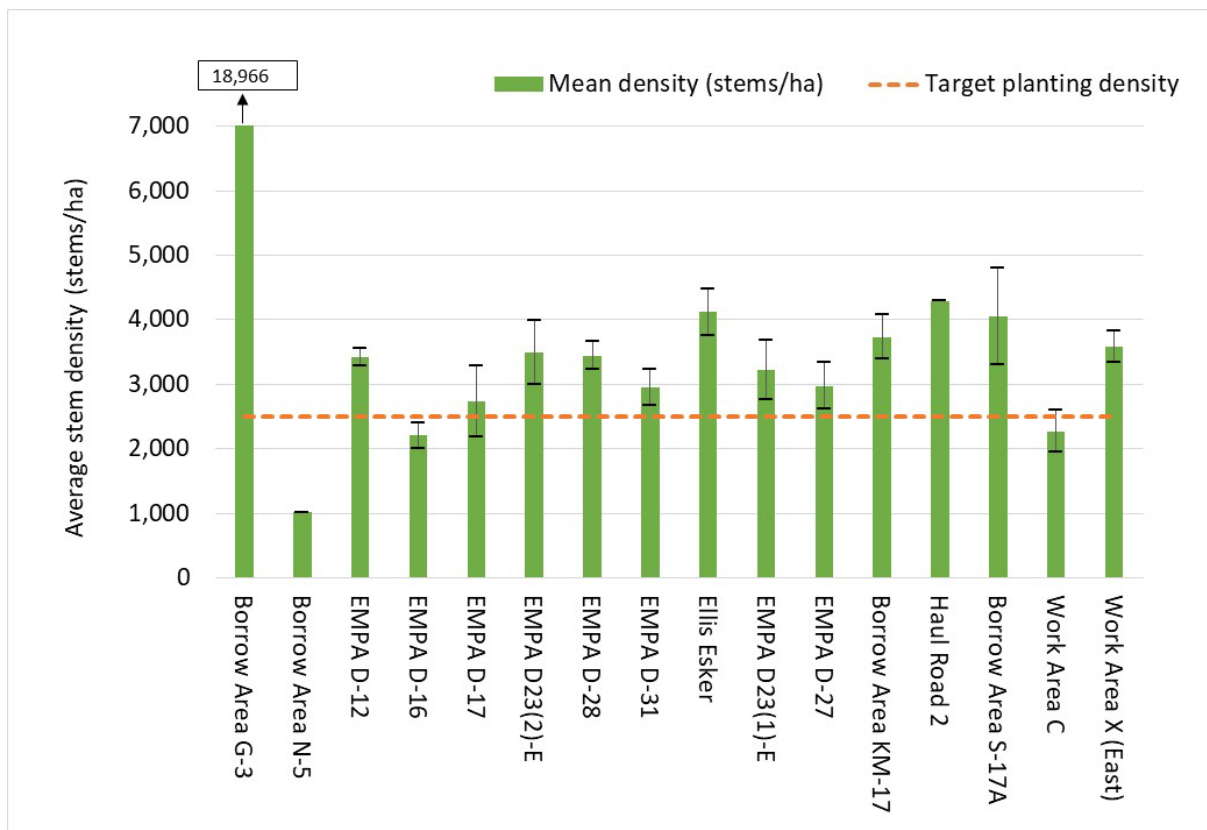
Figure 4-1: Overall live stem density as of 2023 for the portions of rehabilitation locations planted between 2020 and 2022 that were sampled using ground transects.

Based on the combined living stem density (includes natural regeneration) determined from the ground surveys, Borrow Areas G-3 (peripheral natural regeneration area only), E-1, S-17a, KM-17, EMPAs D-12(2)-E, D-28(1)-E, and Work Area X (East) had an estimated live stem density significantly greater than 2,499 stems/ha (Figure 4-1), in 2023. Three of the remaining 9 rehabilitation locations had a mean overall density of less than the target, including Work Area C, which was significantly lower than 2,500 stems/ha, Borrow Area N-5 (1 peripheral natural regeneration transect only) and EMPA D-16, both of which were not significantly below the target density. Estimates for EMPAs D-17-E, D-23(2)-E, D-31(1)-E, D-23(1)-E, D-27(4)-E, and Haul Road 2, were higher than the target, but not significantly.

As of September 2023, eighteen (39%) of the 46 planting areas treated between 2020 and 2022 had a combined live jack pine and black spruce average stem density below 2,500 stems/ha. These planting areas were distributed through all but eight of the 16 rehabilitation locations. The exceptions were Work Area X (East), Borrow Areas E-1, KM-17, EMPA D-12(2)-E, EMPA D-17-E, EMPA D-23(1)-E, EMPA D-23(2)-E, and Haul Road 2 (Table 4-8).

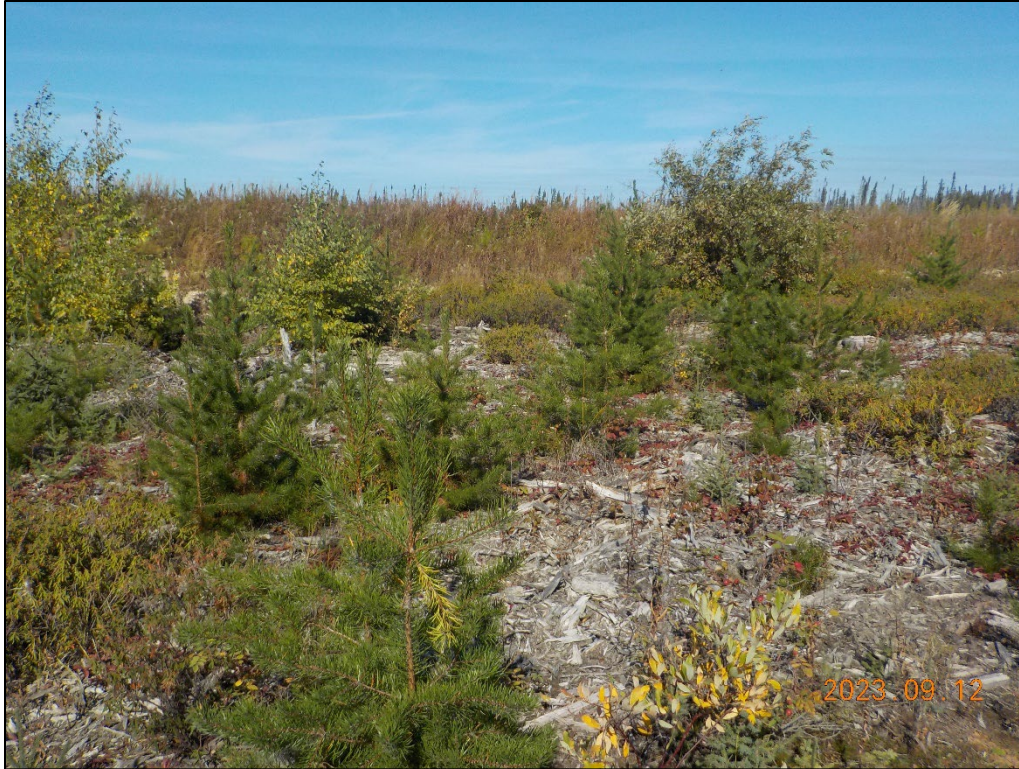
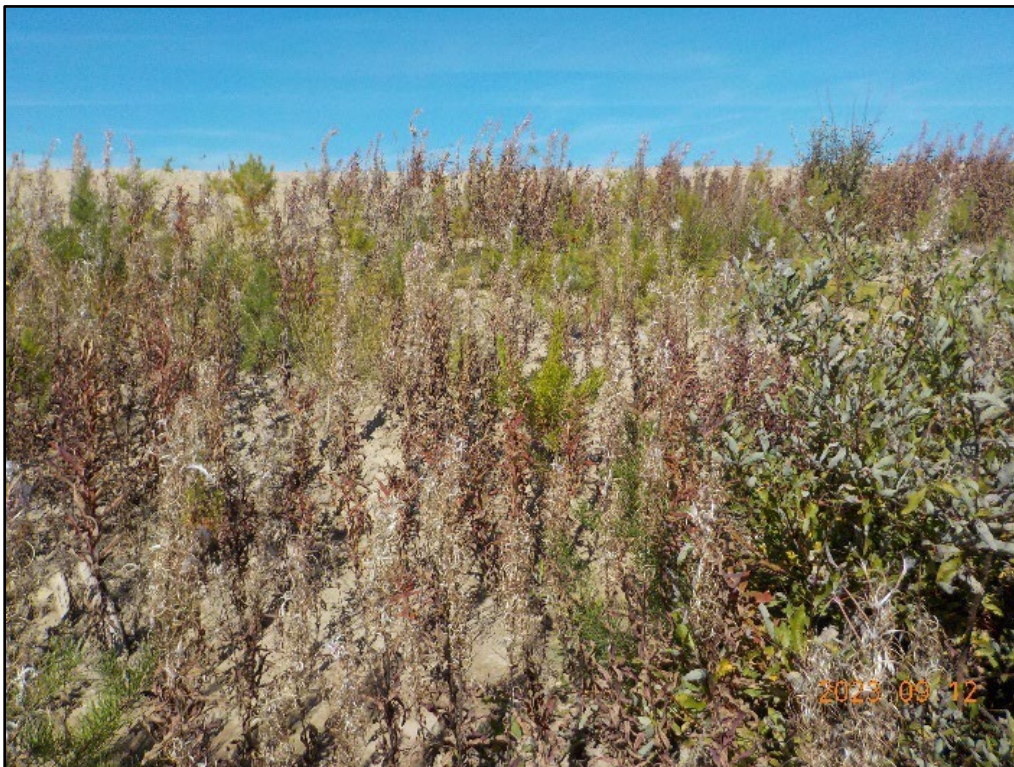
Photo 4-4: Jack pine and black spruce regeneration in a planting area with advanced regeneration (PA-8) in Borrow Area G-3 in 2023

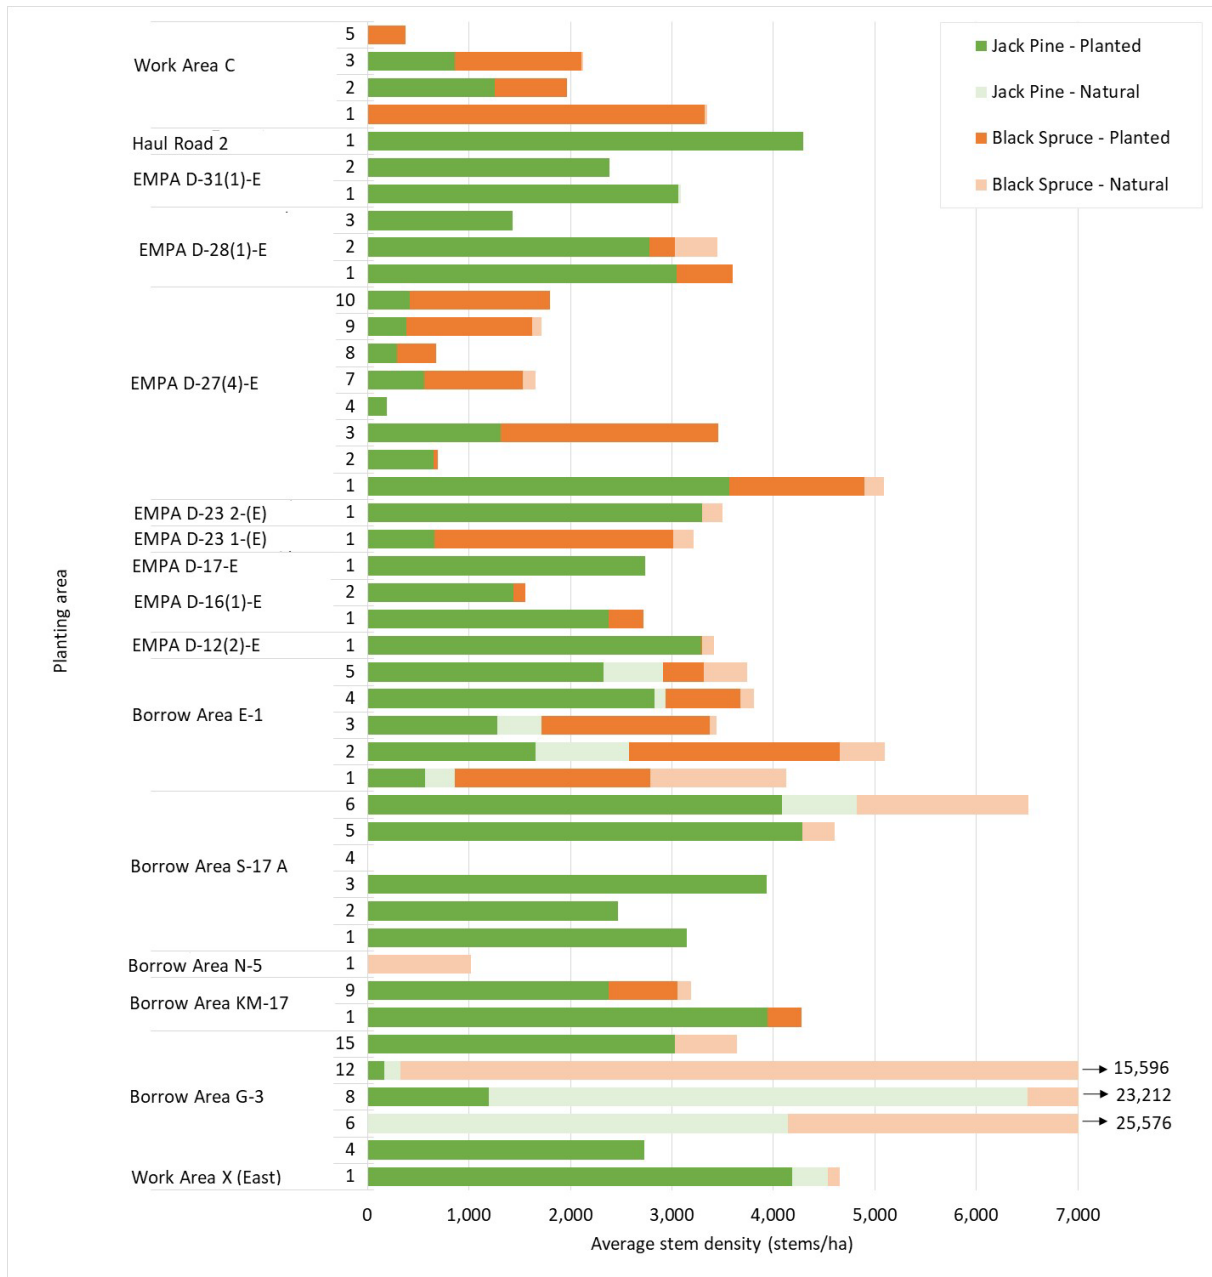
Figure 4-2: Composition of jack pine and black spruce regeneration in the 2020 to 2022 planting areas in 2023

Natural black spruce and/or jack pine regeneration was present in 24 of the 45 planting areas surveyed (Figure 4-2). Naturally regenerating black spruce was more widespread, occurring in 23 of the planting areas, compared to 11 for jack pine (Table 4-9). Where present, naturally regenerating jack pine comprised from 1% to 100% of the tallied stems within a planting area. The planting area with 100% jack pine natural regeneration was located in Borrow Area G-3 (PA-6).

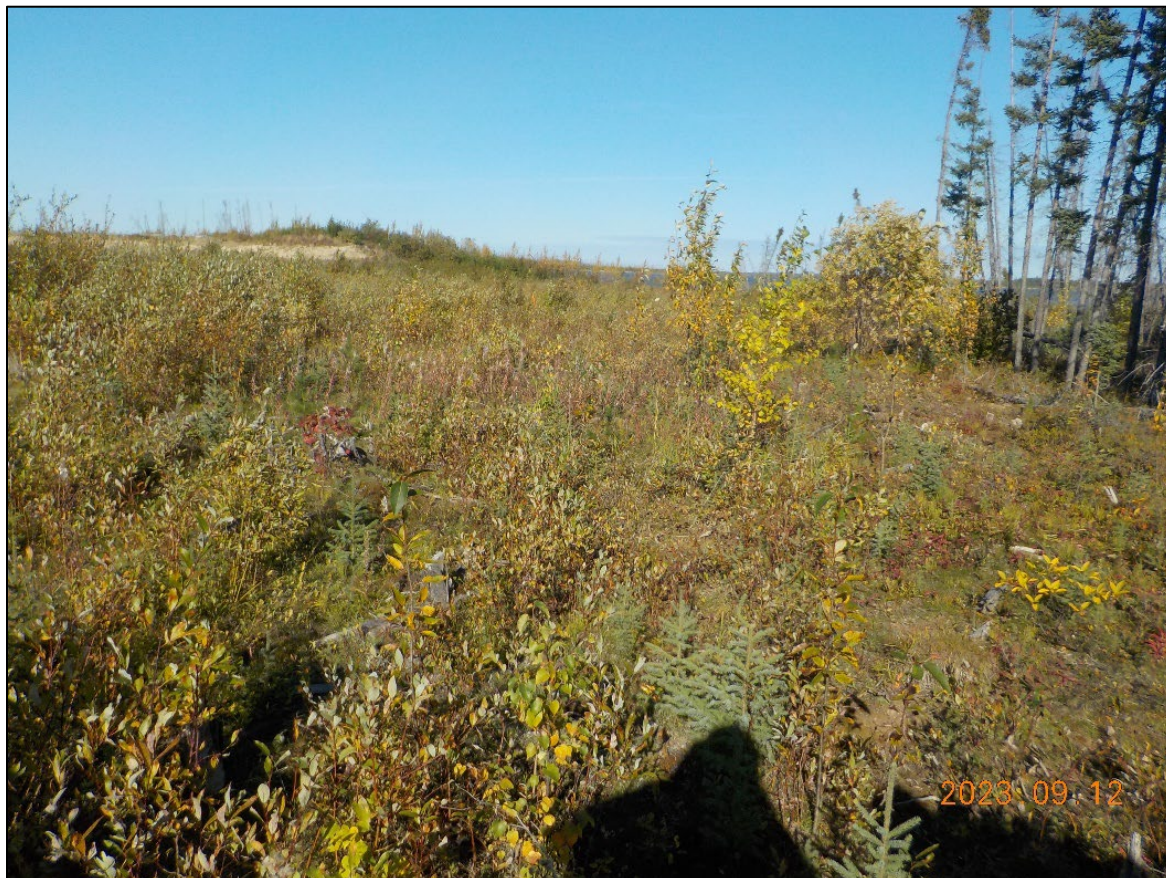
Black spruce natural regeneration was present in all rehabilitation locations except EMPA D-16(1)-E, EMPA D-17-E, EMPA D-31(1)-E, Haul Road 2, and Work Area X (East) (Table 4-9). Naturally regenerating black spruce (Photo 4-5) made up 100% of in the ground surveyed planting areas where the species was present Borrow Area G-3, Borrow Area N-5, EMPA D-12(1)-E , EMPA D-23(2)-E and Borrow Area S-17a. PA-3 and PA-1 of Work Area C had the lowest natural regeneration rate where it was recorded.

Photo 4-5: Naturally regenerating black spruce growing in Borrow Area G-3 (PA-50) in 2023

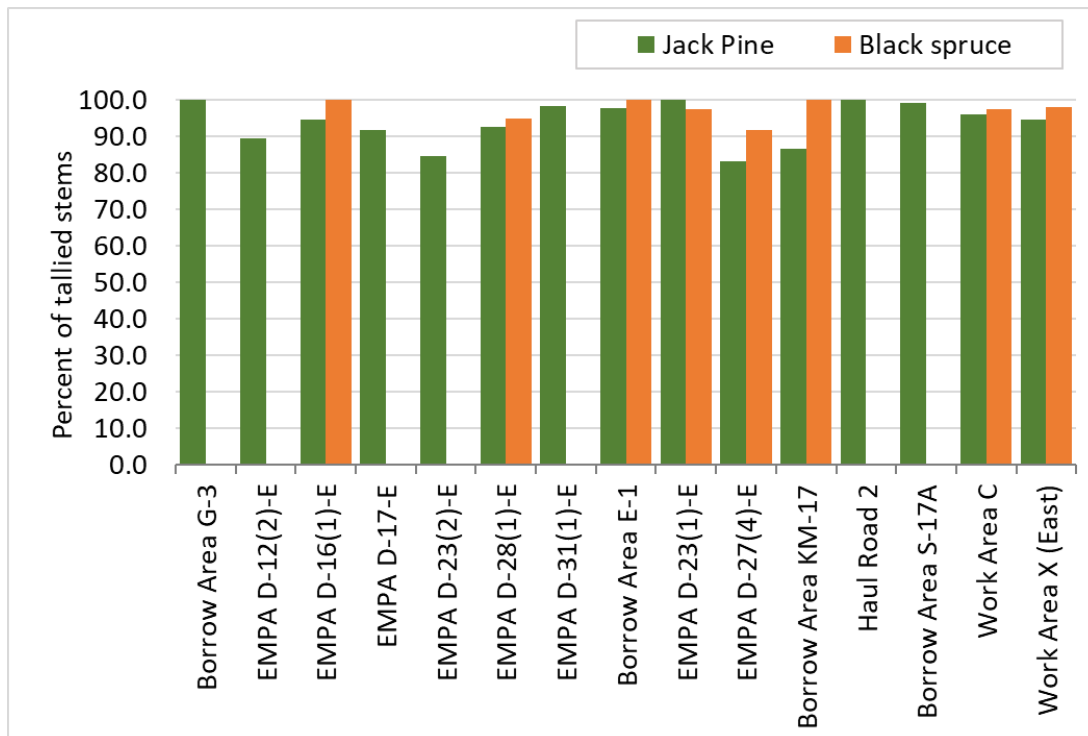
Figure 4-3: Percent survival of tallied planted jack pine and black spruce stems in 2023, for all planting areas pooled by rehabilitation location

Pooling all planted stems tallied in 2023 for each rehabilitation location, overall stem survival was lowest in EMPA D23(2)-E, with 84.7% of tallied stems living (Figure 4-3). This was followed by EMPA D27(4)-E (87.1%, Photo 4-6), Borrow Area KM-17 (88.0%), D12(2)-E (89.6%) and D28(1)-E (92.8%). Stem survival was 100% in the ground sampled planting areas of Borrow Areas G-3 and N-5, and on Haul Road 2.

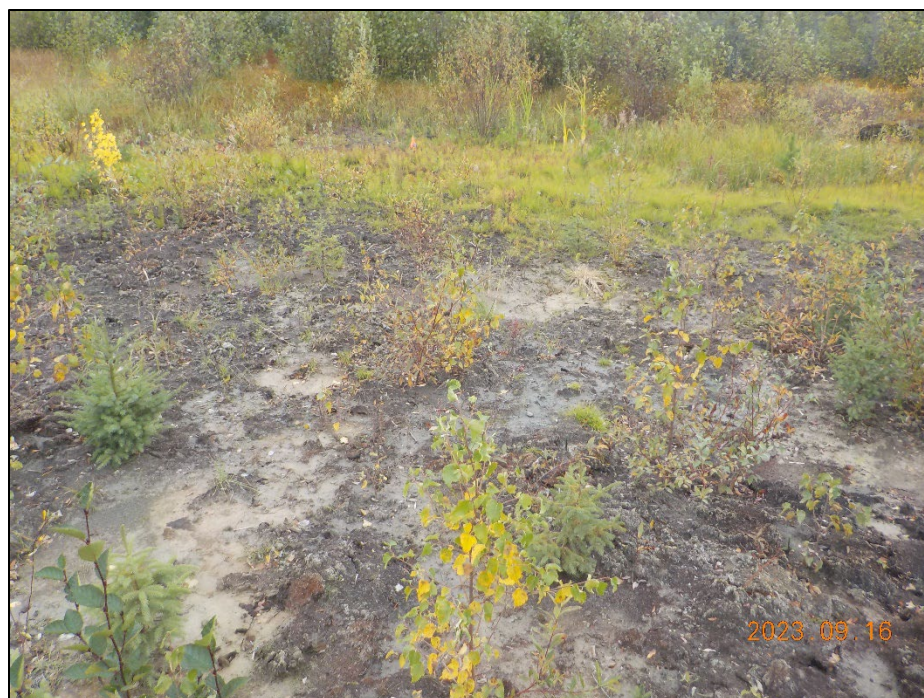
Average vigour class for live black spruce stems was at least 4 in all planting areas. For black spruce, average vigour was above 5 (mostly healthy) in 2 of the 36 planting areas where live stems were present (Photo 4-10).

Photo 4-10: A patch of healthy black spruce (vigour 6) in EMPA D-27(4)-E (PA-3) in 2023

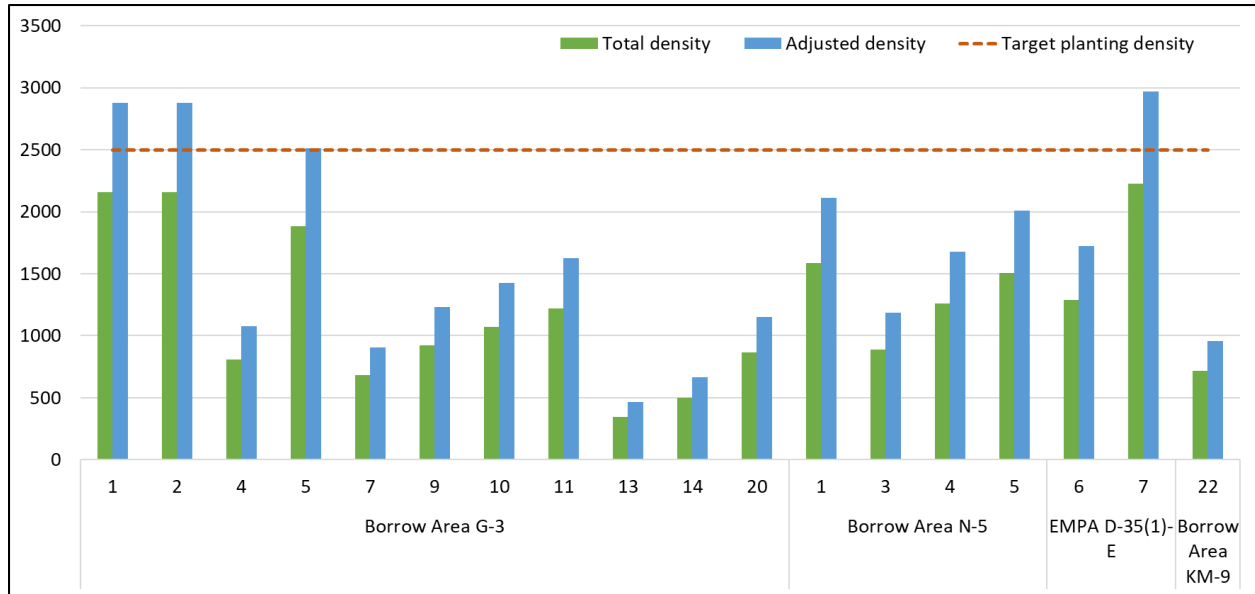
Figure 4-4: Overall live tallied stem density and adjusted stem density as of 2023 for the planting areas surveyed by drone.

Figure 4-4; Table 7-2). None of the 18 planting areas had a combined live jack pine and black spruce stem density that met the original planting target of 2,500 stems/ha. The planting areas that reached a combined live density above 2,000 stems/ha were Borrow Area G-3 PA-1 and 2 and EMPA D-35(1)-E PA-6. Adjusted live stem densities exceeded 2,500 stems/ha for four planting areas, including PA-1, PA-2, and PA-5 in Borrow Area G-3, and PA-7 in EMPA D-35(1)-E (Notes: The dashed line represents the target stem density for a woodland (2,500 stems/ha)

Notes: The dashed line represents the target stem density for a woodland (2,500 stems/ha)

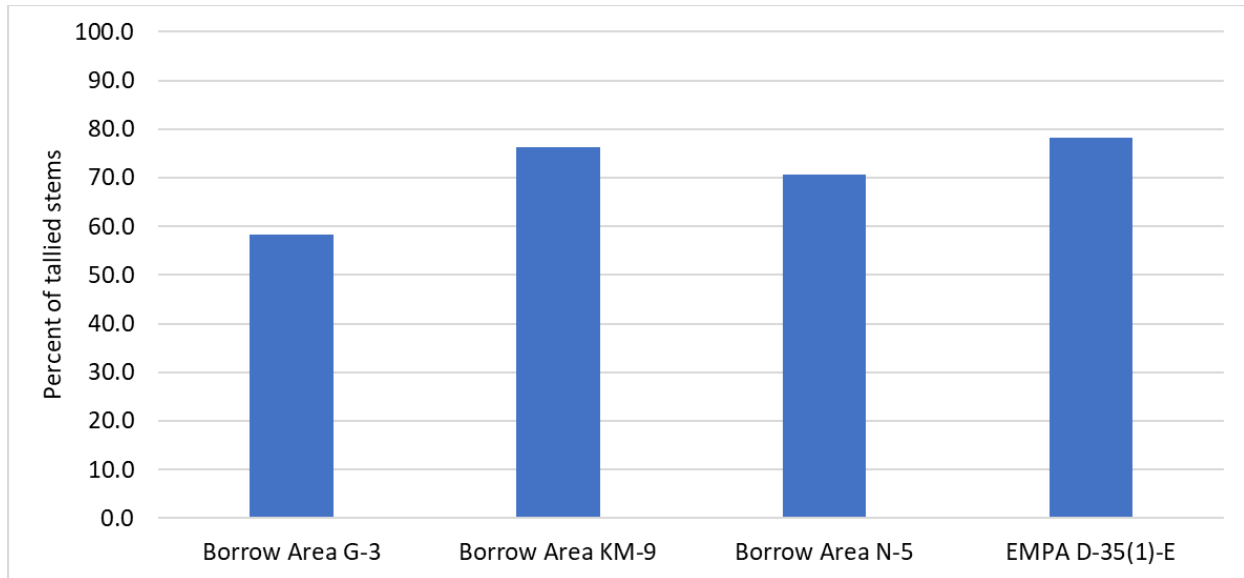
Figure 4-5: Overall percent survival of stems in the planting areas planted in 2020 and 2021 that were surveyed by drone

Pooling all stems tallied during the drone survey in 2023 for each rehabilitation location, overall percent survival was lowest in Borrow Area G-3, with 58.3% of tallied stems living (Figure 4-5). The remaining three rehabilitation locations had an overall stem survival rate between 70% and 80%.

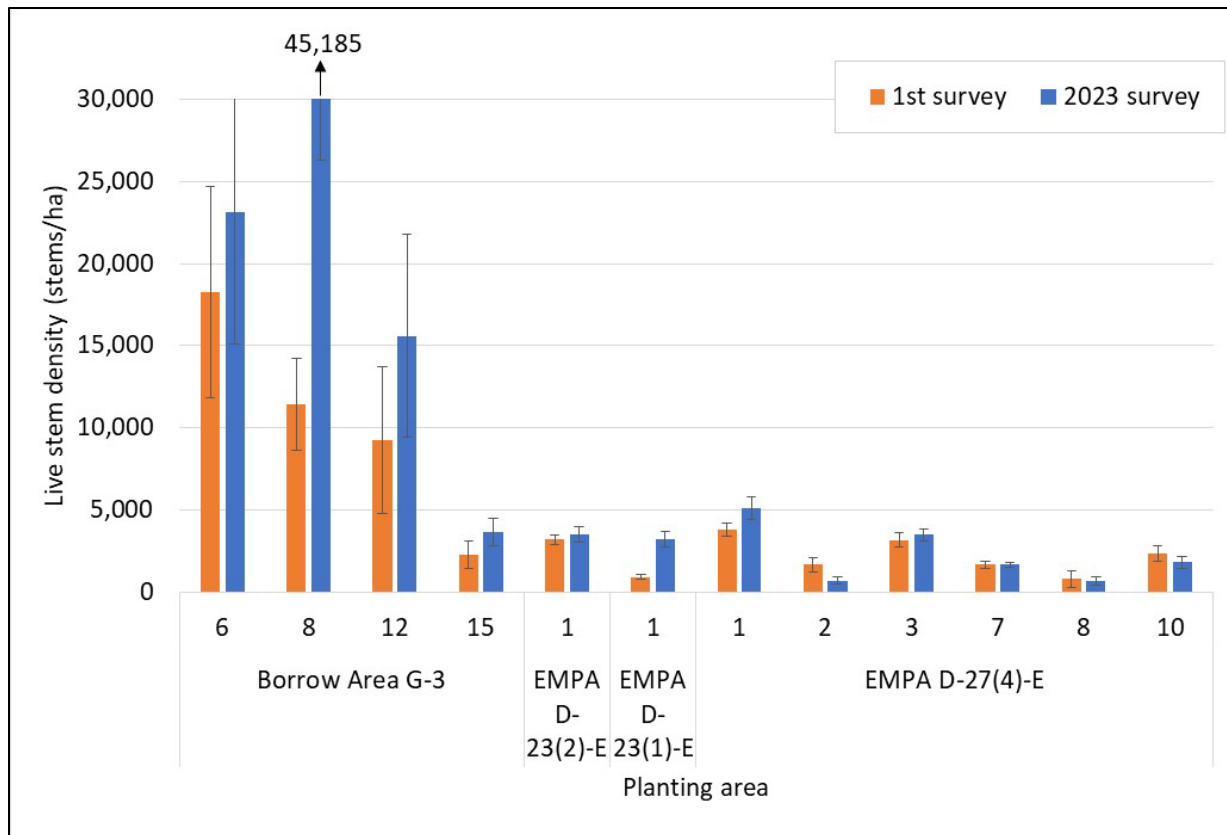
Figure 4-6: Total live stem density and standard error of the mean for the first survey year and the 2023 survey year in planting areas ground surveyed in 2020 and 2021

For areas planted in 2020 or in 2021, average live stem density differed to varying degrees for the planting areas when comparing data from the first survey (i.e., 2021 survey for 2020 planted areas and 2022 survey for 2021 areas) to the 2023 surveys. ANOVA results indicated that between survey differences in average live stem density were significant for Borrow Area G-3 PA-8 and EMPA D-23(1)-E PA-1 (Figure 4-6). In these planting areas, live stem density increased between the first survey year and 2023 by 25% and 28%, respectively.

Borrow Area G-3 PA-8 (50%) and EMPA D-23(1)-E PA-1 (662%) both had a significant increase in jack pine density (Table 4-14). EMPA D-23(1)-E PA-1 (36%) also had a significant increase in black spruce density (Table 4-15). Black spruce also increased significantly in EMPA D-23(2)-E PA-1 (201%). None of the planting areas decreased significantly from the first survey year to 2023.

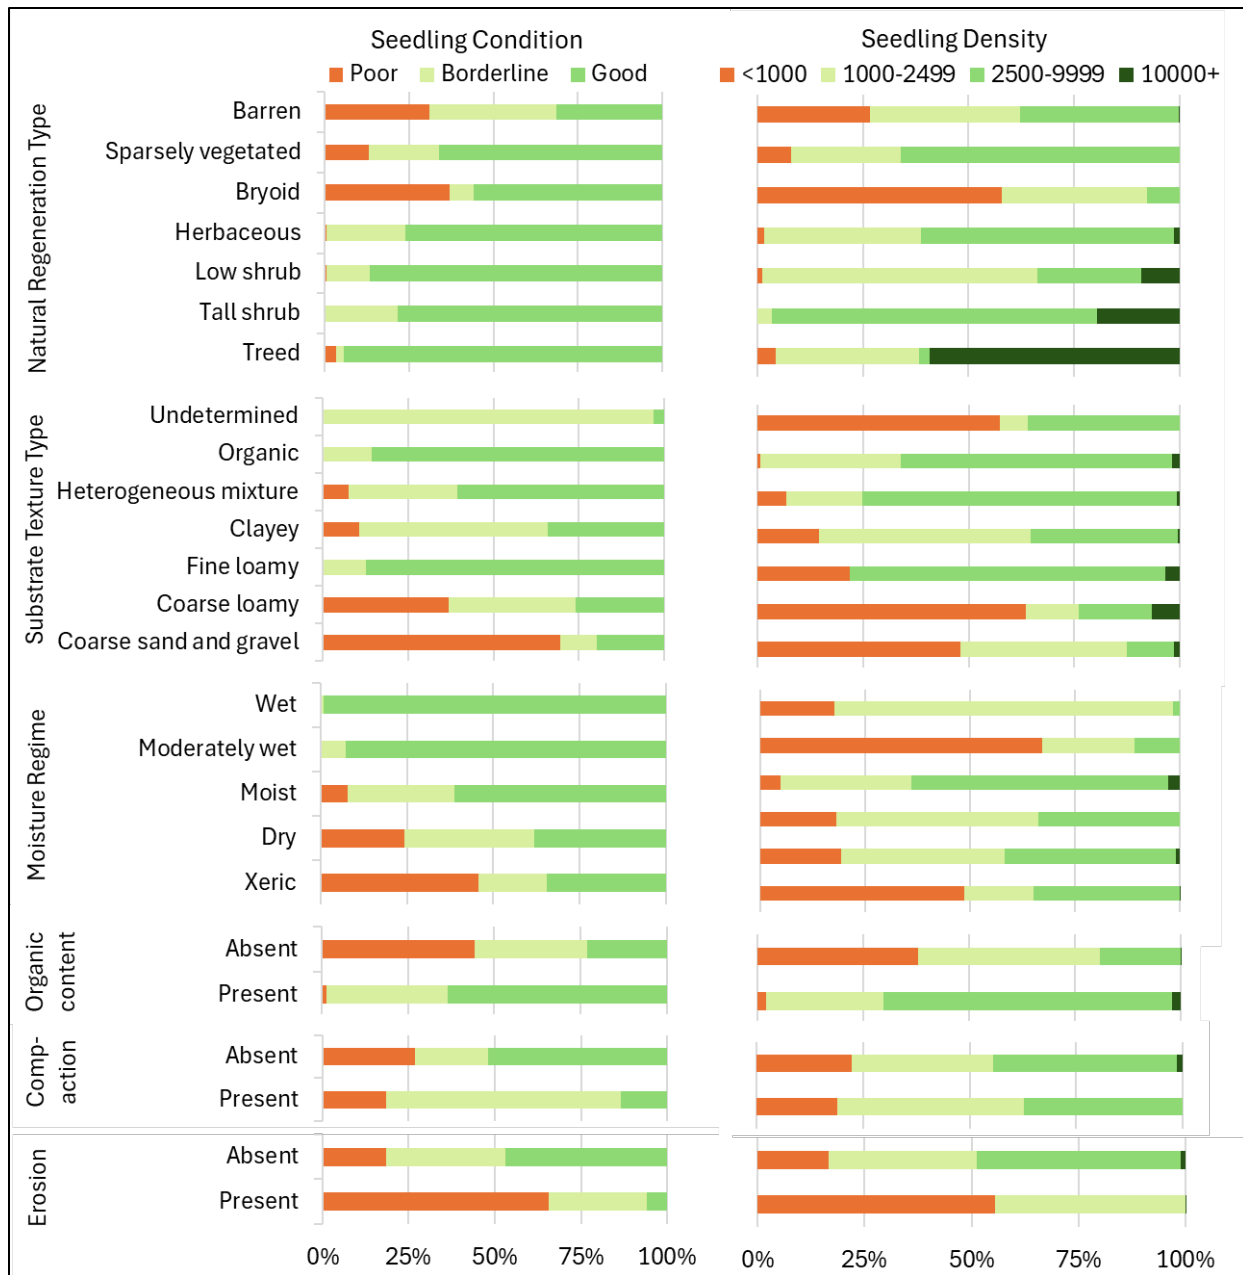
Figure 4-7: Distribution of natural regeneration and substrate conditions across planting areas in 2023, with different seedling condition and density statuses

Figure 4-7 shows how different ground-surveyed conditions were distributed across the different stem condition and stem density classes. For each condition, stacked bars show the percentage of that condition’s area that fell within the areas of different seedling conditions or density classes. Patterns in the distributions suggested that planting areas with poor and borderline seedling condition and lower seedling densities tended to have one or more of the following conditions as a proportion of its total area: lower naturally regenerating vegetation cover, coarser, drier substrates, a lack of organic material, more compacted soils, and/or more eroding area (Figure 4-7).

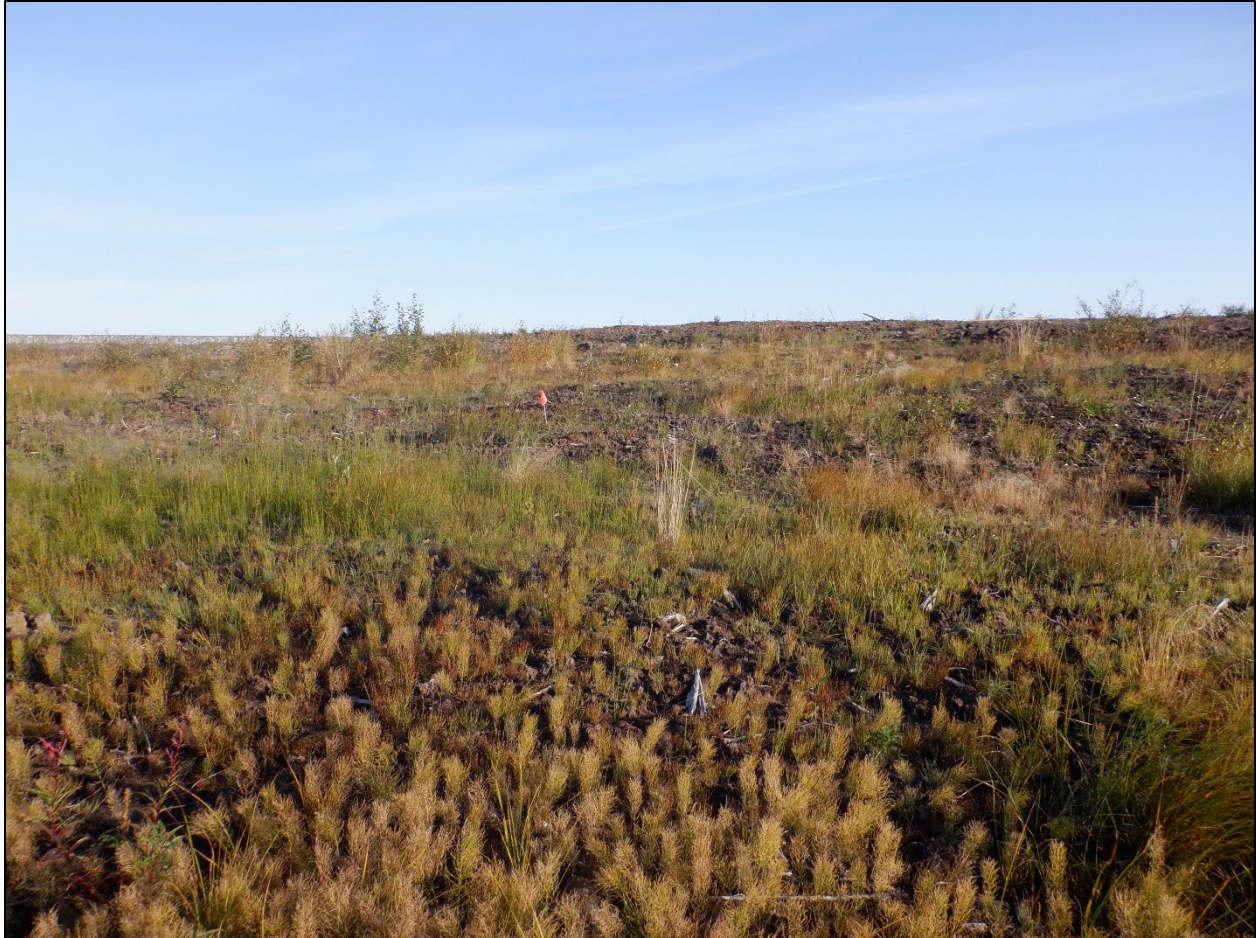
Photo 5-1: Naturally regenerating vegetation in 2023 in EMPA D23(1)-E

Drone detection rates for seedlings were evaluated for different field conditions. This evaluation found that rates drop substantially with increasing amounts of natural regeneration (Photo 5-1). However, data from the 2016 planted areas also showed that once stems increase in size beyond the seedling stage, detection rates increase again, even in areas with substantial natural regeneration.

The 2023 drone survey results generally indicated that the ground transect data collection could be used for the first year of prescription implementation surveys in all planted areas. For subsequent years, the transect method should be used in areas with substantial naturally regenerating vegetation (i.e., more than sparse cover). For other planting areas, drone survey methods are feasible starting in the second year of prescription implementation monitoring. For recovery success monitoring, drone survey methods are feasible for all areas provided most of the trees have grown beyond the seedling stage.
