# LAKE STURGEON STEWARDSHIP & ENHANCEMENT PROGRAM

## Lake Sturgeon Spawning Habitat Enhancement Project

Report 09-01  
February 2010

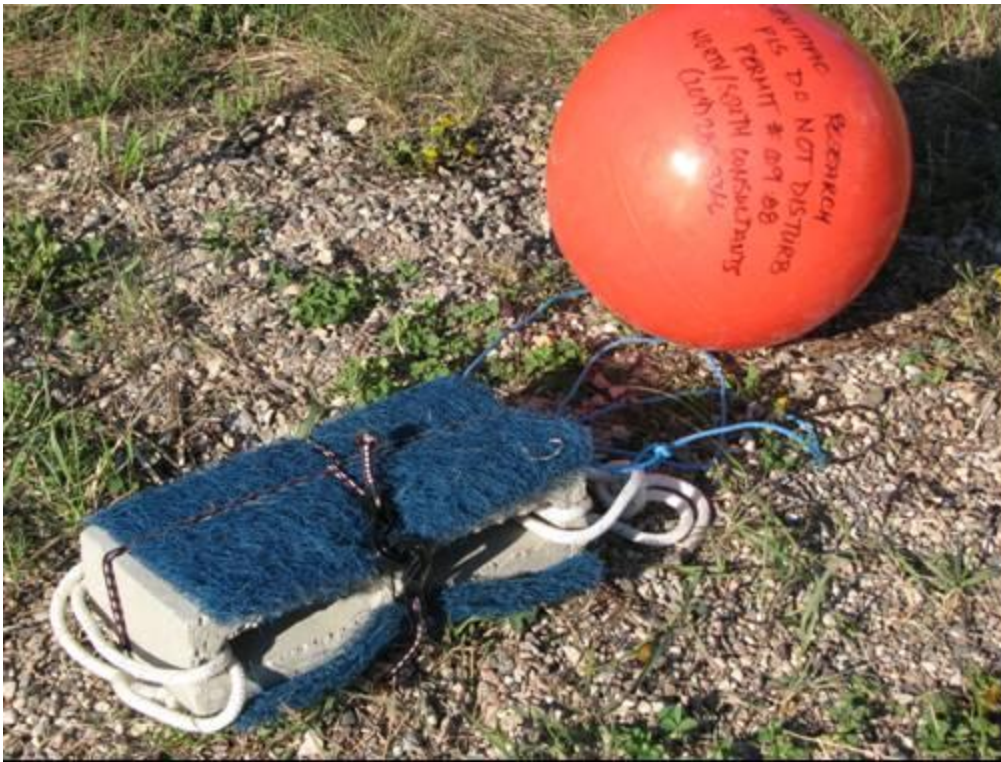
Figure 4. Egg collection mat device used to monitor spawning on and near the enhanced spawning ground.

Egg collection mats were placed on and around enhancement area to search for direct evidence of spawning (Figure 4). The sampling gear consisted of 39x19x9 cm cinder blocks wrapped with furnace air filter material measuring 90x30 cm held in place using bungee cords. The mats were arranged in transects running parallel with the river flow, at approximately 20 to 25 m intervals for the spawning program with additional mats placed on and near the enhanced spawning grounds for monitoring purposes. The majority of transects consisted of four to five egg collection mats spaced 20 to 25 m apart along a braided nylon rope, however, some transects only had two mats and individual mats were also set. A large anchor was attached to the upstream end of each transect and one or more floats were attached to the downstream end for retrieval. The egg collection mats were pulled up every two to three days so that the air filters could be removed and inspected for eggs and replaced. GPS coordinates, depth, and velocity were recorded at each mat location.

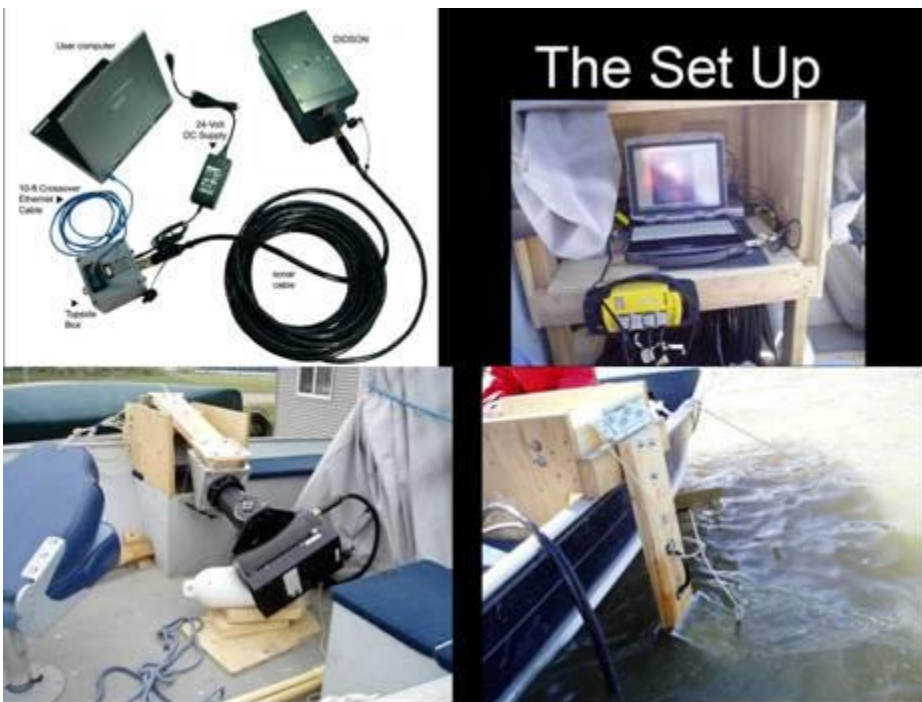
Figure 5. Didson sonar camera set up used to monitor the enhanced spawning ground.

A Didson sonar camera was used to monitor the enhanced area and surrounding habitat during spawning period to determine if lake sturgeon were attracted to the area and if any potential spawning events occurred there (Figure 5). The Didson camera was mounted to the boat's bench and lowered approximately 0.5 m below the surface. The boat was moored just downstream of the enhancement area at a suitable angle for a surface mounted camera. Monitoring of the enhanced spawning ground commenced on 27 May for several hours and continued on the 28 and 29 May. An attempt was made on 29 May to move the camera near unit 2 where spawning was known to have occurred, however, the wooden bracket holding the camera was not stable enough to withstand the flow. From 2-3 June several attempts were made to monitor the spawning ground, but technical difficulties with the camera (image distortion) precluded effective monitoring. After contacting the manufacturer of the camera, the problem was rectified and monitoring was recommenced from 4-7 June. The spawning ground was monitored for approximately 6 hours per day from 4-7 June.

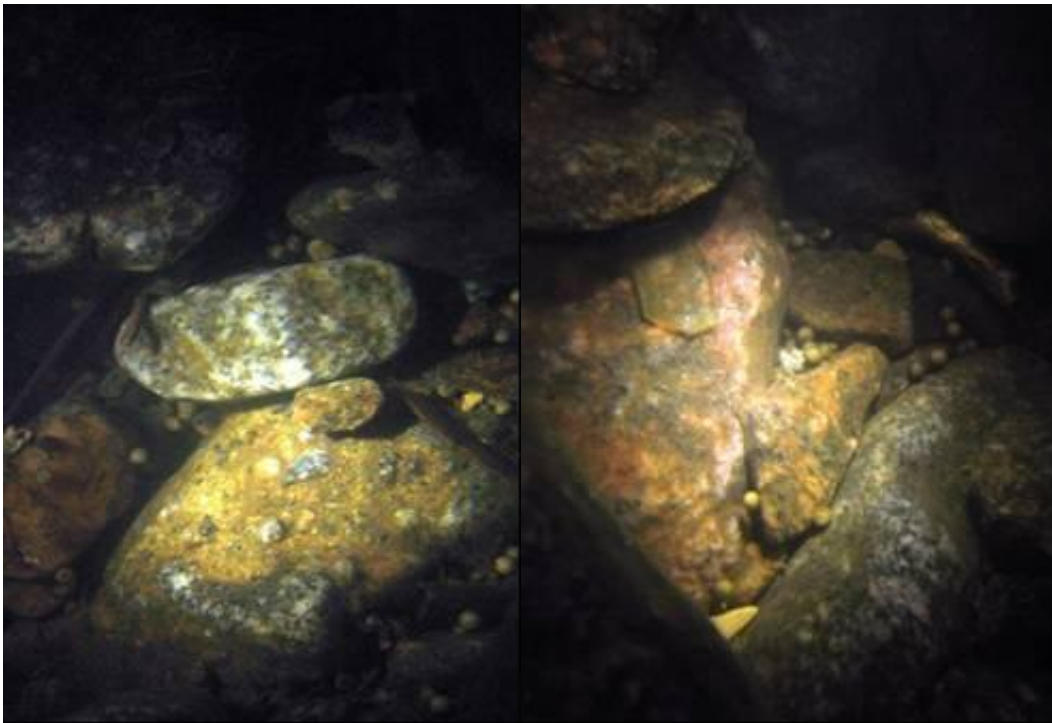
Figure 10. Suitable lake sturgeon spawning substrate below powerhouse tailrace area in vicinity of units 3 and 4.

Egg deposition data from the powerhouse tailrace suggest that lake sturgeon are relating to areas immediately below the powerhouse particularly when a combination of high and low flow areas are present due to unit operation. The lake sturgeon are likely relating to areas at the edge of high currents where suitable substrates exist (Figure 10).
