Keeyask Generation Project Terrestrial Effects Monitoring Plan

### **Beaver Habitat Effects Monitoring Report**

TEMP-2022-09

### **BEAVER HABITAT EFFECTS MONITORING 2021**

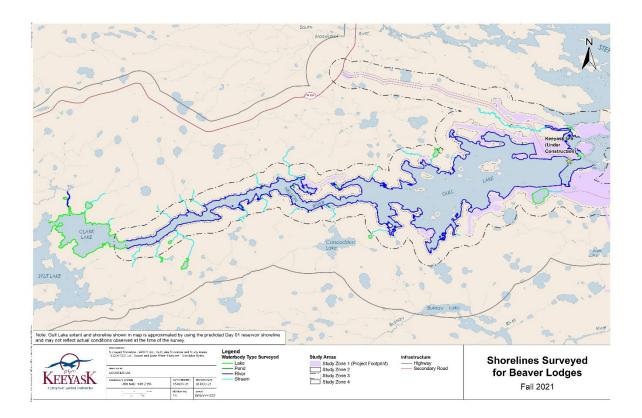
An aerial survey focused on the Keeyask reservoir and upstream Nelson River and Clark Lake shorelines was conducted on September 20, 2021 to determine the number and location of active and inactive beaver lodges in the surveyed area.

A total of 44 beaver lodges were observed along the survey route in Study Zone 3, the Local Study Area (see map above). Nine active lodges were counted in the Project footprint, three of which were in the Keeyask reservoir and had not been observed during monitoring surveys in previous years. There was a small increase in the density of active lodges from the previous year, when density was reduced following reservoir impoundment. No significant difference in the density of active lodges was found between the pre-construction and construction periods, but active lodge density was significantly lower after impoundment than before.

In the Regional Study Area (Study Zone 4, see map above), the density of active lodges declined somewhat over the pre-construction and construction periods but there was little variation after 2001 (WRCS 2021). No substantial decline in lodge density was observed, suggesting that reservoir impoundment had a minimal effect on the regional beaver population, as predicted in the EIS.

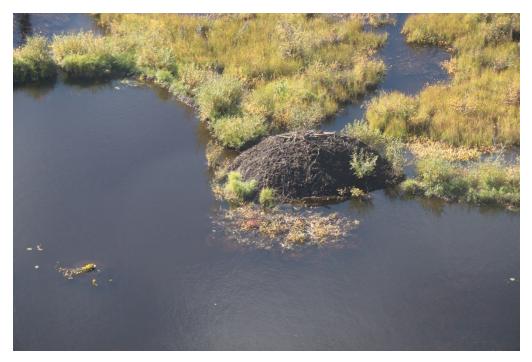
Photo 1: Active Standard Beaver Lodge with Food Cache

On September 20, 2021 a survey focused mainly on the Keeyask reservoir and the Nelson River upstream to Clark Lake was flown in a Bell 206 Jet Ranger helicopter, at a speed of approximately 100 km/hr and approximately 50 m above ground level. Observers were stationed on the left side of the helicopter. Beaver lodge locations were recorded with a handheld Global Positioning System (GPS) unit and photographed. The presence of food caches and whether lodges were active or inactive was recorded. Beaver lodges were classified as either standard lodges or bank burrows. Standard lodges (Photo 1, Photo 2) are commonly freestanding conical mounds of branches and logs plastered with mud with one or more underwater openings to tunnels that meet at a cavity in the center of the mound (Novak 1999). Bank burrows (Photo 3) are dug into shoreline banks where the water is deep or fast, are often covered in sticks and mud, and are occasionally connected to an extensive underground network of tunnels (Novak 1999). Active beaver lodges were characterized by signs of lodge maintenance (fresh mud and timber), nearby recent foraging, and the presence and condition of a food cache (see Photo 1). Lodges lacking these characteristics were considered inactive (see Photo 2).

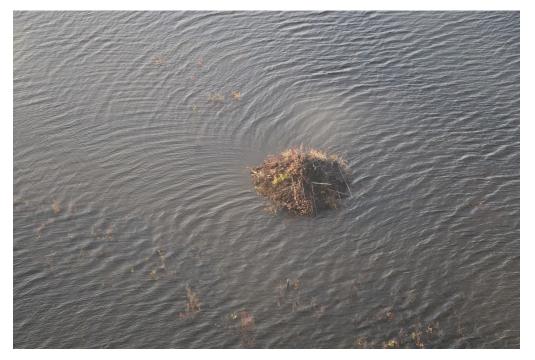
Photo 2: Inactive Standard Beaver Lodge

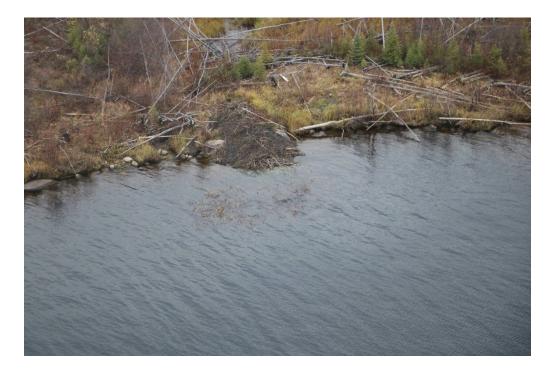
#### Photo 3: Active Beaver Bank Burrow

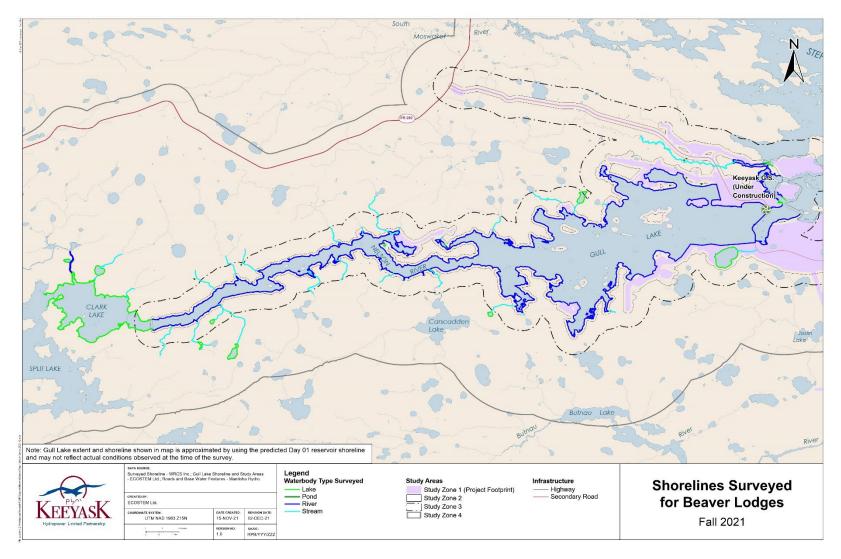
Map 1: Shorelines Surveyed for Beaver Lodges, Fall 2021

A census of beaver lodges was conducted along the Nelson River shoreline from the Keeyask GS upstream to Clark Lake, inclusive (Map 1). Some ponds and portions of streams were also surveyed within Study Zone 3. Because the reservoir had been impounded in 2020, the shoreline length surveyed in Study Zone 1 had changed from 235 km in 2018 and 2019 to 273 km in 2021 (Table 1). A total of 338 km was surveyed in Study Zone 3, the Local Study Area.

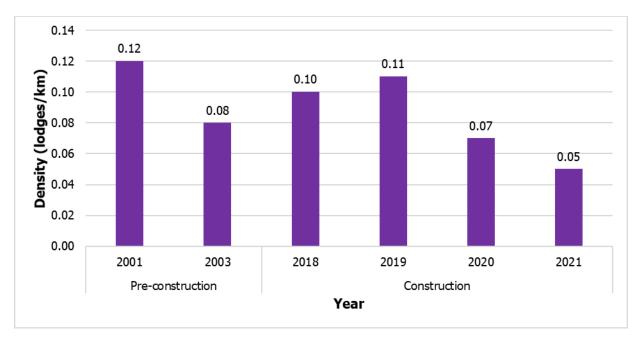
#### Figure 1: Density of Active Beaver Lodges in Study Zones 1–3 before and during Project Construction

In Study Zones 1–3 (the Local Study Area), the density of active beaver lodges was lower in 2020 and 2021, after reservoir impoundment, than in previous survey years (Figure 1). There was no significant difference in active lodge density between the pre-construction (2001–2003; mean = 0.10, variance = <0.01) and construction (2018–2021; mean = 0.08, variance = <0.01) periods (t = 0.73, p = 0.51).

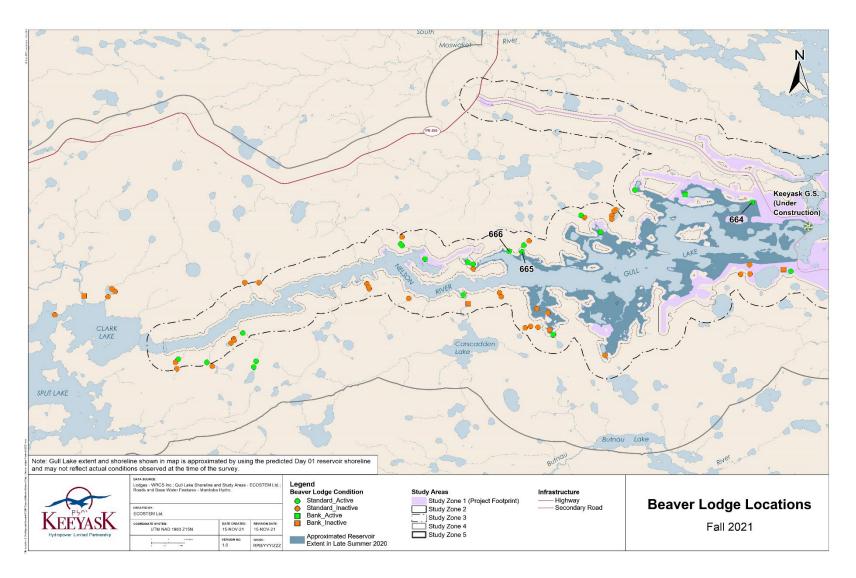
NOTE: Numbered lodges were first obsevered in 2021.

#### Map 2: Beaver Lodge Locations, Fall 2021

A total of 44 beaver lodges, including 41 standard lodges and three bank burrows, were observed along the survey route in Study Zone 3 (the Local Study Area) during the fall 2021 aerial survey. Seventeen lodges were active and 27 were inactive. Other lodges (n = 16) were observed off the survey route or beyond Study Zone 3 and were recorded as incidental; all beaver lodges observed during the fall aerial survey are depicted in Map 2 and listed in Appendix 1, Table 1-1. Three of the active lodges observed in Study Zone 1 were in the Keeyask reservoir and had not been observed during previous surveys.
