# Beaver Habitat Effects and Mortality Monitoring Report

## **KEEYASK GENERATION PROJECT**

### **TERRRESTRIAL EFFECTS MONITORING PLAN**

### **BEAVER HABITAT EFFECTS AND MORTALITY 2018**

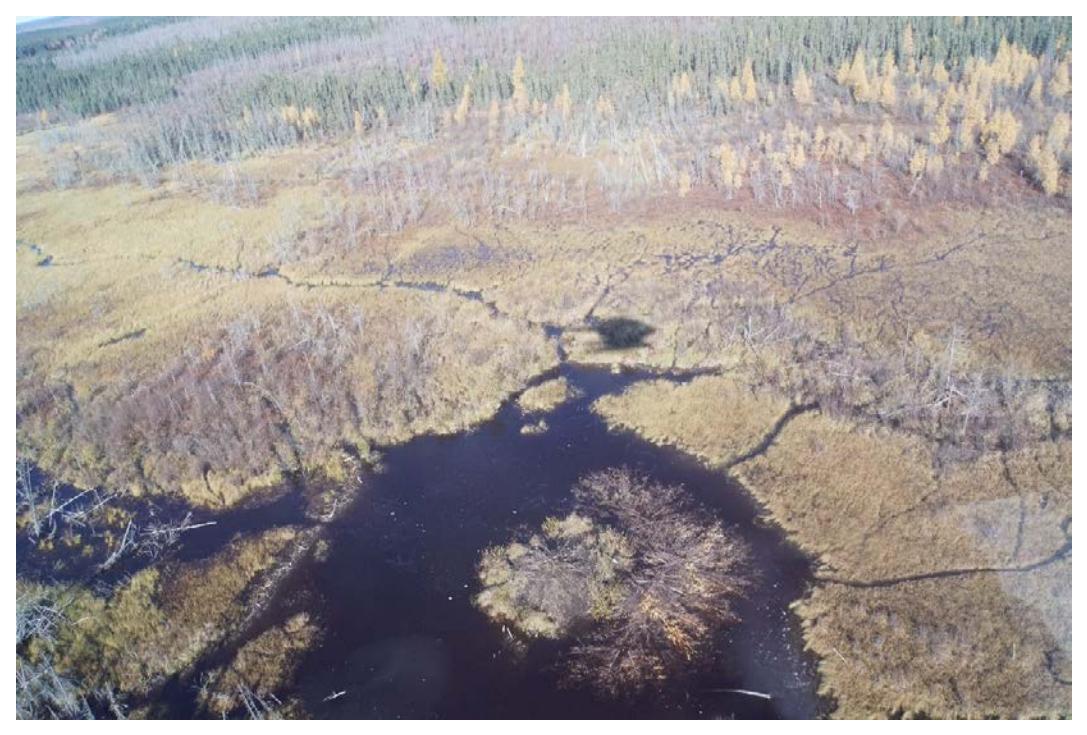
Photo 1: Active Standard Beaver Lodge with Large Food Cache

Survey routes were flown following a predetermined pathway of water bodies and watercourses, at a speed of approximately 100 km/hr at approximately 50 m above ground level. Observers were stationed on the left side of the helicopter. Beaver lodge locations were recorded with a handheld GPS unit and photographed. The presence of food caches and whether lodges were active or inactive was recorded. Typically, active beaver lodges in fall are characterized by signs of lodge maintenance (*i.e.*, fresh mud and timber), nearby recent foraging, and the presence and condition of a food cache (Photo 1). Inactive lodges typically lack these characteristics (Photo 2).

Beaver lodges were classified as either standard lodges or bank burrows. Standard lodges (Photo 1; Photo 2) are commonly freestanding conical mounds of branches and logs plastered with mud with one or more underwater openings to tunnels that meet at a cavity in the center of the mound (Novak 1987). Bank burrows (Photo 3) are dug into shoreline banks where the water is deep or fast, are often covered in sticks and mud and are occasionally connected to an extensive underground network of tunnels (Novak 1987). Based on the condition of the structure, signs of ongoing maintenance, nearby recent foraging and the presence and condition of a food cache, lodges were categorized as being either active (Photo 1) or inactive (Photo 2).

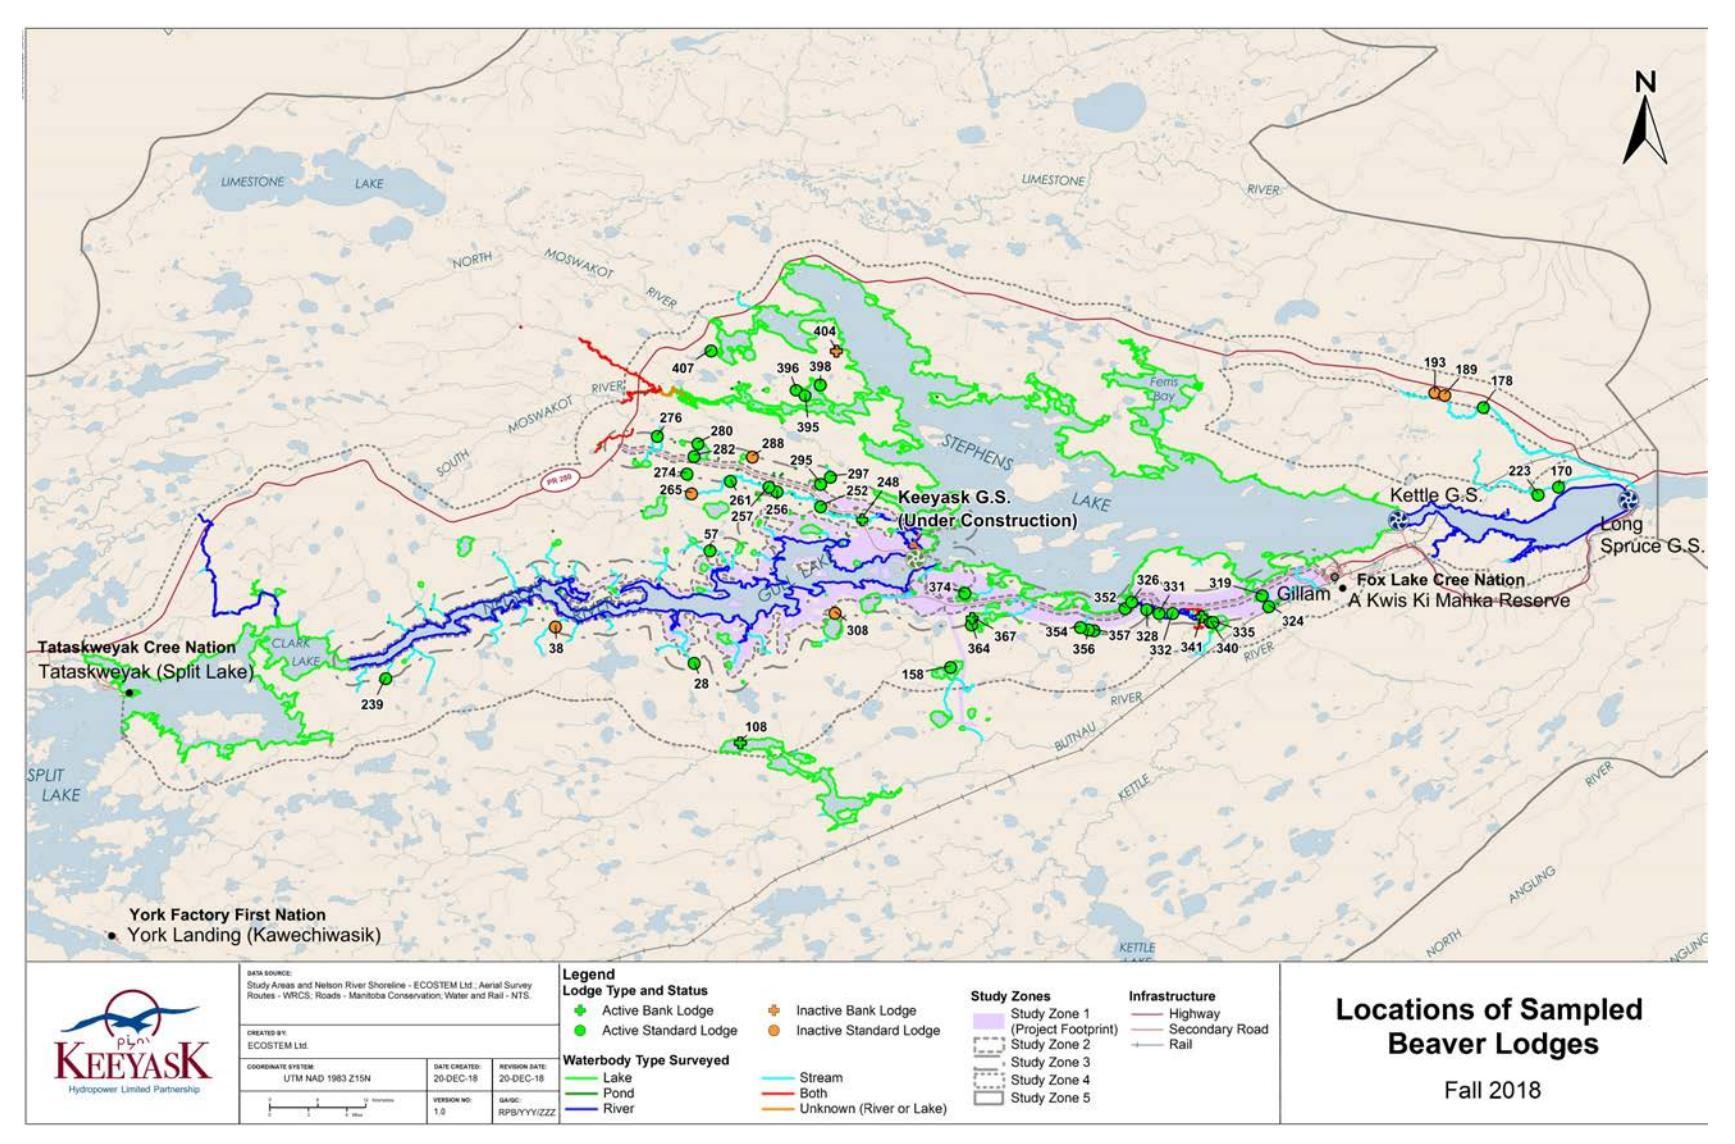
Map 2: Beaver Lodge Survey Areas and Locations of Sampled Lodges in Fall 2018

During the fall 2018 beaver lodge ground survey, characteristics of 46 beaver lodges in Study Zones 1 through 4 were measured and described (Appendix 2). Of the 46 lodges, 41 were standard lodges and five were bank burrows. Of the 41 standard lodges, 35 were active and six were inactive. Of the five bank burrows, four were active and one was inactive.

No lodges in Study Zone 1 (the Project footprint) were measured. In Study Zone 2, characteristics of one active bank burrow and one active standard lodge was measured. In Study Zone 3, characteristics of two active bank burrows, 22 active standard lodges and three inactive standard lodges were measured. In Study Zone 4, characteristics of one active bank burrow, one inactive bank burrow, 12 active standard lodges and three inactive standard lodges were measured.

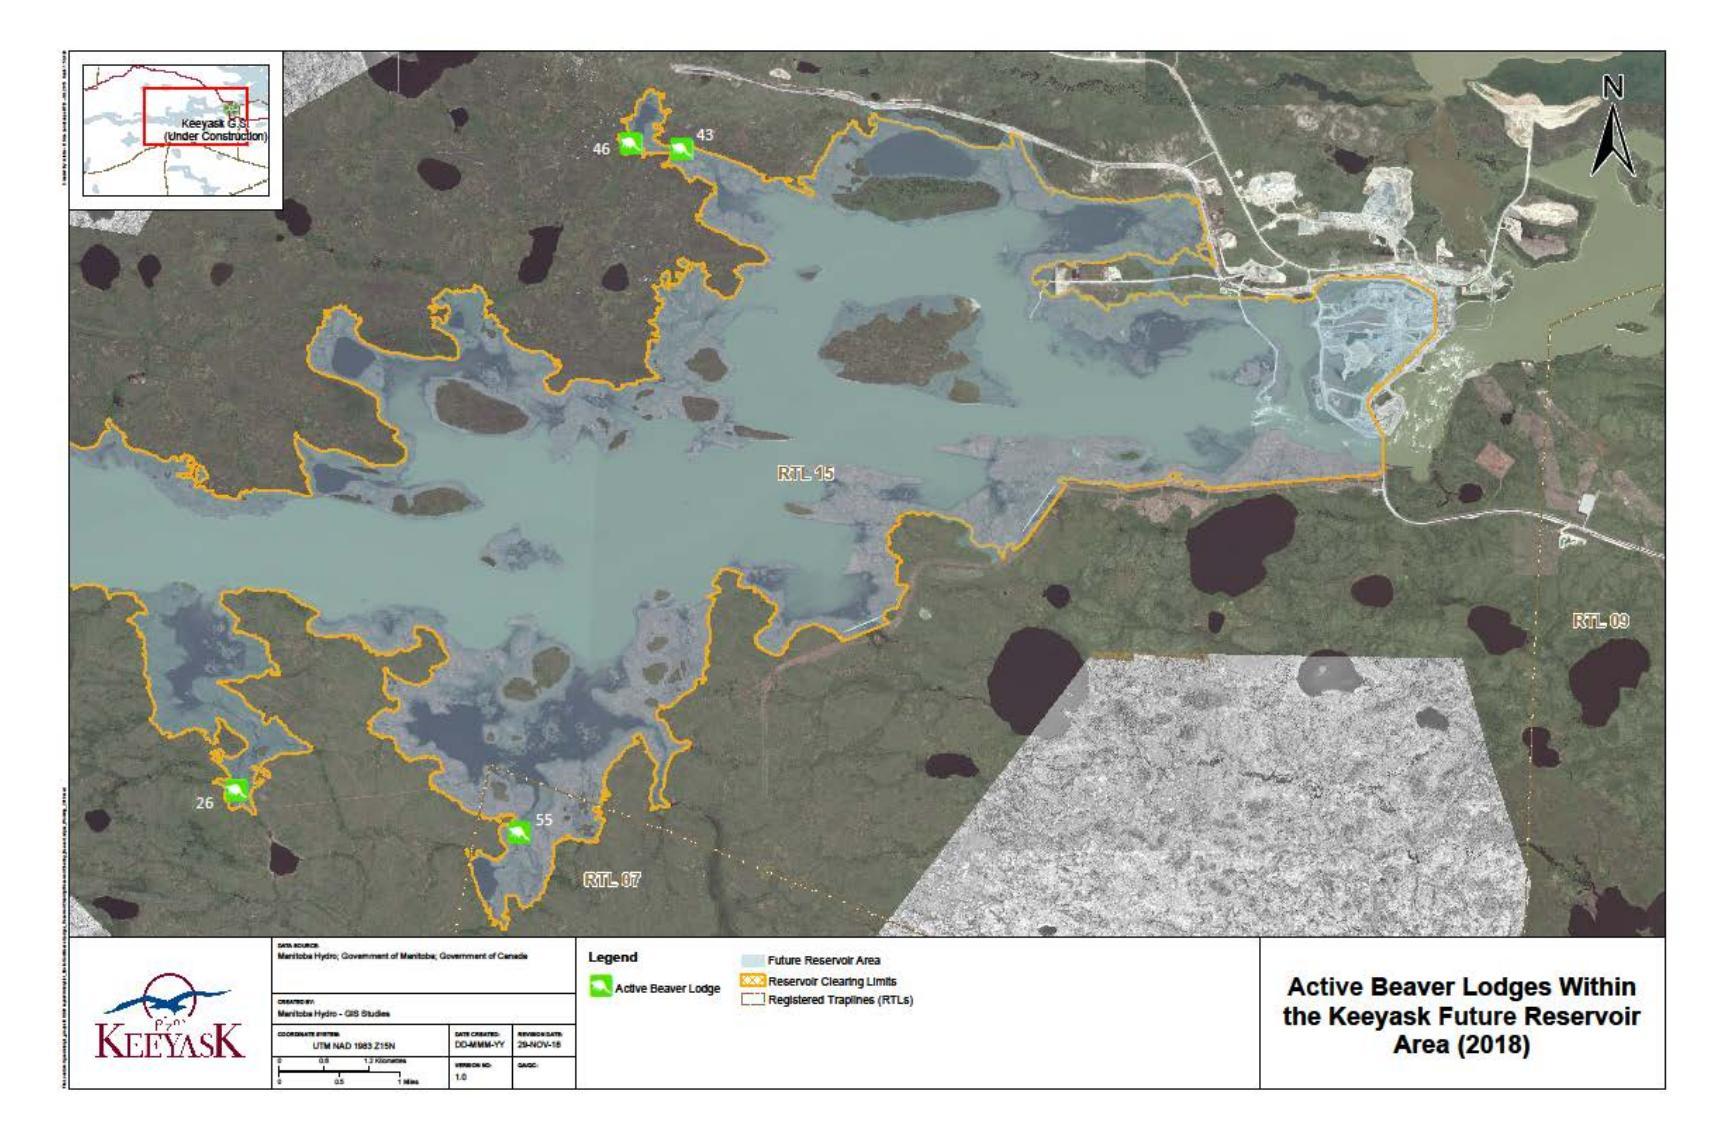
#### Map 3: Locations of Beaver Trapping in the Future Reservoir Area in 2018/19

Trapping efforts in 2018/19 focused on four active beaver lodges located in the Nelson River in the future reservoir (Map 3). From these lodges six beaver were trapped, as well as five muskrats (Table 6). Two beaver were captured from two lodges (four beaver at two lodges) and single beavers were caught from the remaining lodges. Based on their measurements, two beaver were classified as adults and the remaining were classified as juveniles. No pairs of adult beaver were removed from a single lodge.
