Keeyask Generation Project Terrestrial Effects Monitoring Plan

Bank Swallow Habitat Monitoring Report

REPORT #TEMP-2021-09

BANK SWALLOW MONITORING 2020

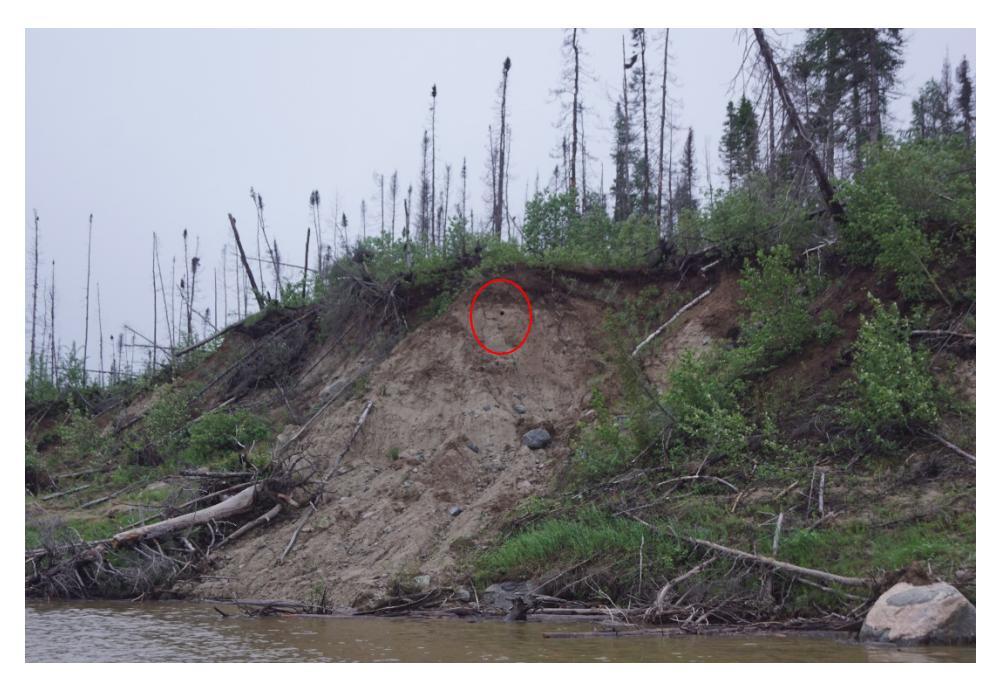
Red oval indicates bank swallow burrow; note toppled trees and bank erosion.

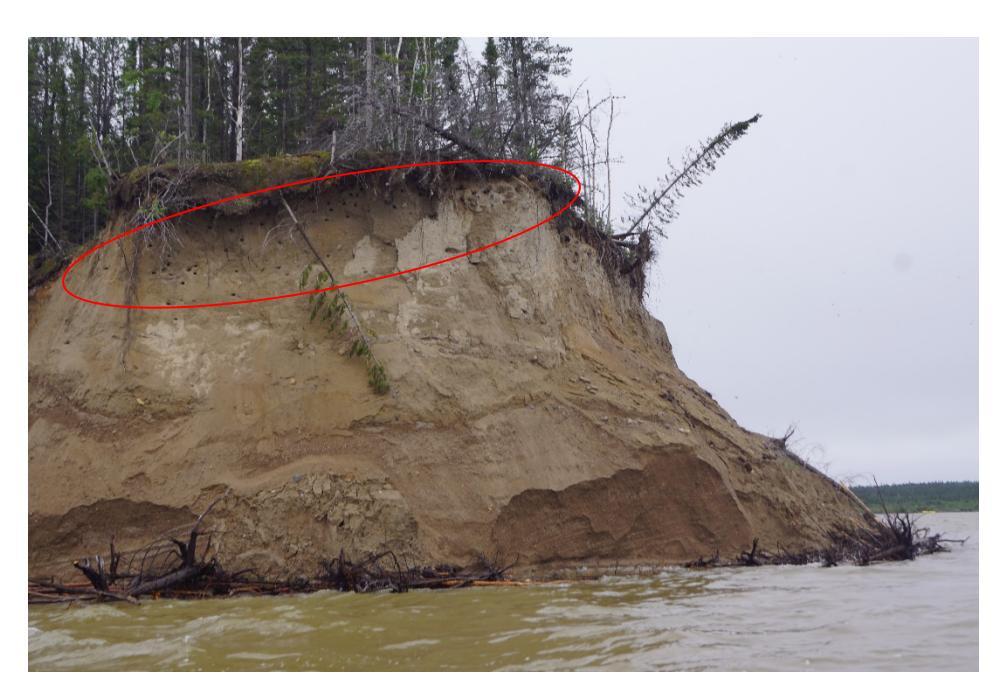
Photo 2: Portion of a Large Bank Swallow Colony at Site 12, July 2020

Red oval indicates bank swallow burrows; note undercutting of bank at water level.

The large colony at site 12 was formed from erosion processes shortly after a small peninsula separated from the mainland and formed two islands on Stephens Lake circa 2005. There was no evidence of bank swallow colonies on the small island in 2008. A small to moderate-sized cluster of nesting burrows was first observed in 2011, suggesting that the colony formed between 2009 and 2011. Substantial numbers of burrows were recorded on this island in 2016 and 2018. The size of the pioneering bank swallow colony is unclear, and it is unknown whether the increase in colony size several years later might be attributed to con-specific attraction, high colony productivity and survival, or both. There was a small increase (6%) in the mean number of burrows observed at this site from 2016 to 2018 and a 44% decrease from 2018 to 2020. This relatively large decrease could be due to erosion caused by high water levels in 2020, which may have resulted in the collapse of previous years' burrows (see Photo 2). However, site 12 remained the largest colony in the study area in terms of the mean number of burrows.

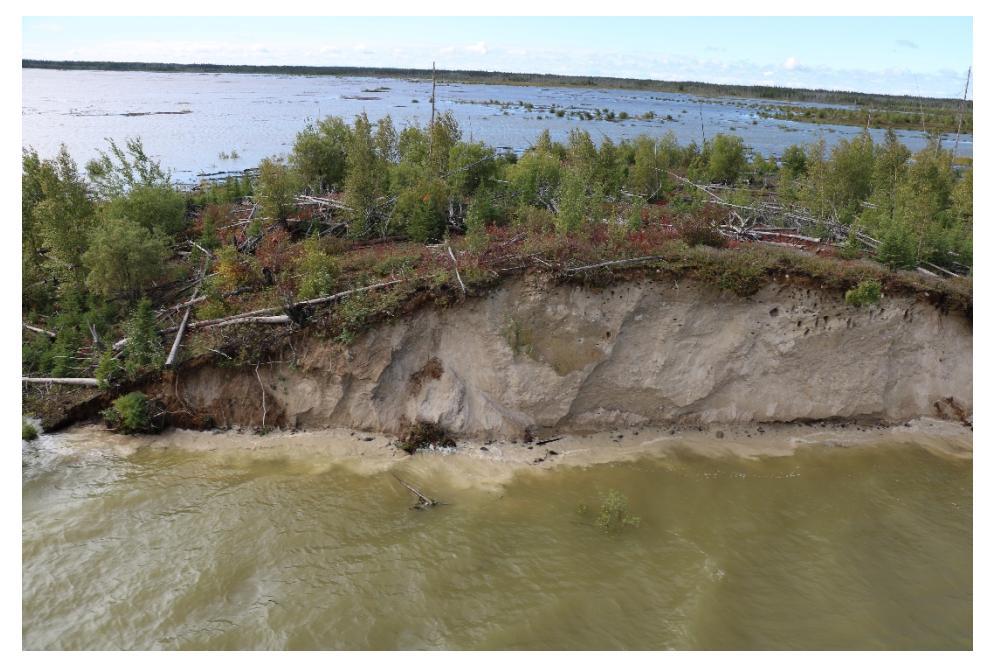
Photo 4: Undercutting and Bank Erosion at Site 04, September 2020

All bank swallow nesting colonies in the reservoir area were monitored before and during impoundment (sites 04, 06, 07, 09, 10, and 11+19; see Map 1). Sites outside of the affected area were also monitored. Up to 50 bank swallows, some of which were feeding their young, were observed at sites 04 and 07 during the pre-impoundment surveys in late August. Nesting material was seen in a burrow at site 07 (Photo 3). A single bird was also observed at site 02, outside of the affected area. However, no activity was observed at these sites, or any other colonies, immediately preceding or during impoundment. Undercutting of the bank and erosion were observed at sites 04, 06, and 07 during reservoir impoundment (Photo 4 to Photo 6), resulting in the collapse of an estimated 50% of the burrows at sites 04 and 07 and approximately 10% of the burrows at site 06. None of the burrows at these sites were flooded; all were above the reservoir water level and the bank habitat at each site still appeared to be suitable for future nesting.

In September 2020, there was bank undercutting and erosion underneath the existing bank swallow burrows at three nesting sites within the reservoir during impoundment, resulting in the collapse of up to half of the unoccupied burrows at each. The steep, sandy banks required for nesting persisted at each site. As such, the collapse of existing burrows will likely have little or no effect on the regional population, given that new burrows are typically constructed each year (Garrison 1999; Falconer et al. 2016). While the remaining habitat appeared be suitable for nesting at the time of the impoundment monitoring survey, it is uncertain if these sites will be suitable in the near future, and nesting success may be reduced if a high rate of bank erosion results in the collapse of active burrows. There are numerous other natural sites available for nesting in the region. No accidental bank swallow mortality was reported during construction or impoundment monitoring.

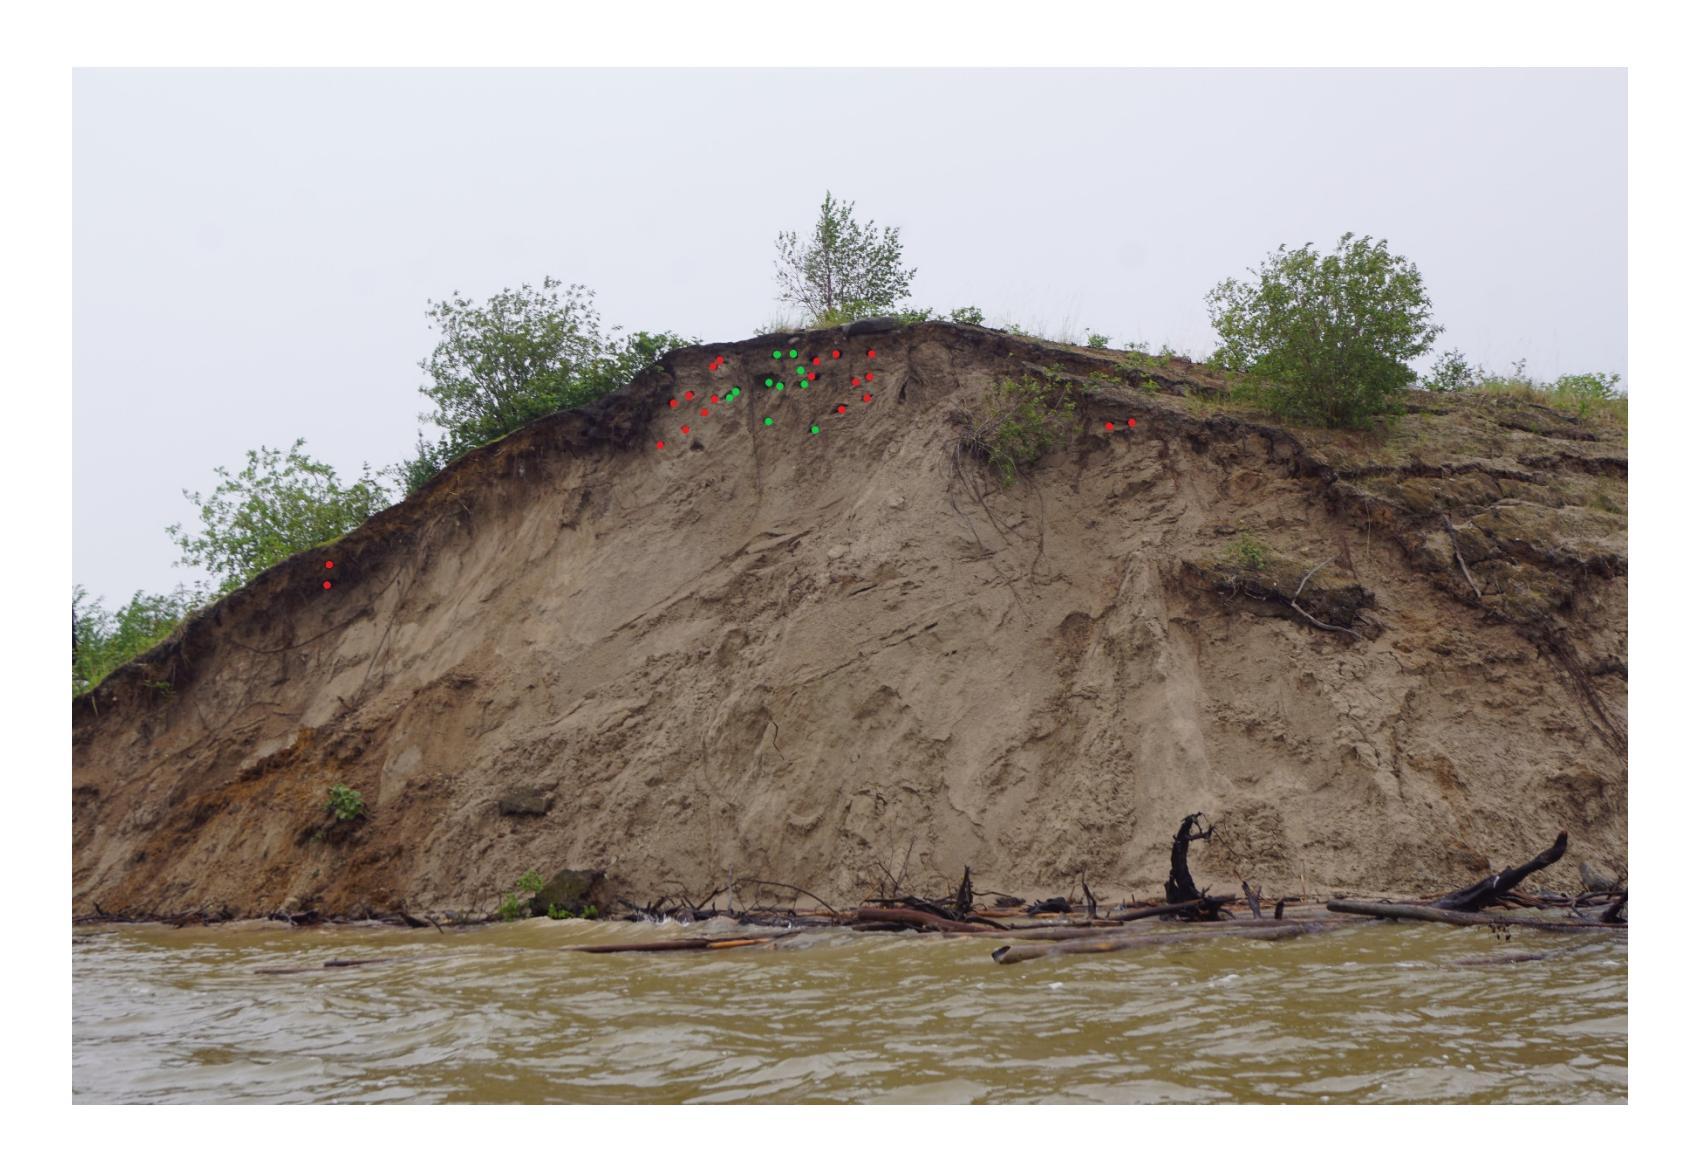
APPENDIX 1: EXAMPLE COUNT OF BURROWS IN PHOTOGRAPH

Note: Alternating colours were used for each group of 10 burrows to facilitate counting.

Photos taken at each colony were magnified in Paint 3D, and the number of burrows was counted independently by two observers (Appendix 1). The mean of these counts and the preliminary field count, plus standard deviation and 95% confidence interval were calculated at each site for each of the two visits.
