Keeyask Generation Project Environmental Impact Statement

Supporting Volume Physical Environment

KEEYASK
GENERATION PROJECT
SHORELINE EROSION
PROCESSES

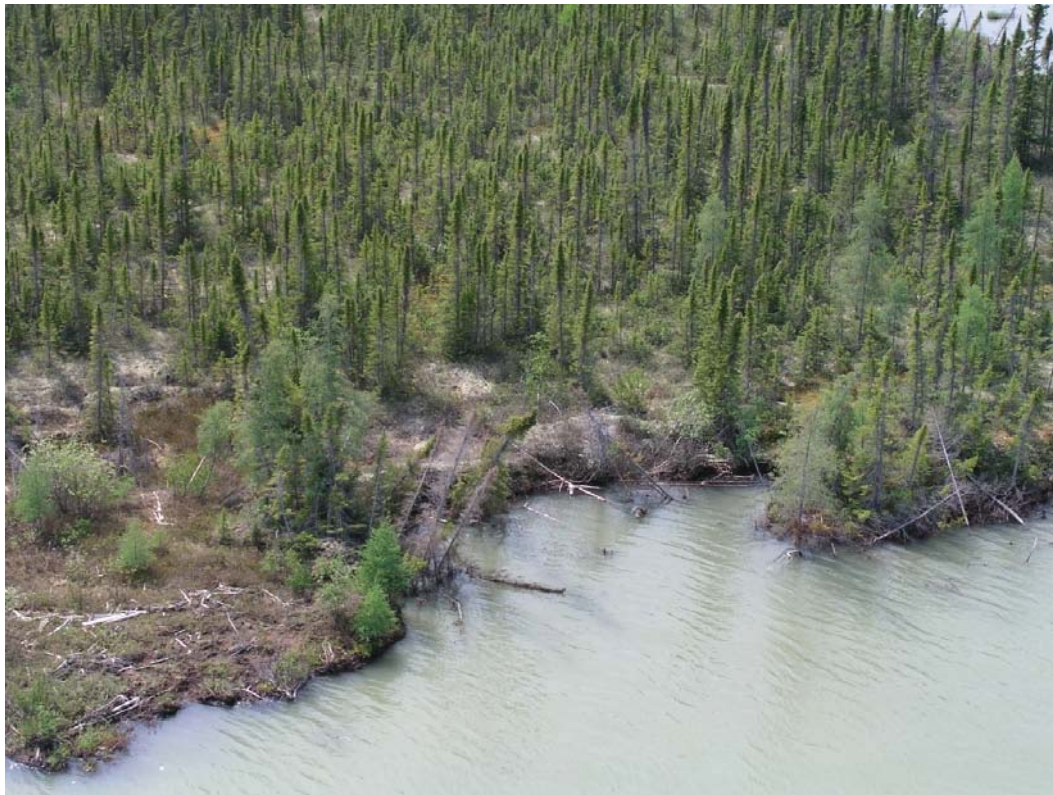
Photo 6.1-1: Peat Shoreline on the Nelson River that is Formed by Inland Peatlands

(Note that Water Level is High, Hiding Most of the Bank Face)

Most **shoreline** peatlands on the existing Nelson River shoreline within the Shoreline Erosion Processes Study Area (defined in the following section) are the banks of **inland peatlands** that extend to the river and stop at the water's edge (Photo 6.1-1). In **off-system** streams and lakes, inland peatlands often transition into **aquatic peatlands** that extend into the shallow water zone. (Note the Aquatic Peatlands adjacent to the open water, adjacent treed areas are also Peatlands – Photo 6.1-2).

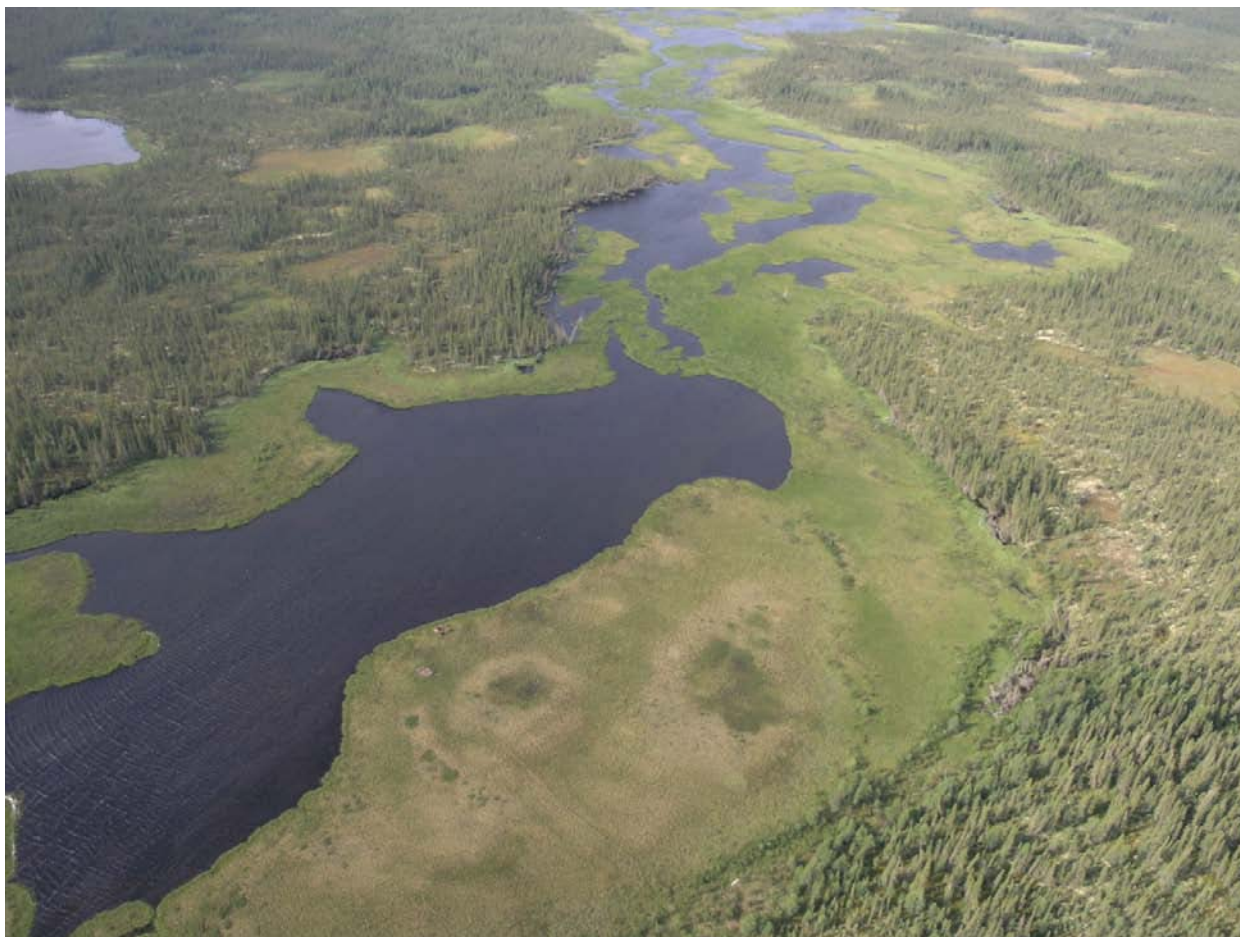
Photo 6.1-2: Example of Shoreline Peatlands in Off-System Lakes and Streams

(Note the Aquatic Peatlands Adjacent to the Open Water. Adjacent Treed Areas are also Peatlands)

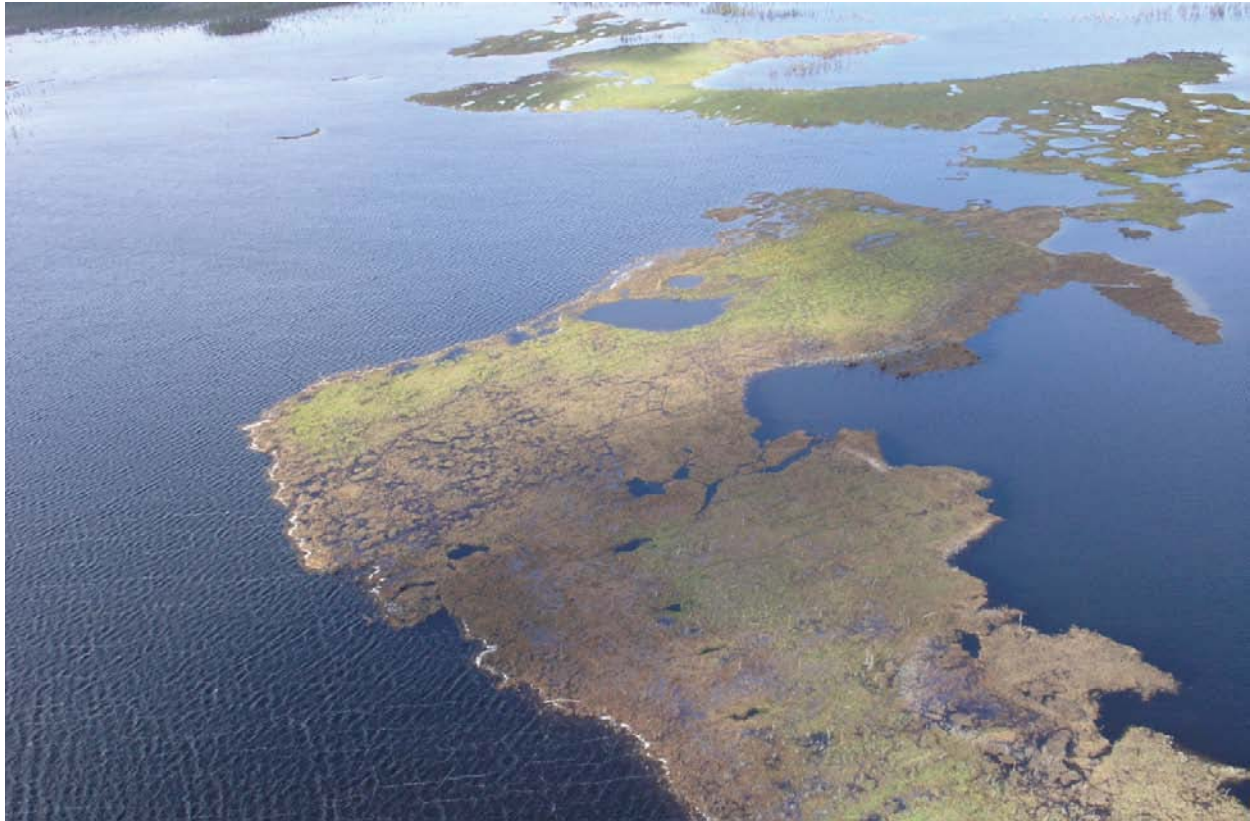
Photo 6.1-3: Example of Flooded Peatlands and Peat Resurfacing

The islands in the Photo are the Surface Layer of Peatlands that were Submerged by Flooding which Subsequently Floated to the Water Surface

The **Post-project** environment will include peat resurfacing, a peatland process that is not currently occurring in the existing environment. Portions of flooded peatlands will float to the surface (Photo 6.1-3). The amount and timing of peat resurfacing is primarily determined by the degree to which flooded peat mat buoyancy is counteracted by sediment accumulation, hydrostatic pressure and physical attachment. The primary additional driving factors for peat resurfacing are as follows:

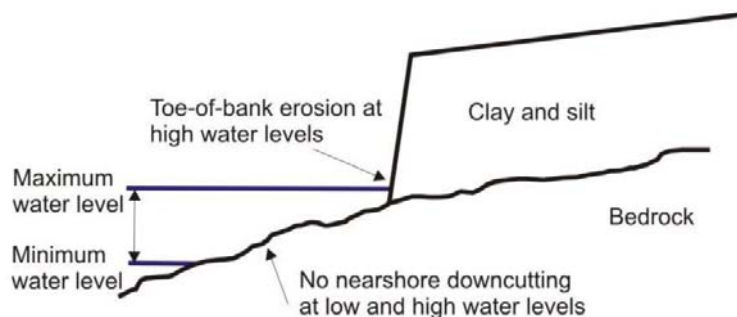
Figure 6.1-3: Schematic Illustrating Erosion of Mineral Material Over Bedrock Under High and Low Water Levels

Figure 6.1-3 illustrates erosion processes during periods of high and low water levels in clay and silt shorelines and shorelines where clay and silt overlies bedrock. When water levels are high enough to reach the bank toe, wave erosion at the bank toe dominates the shore erosion process. Over steepening of the bank due to toe erosion commonly causes accompanying topple and slumping failure of the upper bank slope, which results in rapid short-term top-of-bank recession.

With respect to both riverine and lake processes, when water levels are low, weathered bank material shed by mass-wasting accumulates at the toe-of-bank, temporarily above the reach of incoming waves or current flow. The dominant wave erosion process at times of low water level is progressive down cutting and flattening of the beach slope due to dissipation of wave energy across the nearshore slope. Washing by waves reworks coarser sediment accumulated on the beach surface. For those shores where bedrock is exposed at lower water elevations no nearshore down cutting occurs.

High water levels following a period of low water level result in removal of failed bank material. If high water levels are sustained, removal of failed bank material is followed by toe-of-bank erosion and continued erosion of the nearshore slope. As water levels drop again, weathered and sloughed bank material begins to accumulate at the bank toe again; and remains there until the next rise in water level and incursion of waves. Prolonged saturation of submerged shoreline sediments during sustained periods of high water levels and during winter months generally reduces the inherent internal strength of **cohesive** sediments making them more susceptible to erosion during subsequent open-water wind events.

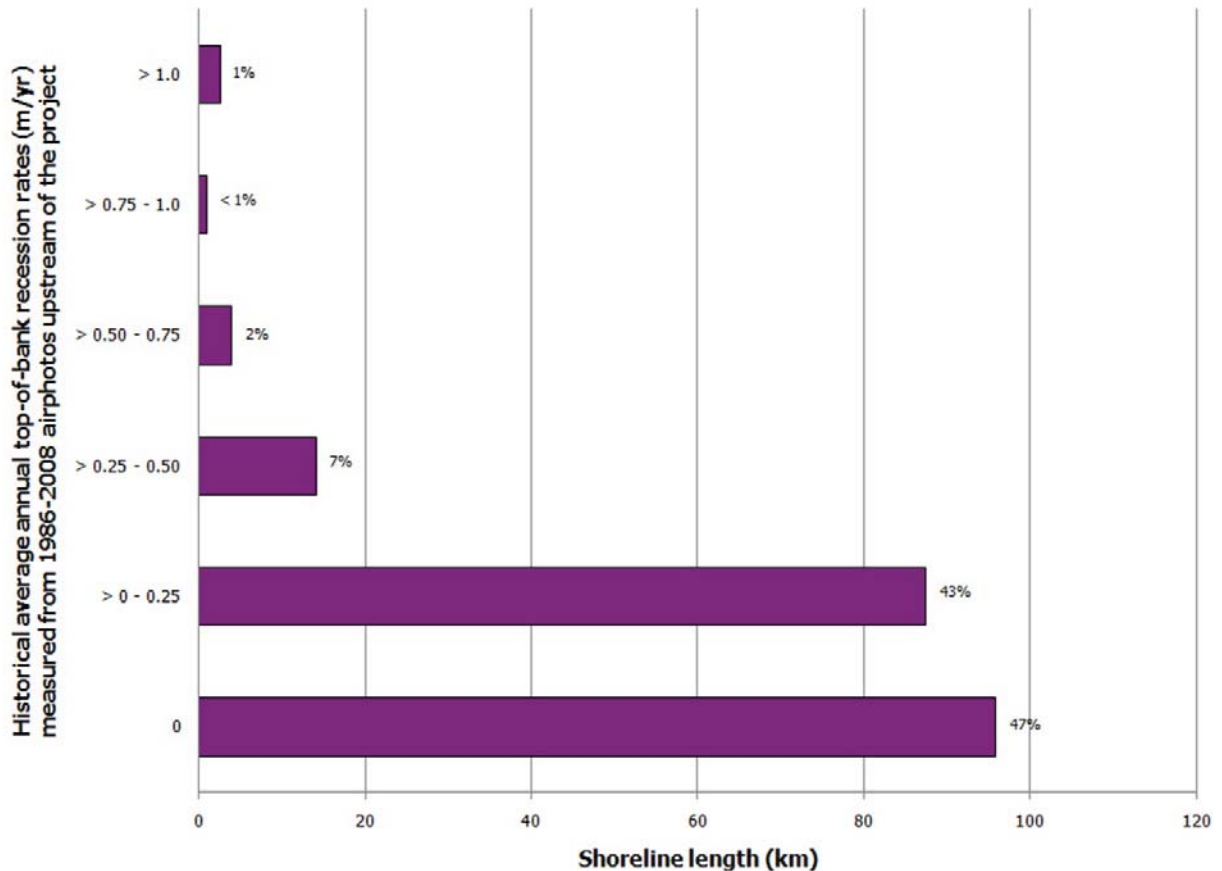
Figure 6.3-1: Historical Average Annual Top-of-Bank Recession Rates Measured from Air Photos

Average annual bank recession rates determined by comparing air photos from 1986 and 2006 (20-year period) for shorelines upstream of the Project are summarized in Figure 6.3-1. Shoreline lengths listed (in Figure 6.3-1) include all mineral and peat shoreline types. Nearly half of all shoreline did not erode from 1986 to 2006, approximately 43% of eroding shorelines eroded less than 0.25 m/yr and less than 10% eroded between 0.25 m/y to 1.0 m/y. Very little shoreline (1.3%) eroded more than 1 m/y. Shoreline reaches that experienced the highest bank recession rates tend to be located in the Gull Rapids area where ice dams cause channelized flow and localized high bank erosion rates.

Historical average annual top-of-bank recession rates measured from air photos agree closely with recent bank recession rates measured at erosion **transect** sites in the study area. The average recession rate for eight transect sites in the riverine reach between Gull Lake and Clark Lake was 0 m/y for the 1-year period 2006-2007. The average recession rate at 14 transect sites in Gull Lake for the 2006 to 2007 period was 0.28 m/y. Even though the comparison between long-term historical rates and recently measured rates at transects is similar, it must be noted that bank recession rates typically show a high degree of year-to-year variability. Therefore, longer-term transect data would be helpful to confirm the comparison with historical rates measured from air photos.

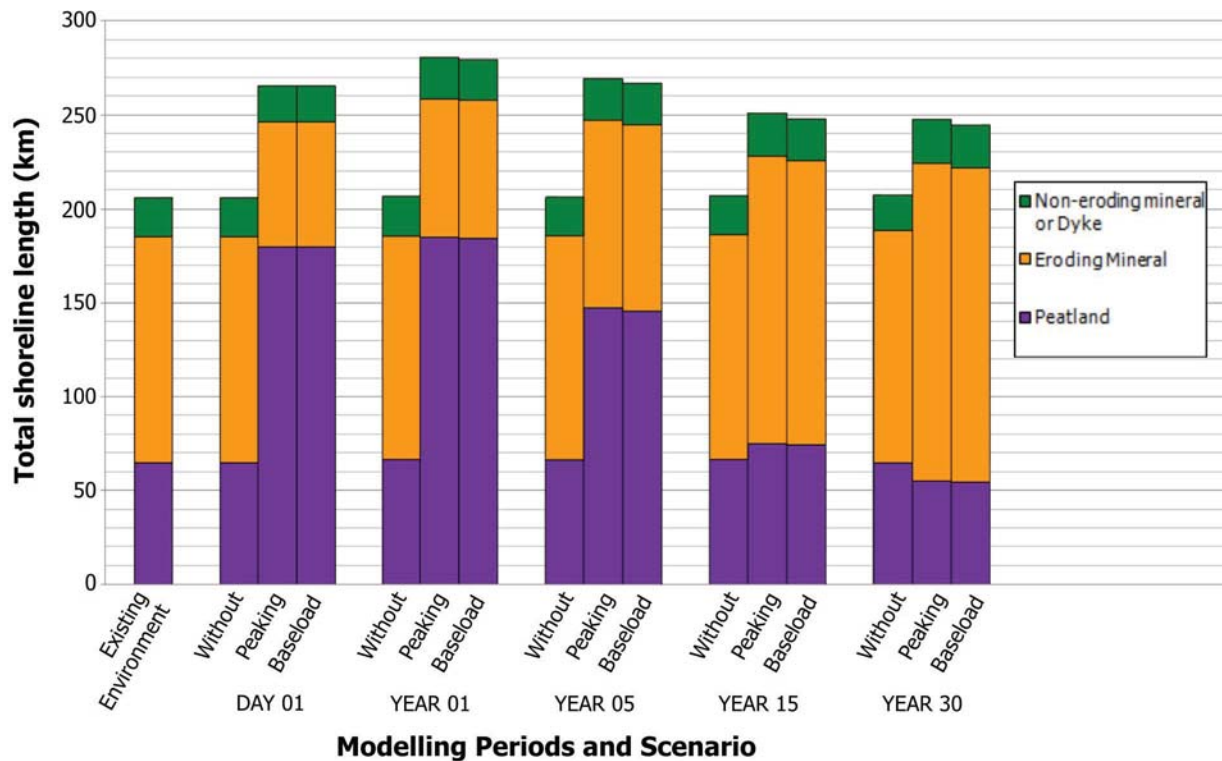
Figure 6.4-1: Histogram Showing the Length of each Shoreline Type and Total Shoreline Length for each Model Interval. Eroding Mineral Shorelines

(Note: include shorelines where mineral bank is overlain by peat)

Shoreline material composition at Year 30 is shown in Map 6.4-4 and Map 6.4-5. The primary change in shoreline composition over the first 30 years of operation consists of saturated peat shorelines transitioning to mineral overlain by peat shorelines. Mineral shorelines and mineral overlain by peat shorelines account for 68% to 69% of shoreline length by Year 30 (Figure 6.4-1). Although the length of shoreline along bedrock outcrop and the proposed dykes and dam increases slightly, the total percentage of this shoreline type remains at approximately 9% during the first 30 years of operation.

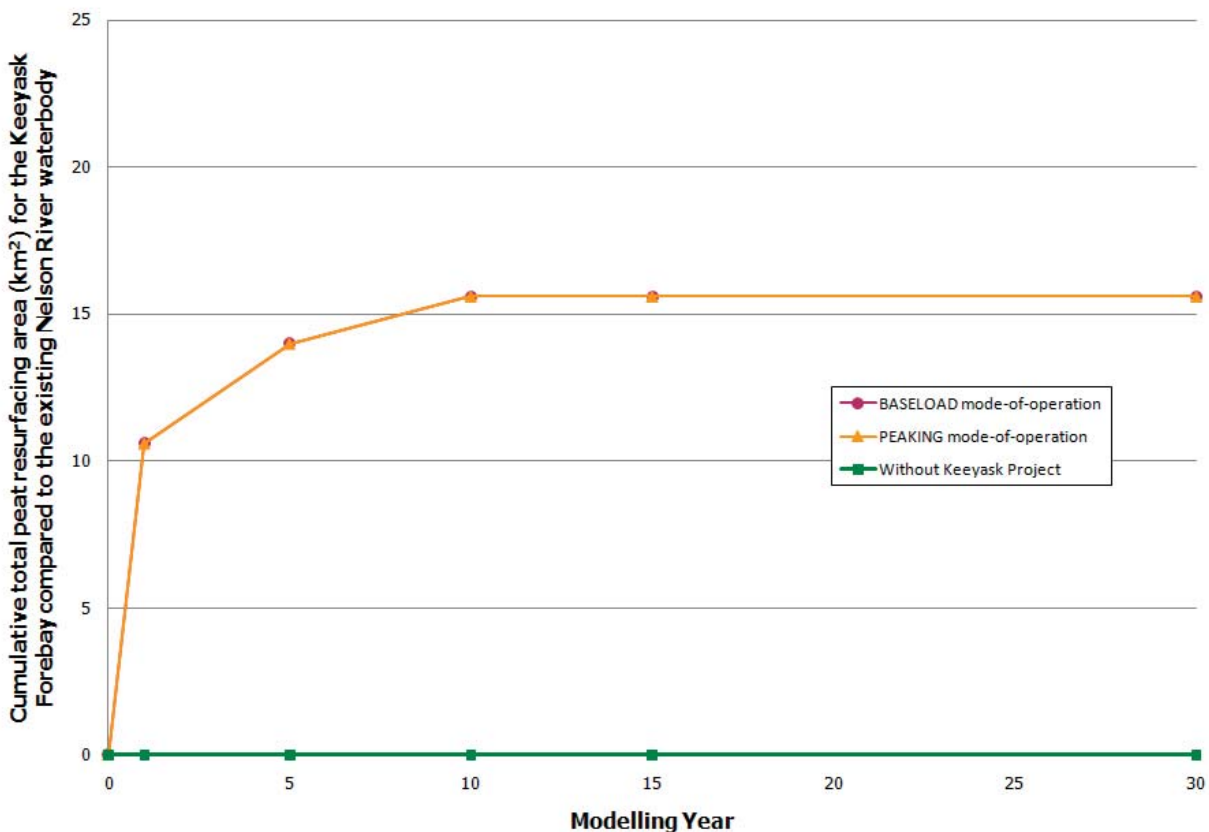
Figure 6.4-5: Cumulative Total Peat Resurfacing Area for With and Without Project Conditions

Two-thirds of all of the peat resurfacing is expected to occur in the first year and then decline steadily until there is no peat resurfacing after 10 years of operation. Figure 6.4-5 shows the cumulative peat resurfacing area for the Keeyask reservoir compared to existing conditions for the 30-year modelling period. It should be noted that there is relatively high **uncertainty** concerning the timing of the peat resurfacing during the first few years.

It is predicted that approximately 15 km² to 16 km², or 35% to 36%, of flooded peatland area will resurface. Floating peatlands that move up with the rising water during reservoir impoundment are included in this total area. More than 80% of predicted **peat resurfacing** is in water shallower than 2 m. Approximately 25% of floating peat mats is expected to be mobile during Year 1.

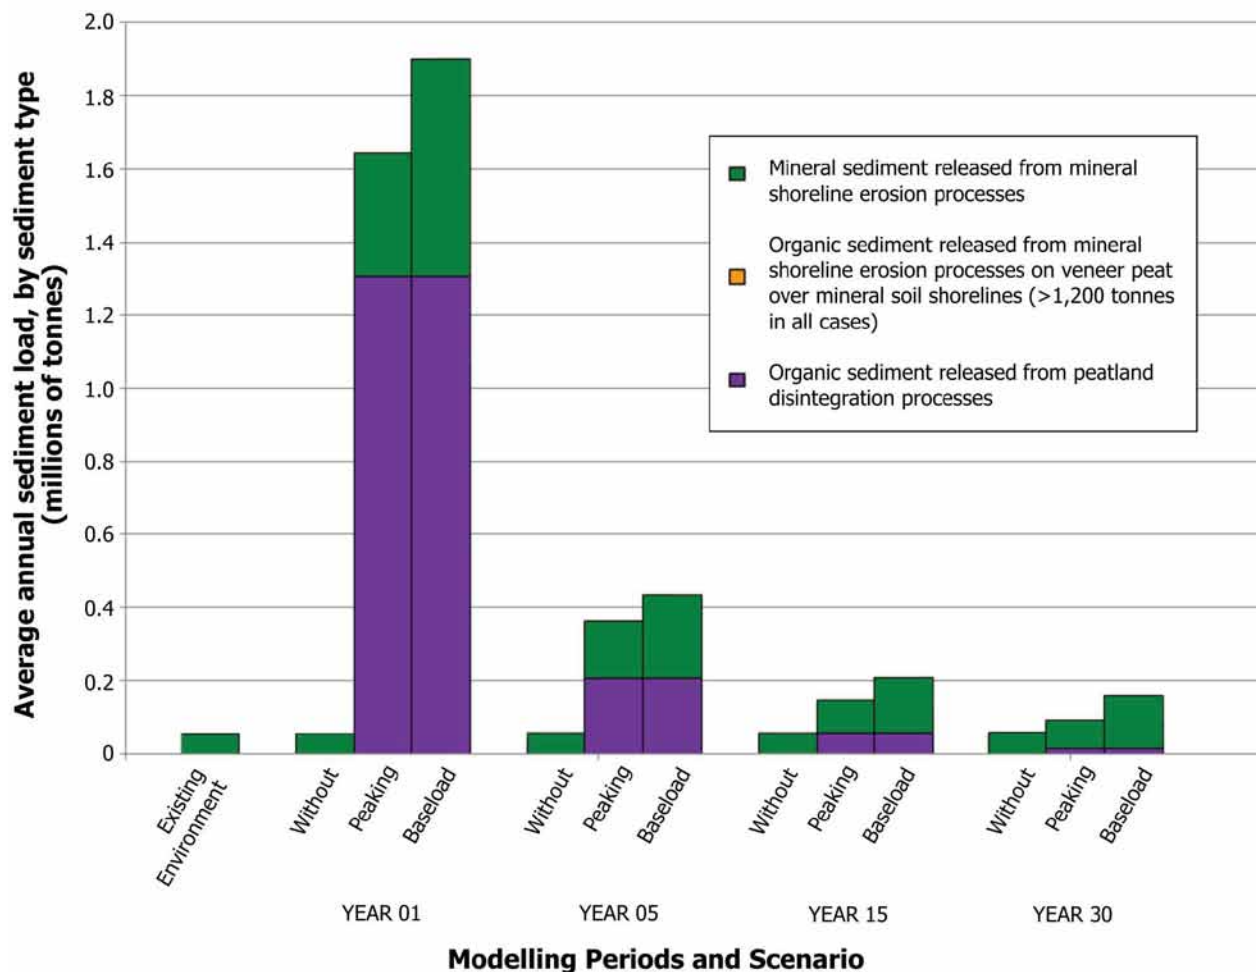
Figure 6.4-8: Comparison of Projected Average Annual Mineral and Organic Sediment Loads Generated by Peatland Disintegration and Erosion of Mineral Banks With Overlying Peat With and Without the Project

More than 90% of the total peat area disintegrated during a prediction period comes from water shallower than 3 m due to a combination of two factors. First, hydrostatic pressure increases linearly with water depth and counteracts submerged peat mat buoyancy to reduce resurfacing rates. Second, the water in a high percentage of the flooded area is shallower than 3 m (*i.e.*, 63%) which reduces the potential influence of hydrostatic pressure on peat resurfacing. The percentage of peat disintegration in water shallower than 3 m is highest during Year 1 and Years 16 to 30. Peat resurfacing in shallow-flooded areas contributes to this pattern in Year 1. Shoreline peatland breakdown is the sole source of organic input from peatland disintegration processes during Years 16 to 30.
