Peatland Disintegration and Erosion in the Western Upstream Reaches

During First 30 Years of Operation

PE - 6

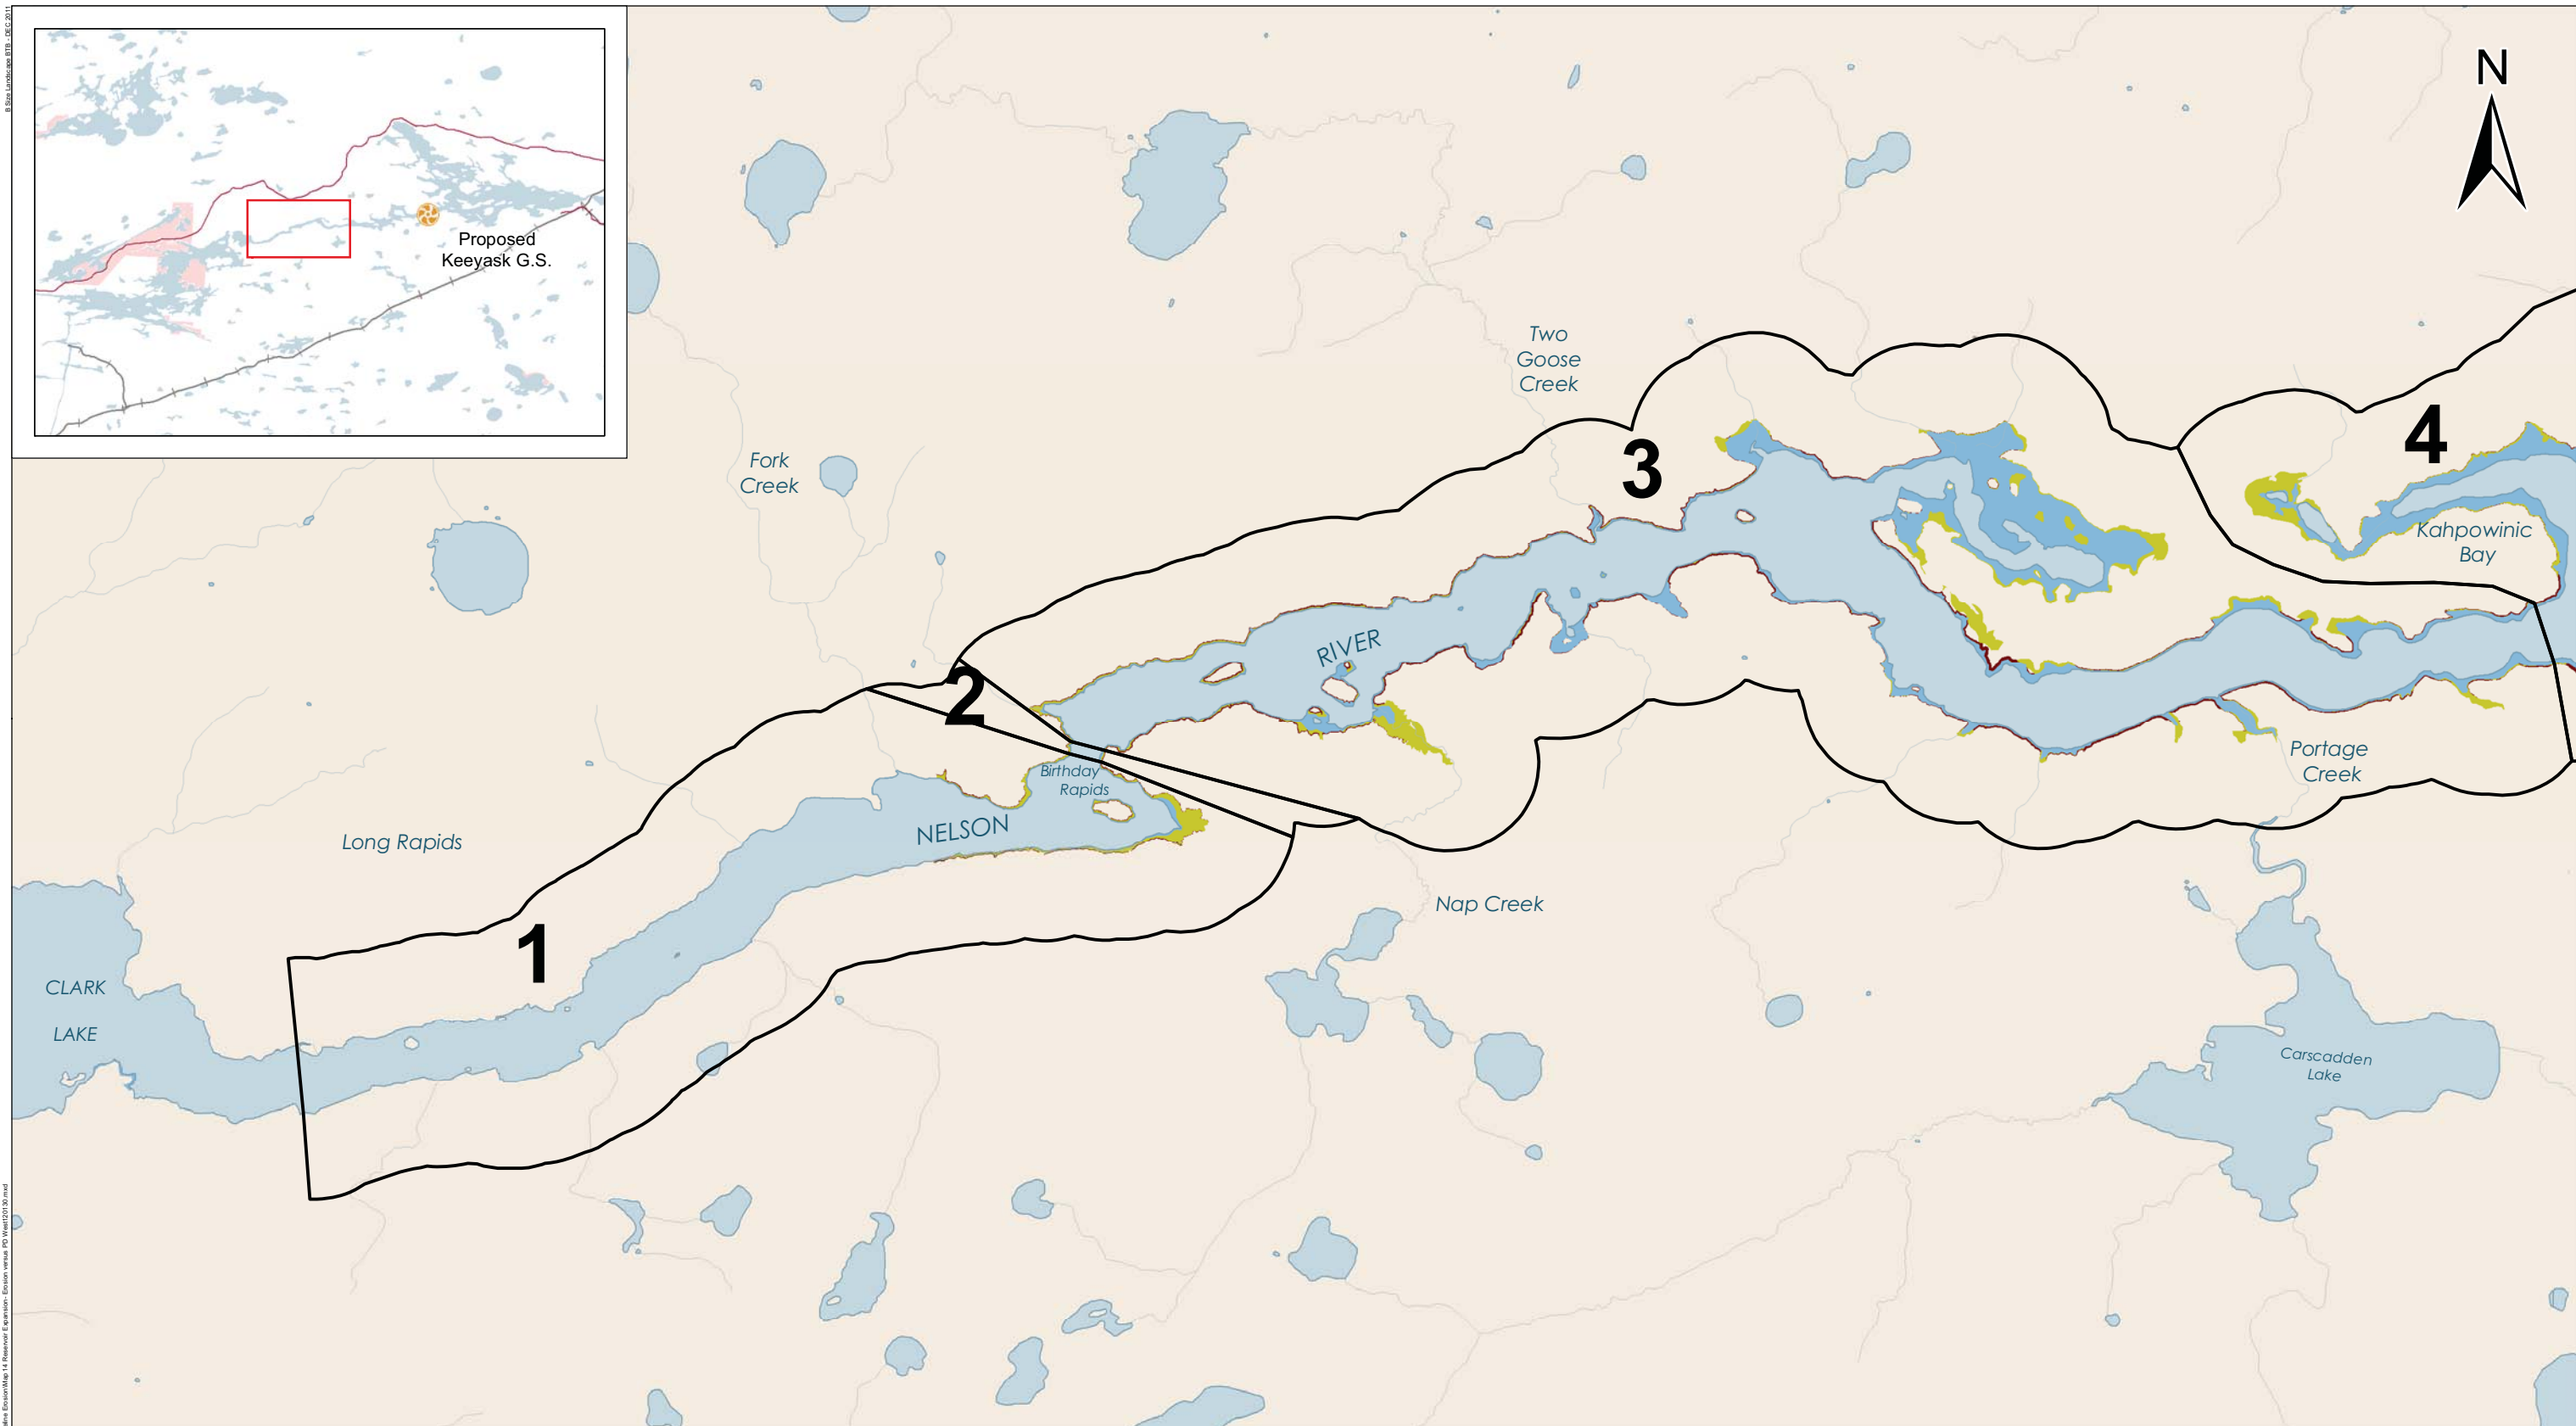
- Existing Water Surface Area
 - Initial Flooded Area (159 m)
 - Peatland Disintegration
 - Mineral Bank Erosion
- Post Project Reach**
- 1 = Riverine Shore Zones Upstream of Birthday Rapids
 - 2 = Riverine Shore Zones at Birthday Rapids
 - 3 = Riverine Shore Zones Downstream of Birthday Rapids to the Inlet of Gull Lake
 - 4 = Lake Shore Zones in Gull Lake
